U.S. Department of Energy
National Nuclear Security Administration
Livermore Field Office, Livermore, California 94551

Lawrence Livermore National Laboratory

Second Five-Year Review Report for the
Building 854 Operable Unit at
Lawrence Livermore National Laboratory Site 300

January 8, 2014

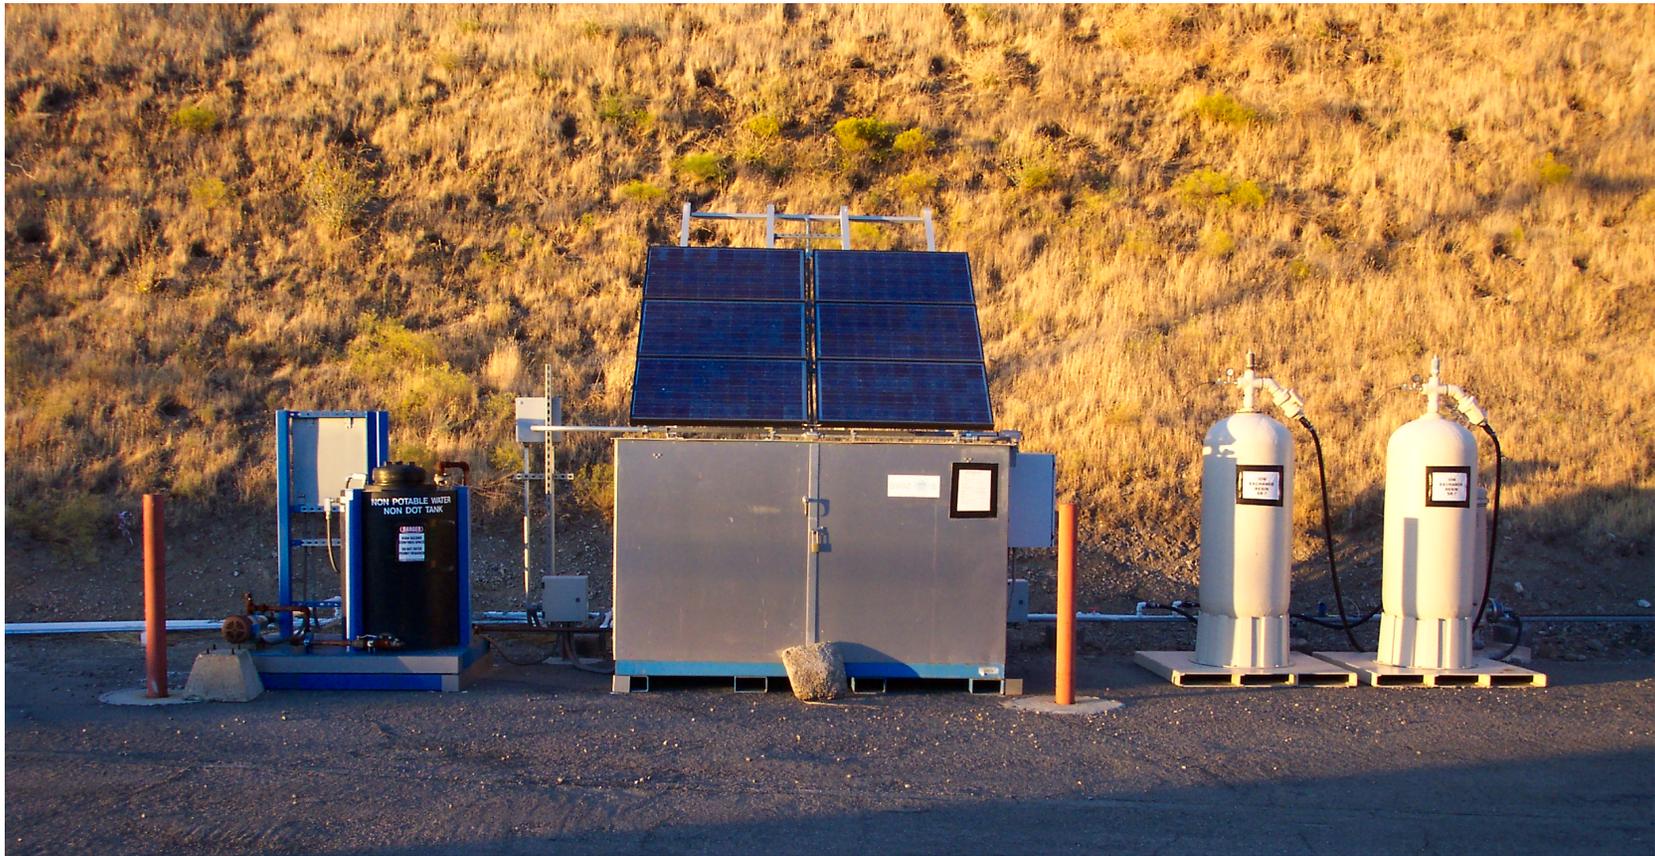
The Building 854-Source ground water extraction and treatment system (GWTS) began operation in December 1999 removing volatile organic compounds (VOCs) and perchlorate from ground water. Ground water extraction was expanded in September 2006 from one well, W-854-02, extracting at a flow rate of approximately 1 gallons per minute (gpm), to include wells W-854-18A, W-854-17, and W-854-2218 currently extracting at an approximate combined flow rate of 1.7 gpm. The GWTS configuration includes a particulate filtration system, two ion-exchange resin columns connected in series for perchlorate removal, and three aqueous-phase granular activated carbon (GAC) units connected in series for VOC removal. Nitrate-bearing treated effluent is then discharged via a misting tower onto the landscape for uptake and utilization of the nitrate by indigenous grasses (next picture).

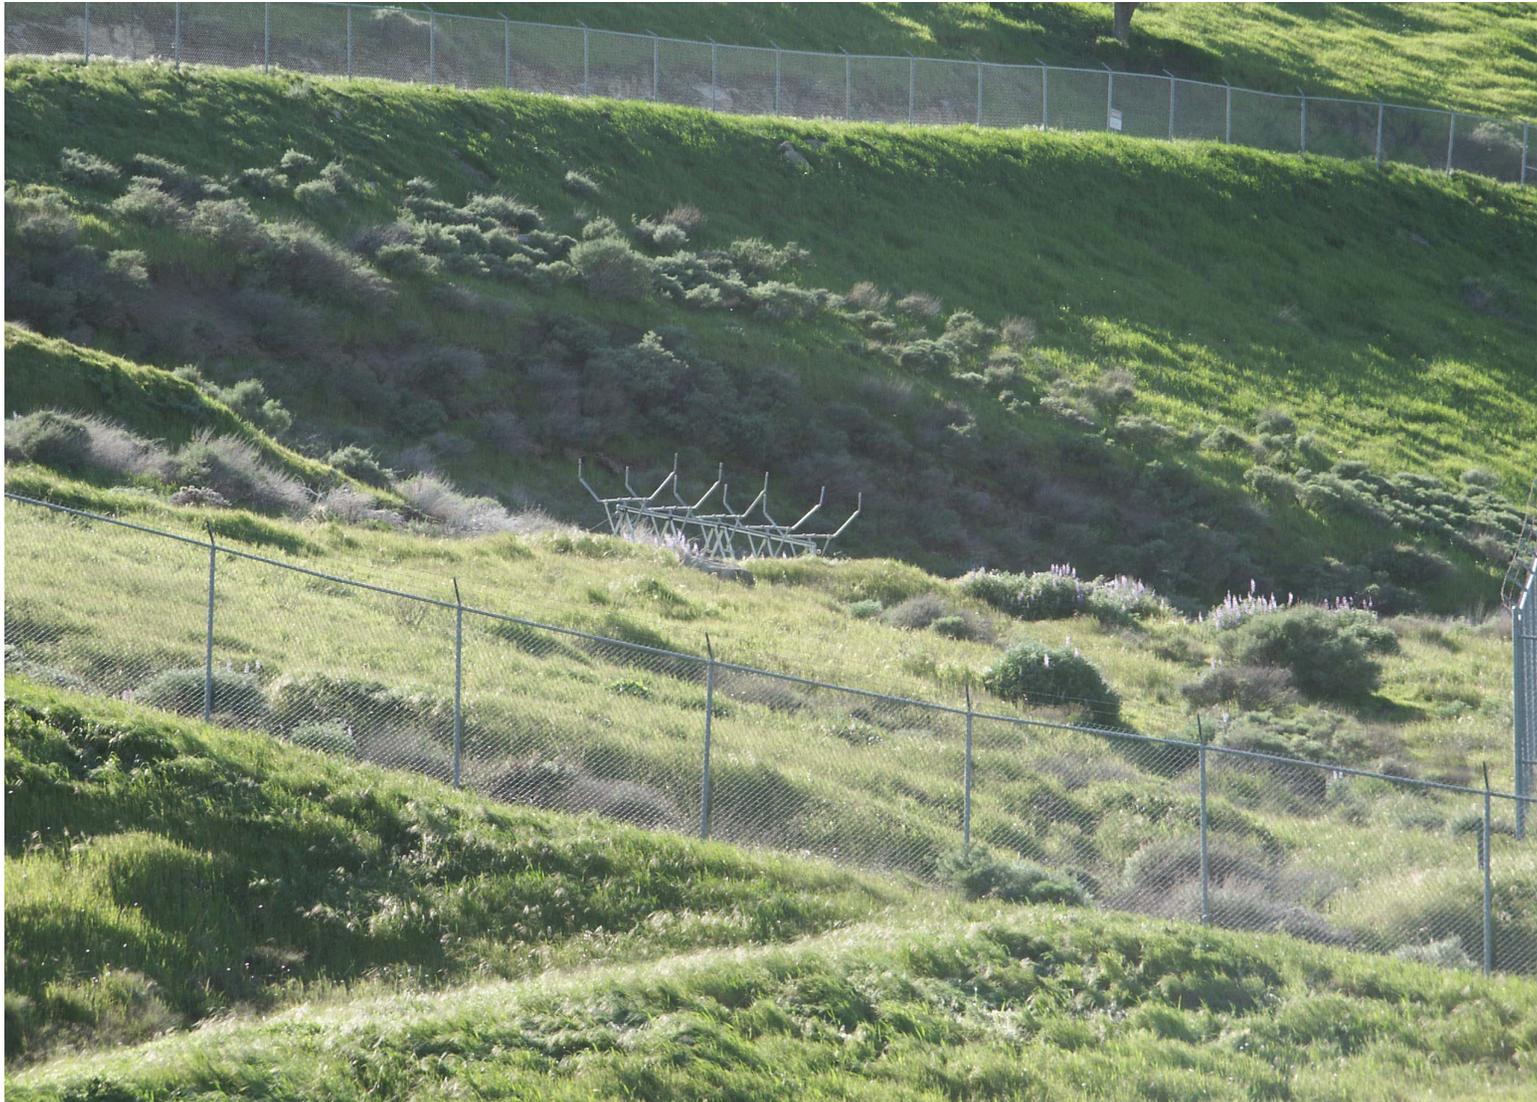
Building 854-Source ground water extraction and treatment system misting towers.

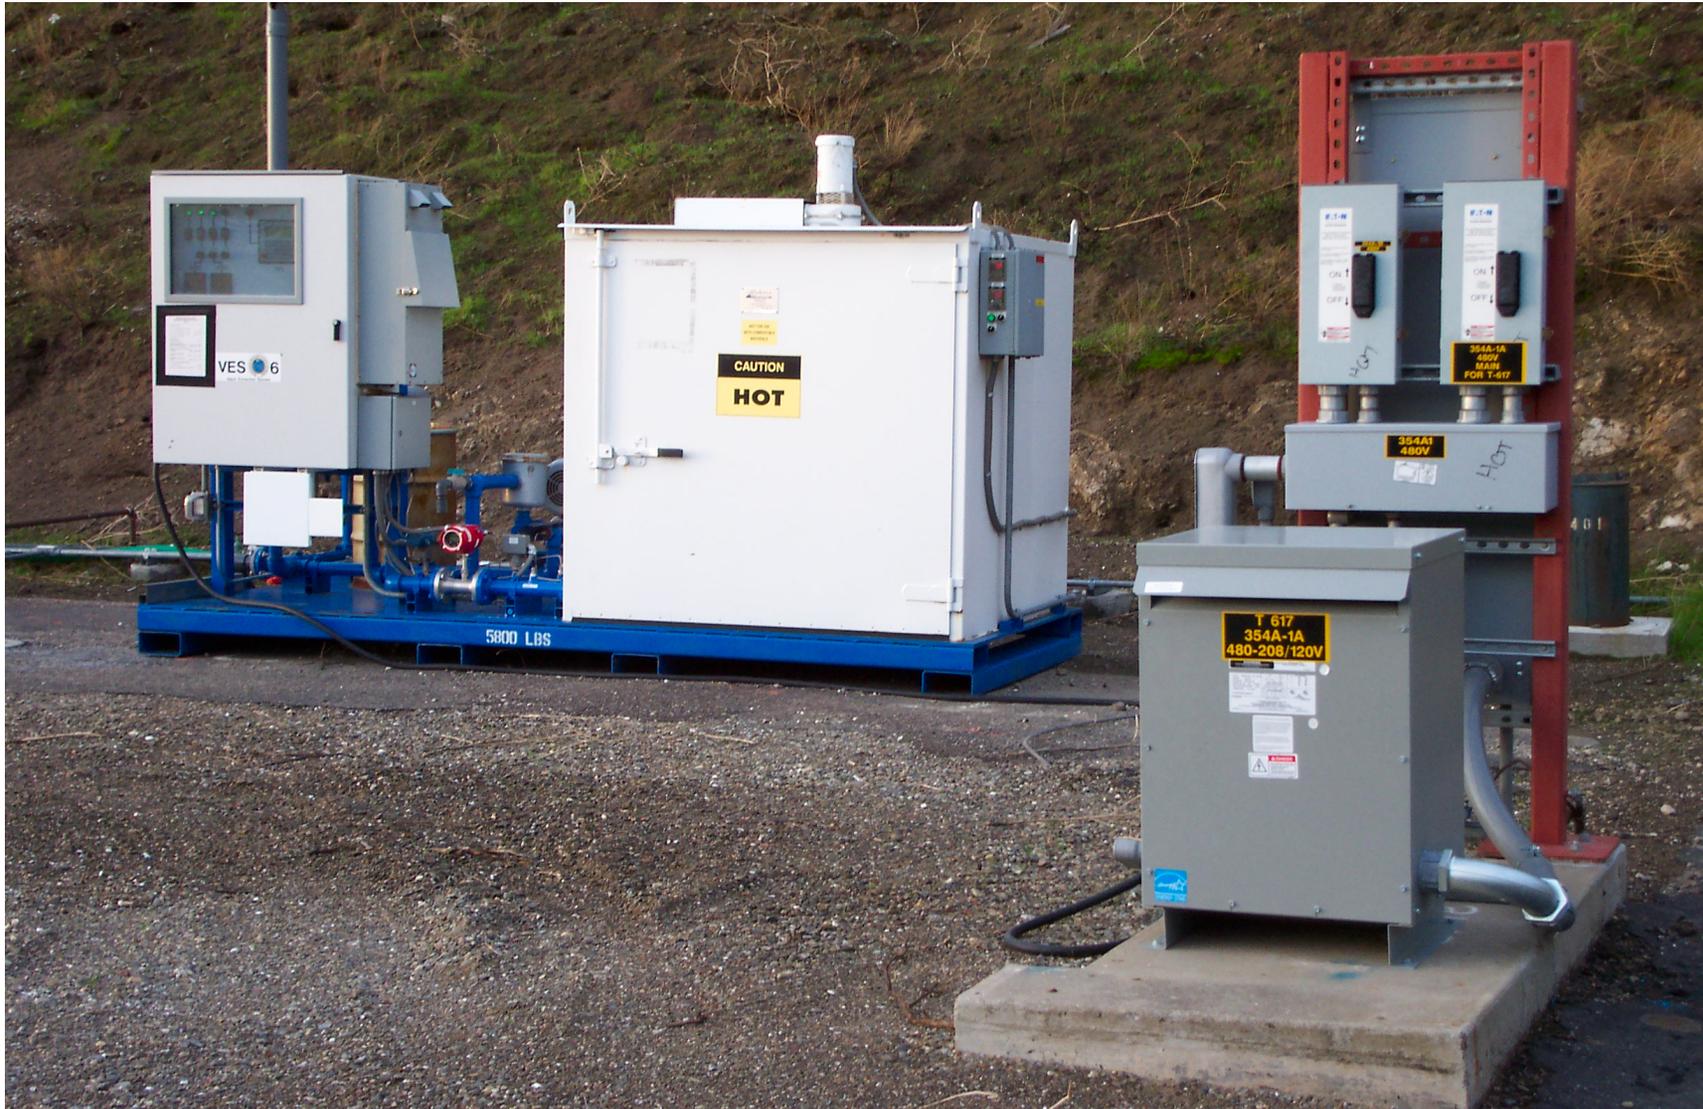
The Building 854-Source soil vapor extraction and treatment system (SVTS) began operation in November 2005. Soil vapor is currently extracted from well W-854-1834 at an approximate flow rate of 45 to 50 standard cubic feet per minute (scfm). This system consists of vapor-phase GAC to remove VOCs from extracted soil vapor. Treated vapors are discharged to the atmosphere under a permit issued by the San Joaquin Valley Air Pollution Control District.

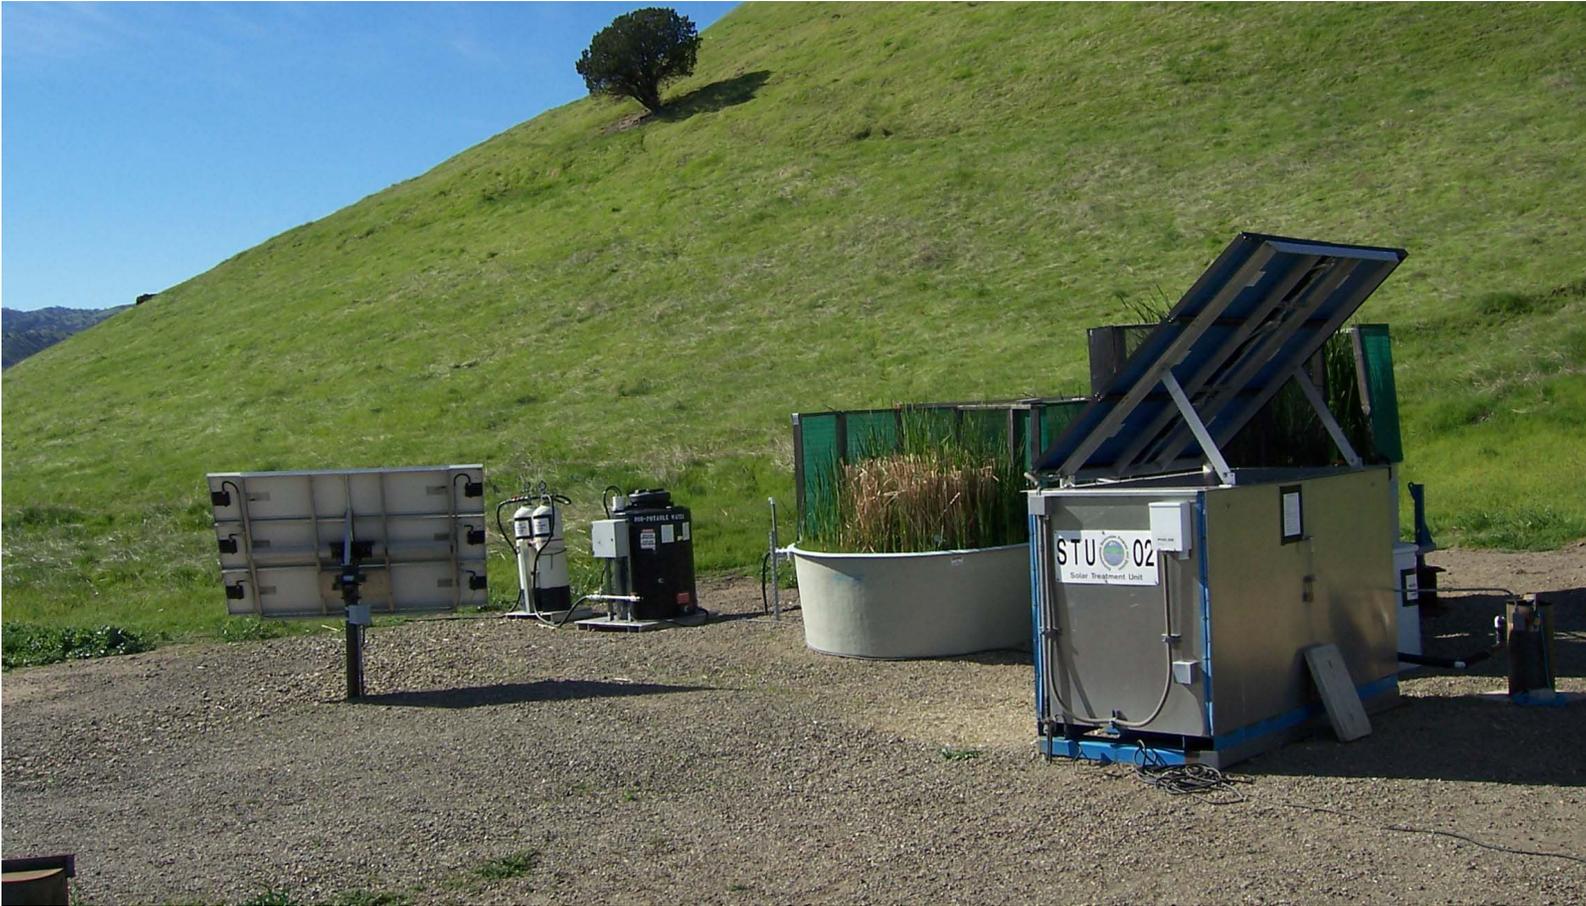
The Building 854-Proximal GWTS began operation in November 2000 removing VOCs, nitrate, and perchlorate from ground water. Ground water is currently extracted at an approximate flow rate of 1.5 gpm from well W-854-03, located southeast of the Building 854 complex. The GWTS configuration includes two ion-exchange resin columns connected in series for perchlorate removal, three aqueous-phase GAC units connected in series for VOC removal, and an aboveground containerized wetland biotreatment for nitrate removal prior to being discharged into an infiltration trench. In 2007, the treatment system was modified to replace the solar power with site power to increase the volume of extracted ground water by operating the GWTS 24-hours a day.

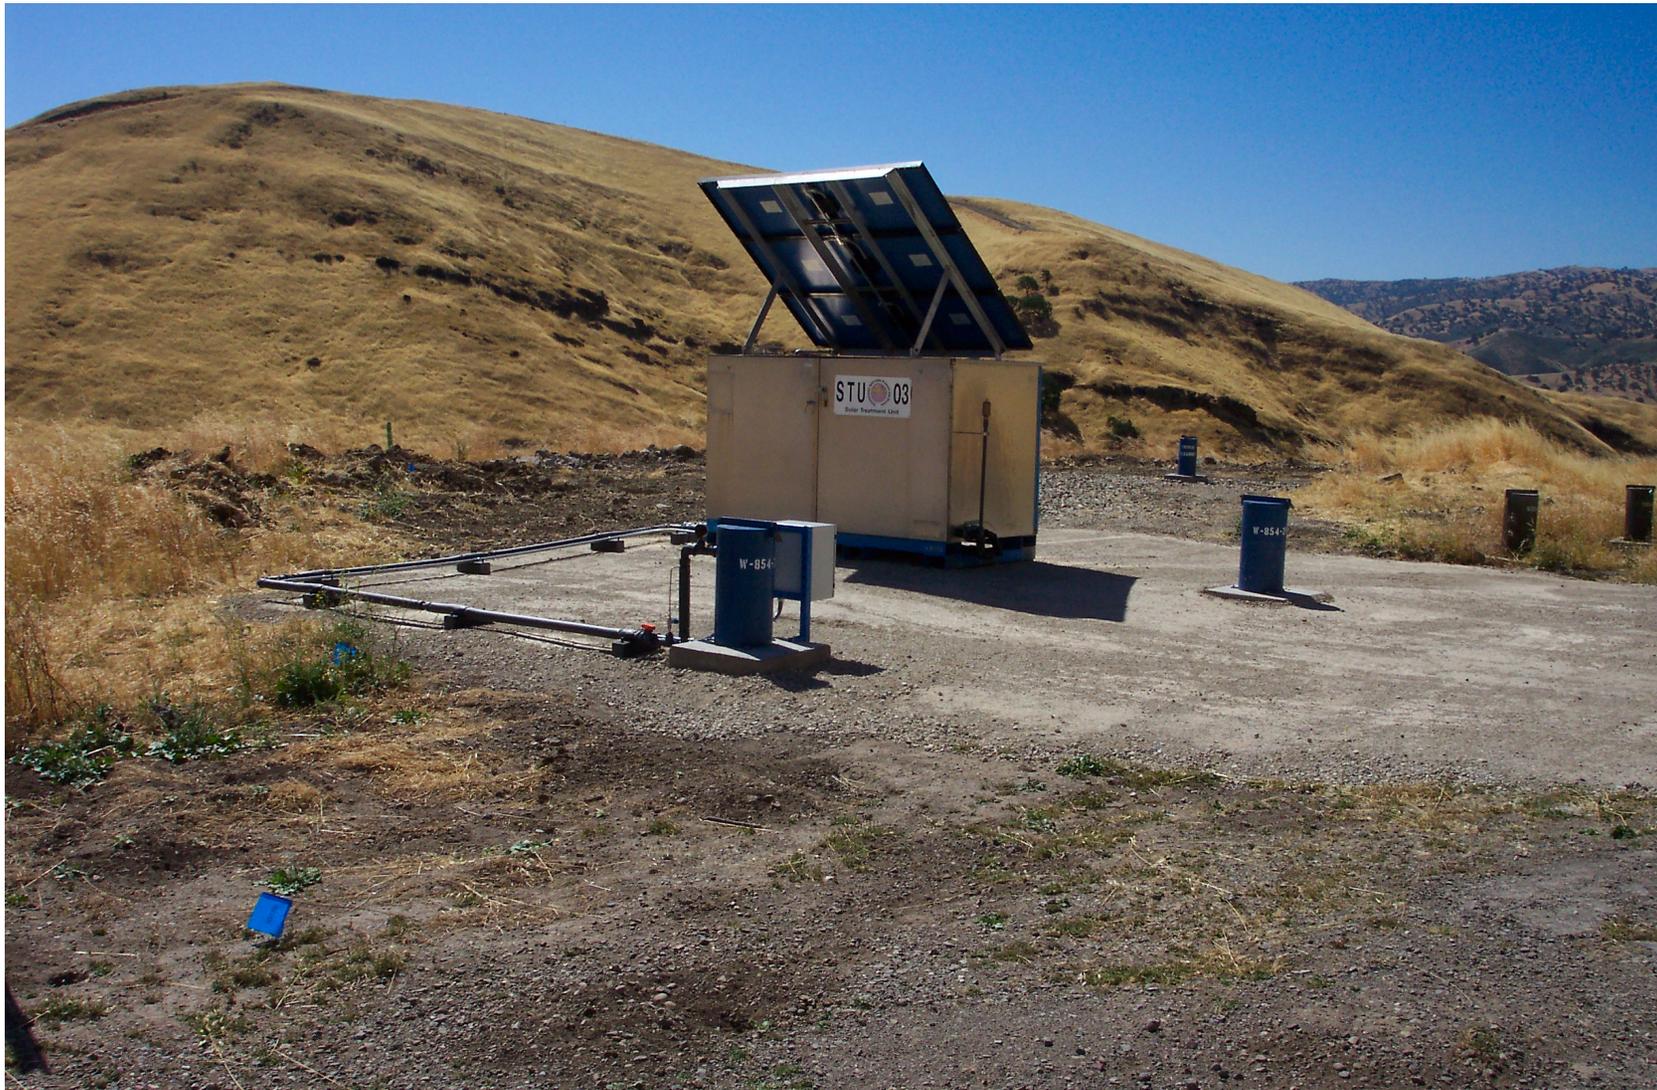
The Building 854-Distal GWTS is solar-powered and began operation in July 2006 removing VOCs and perchlorate from ground water. Ground water is extracted from well W-854-2139. The current operational flow rate averaged over time is approximately 700 to 800 gallons per month. The GWTS configuration includes two ion-exchange resin columns connected in series for perchlorate treatment followed by three aqueous-phase GAC units connected in series for VOC removal prior to discharge to an infiltration trench.

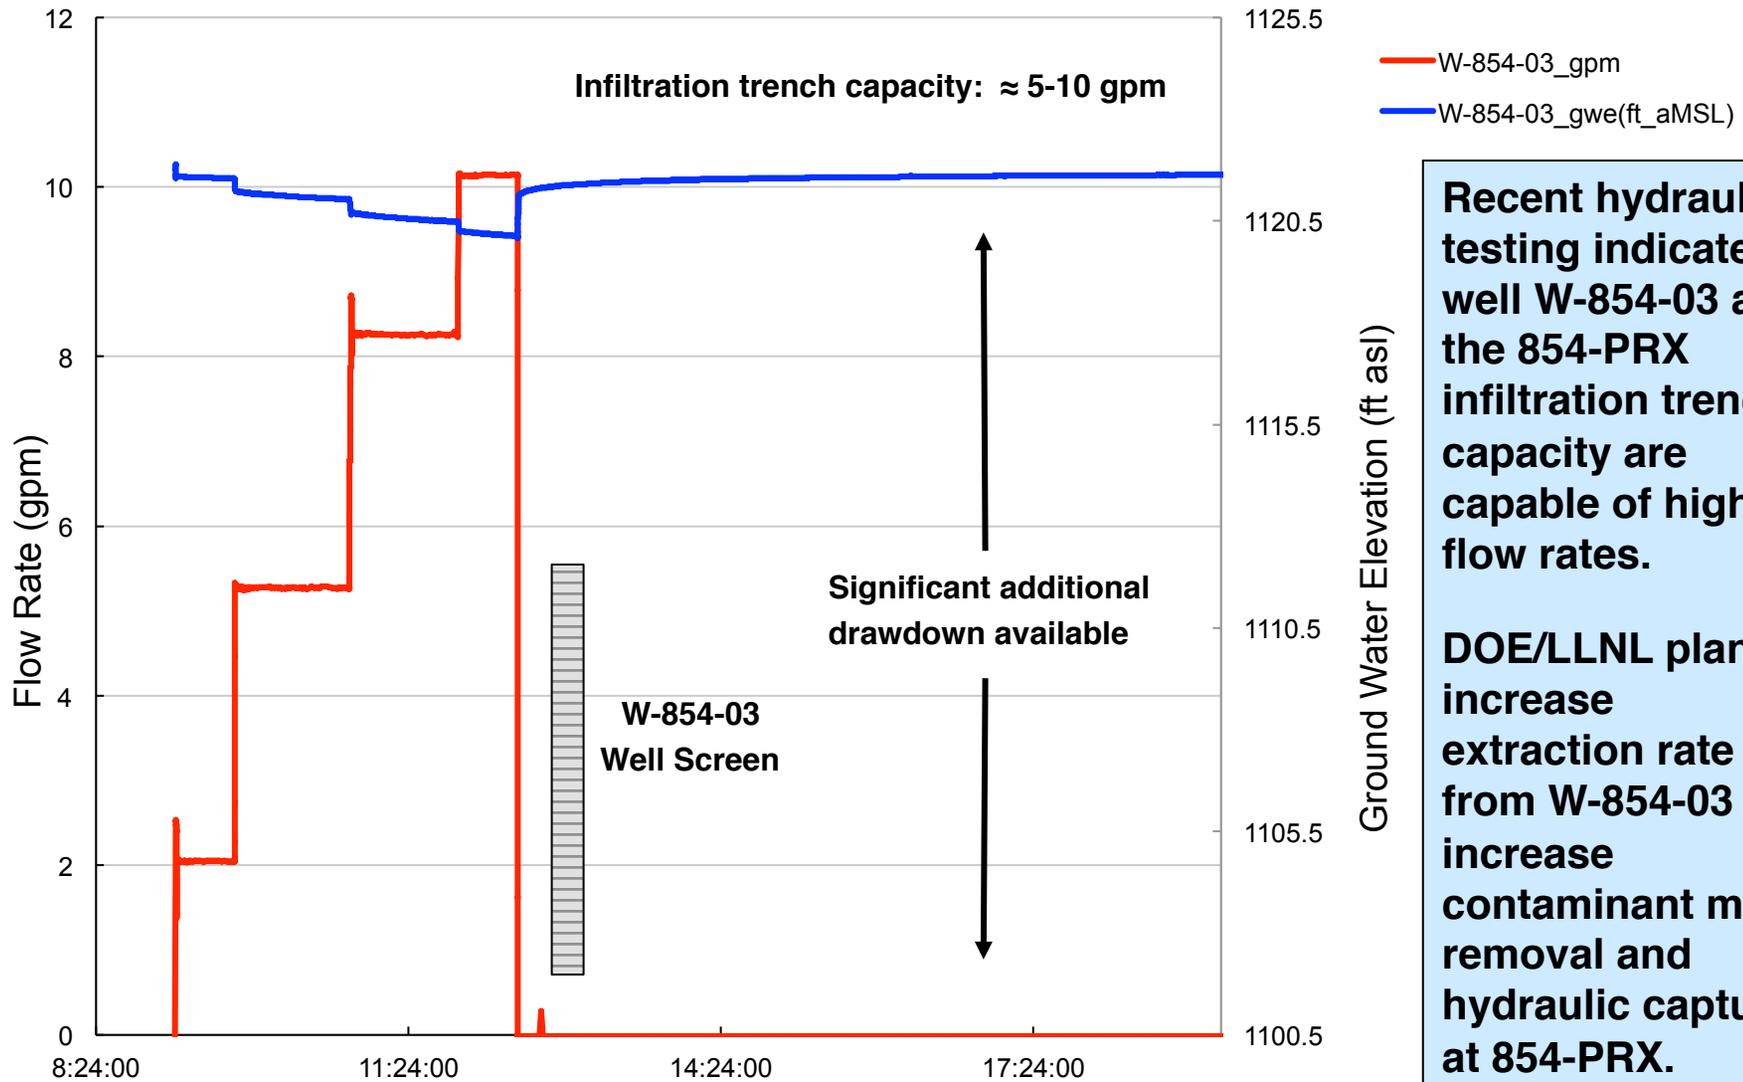
Extraction well W-854-03 hydraulic test results indicate that significant additional drawdown is available

Recent hydraulic testing indicates well W-854-03 and the 854-PRX infiltration trench capacity are capable of higher flow rates.

DOE/LLNL plan to increase extraction rate from W-854-03 to increase contaminant mass removal and hydraulic capture at 854-PRX.
