**First Five-Year Review Report for the
Building 850/Pit 7 Complex Operable Unit at
Lawrence Livermore National Laboratory
Site 300**

April 2016

Environmental Restoration Department

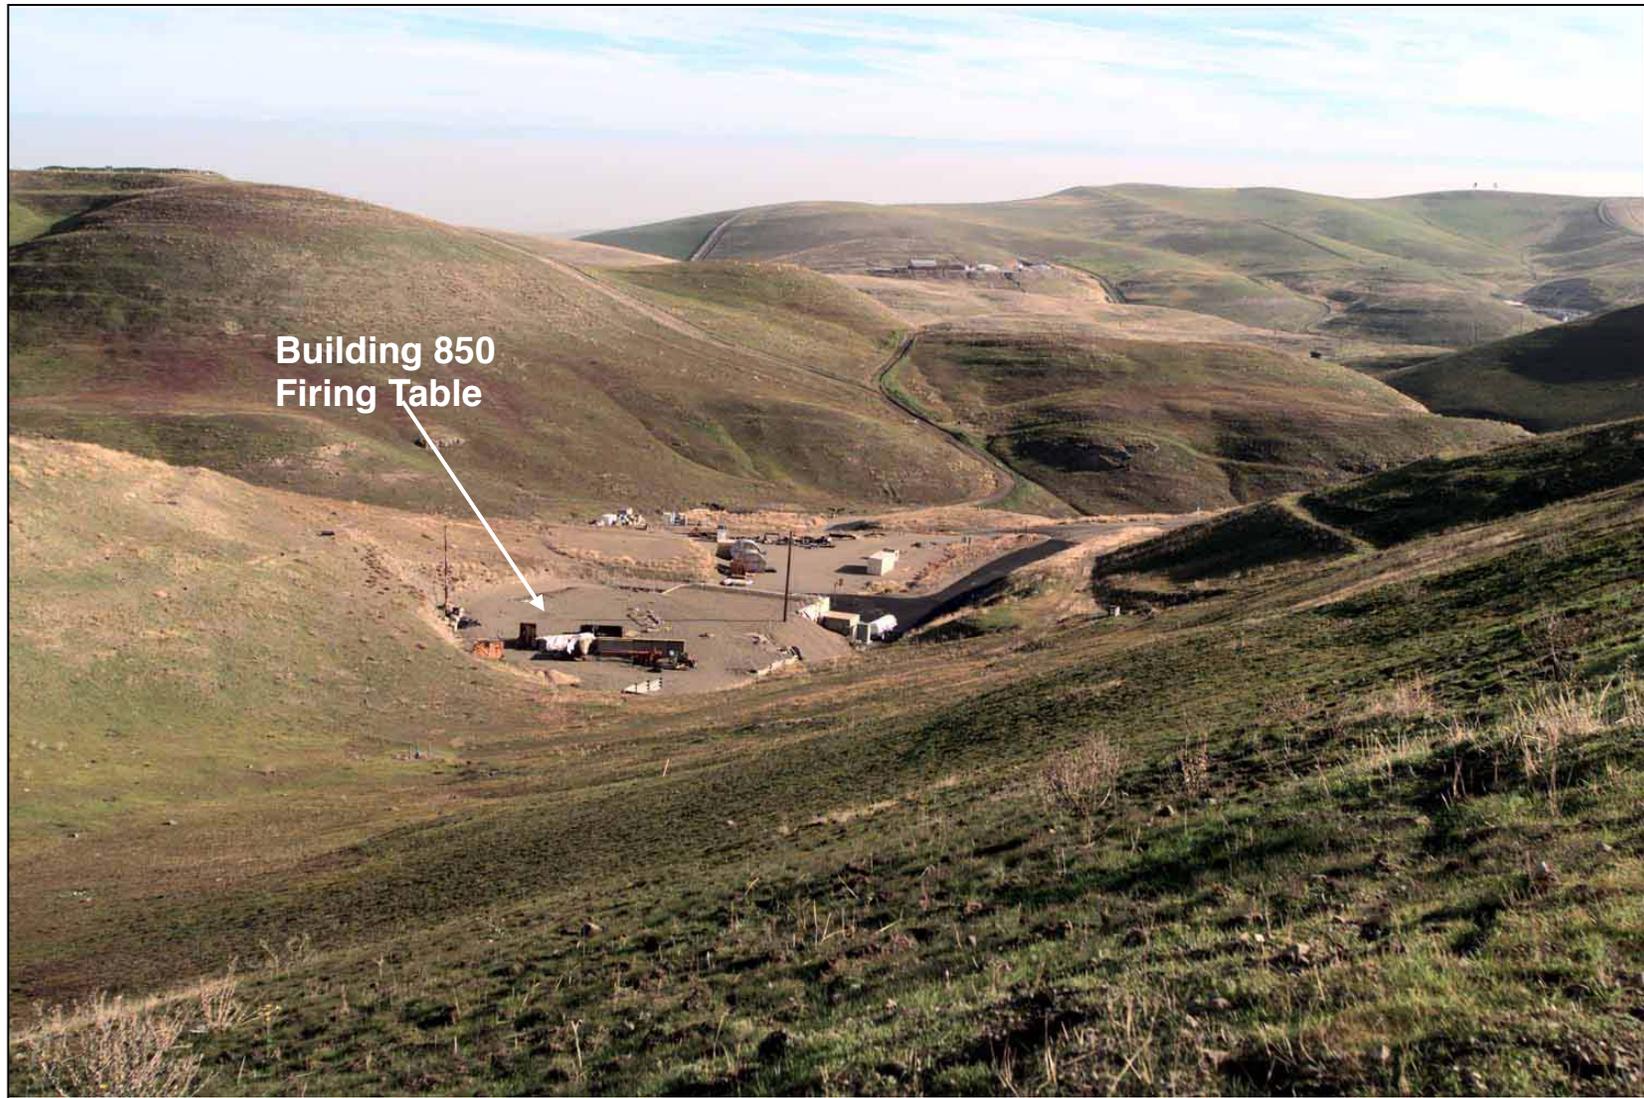
In the early 1960s, about 1,000 capacitors were destroyed during testing at the Building 850 Firing Table, contaminating soil on the surrounding hillsides with polychlorinated biphenyls (PCBs), dioxins, and furans. (Photograph of Building 850 Firing Table area prior to CERCLA soil removal action.)

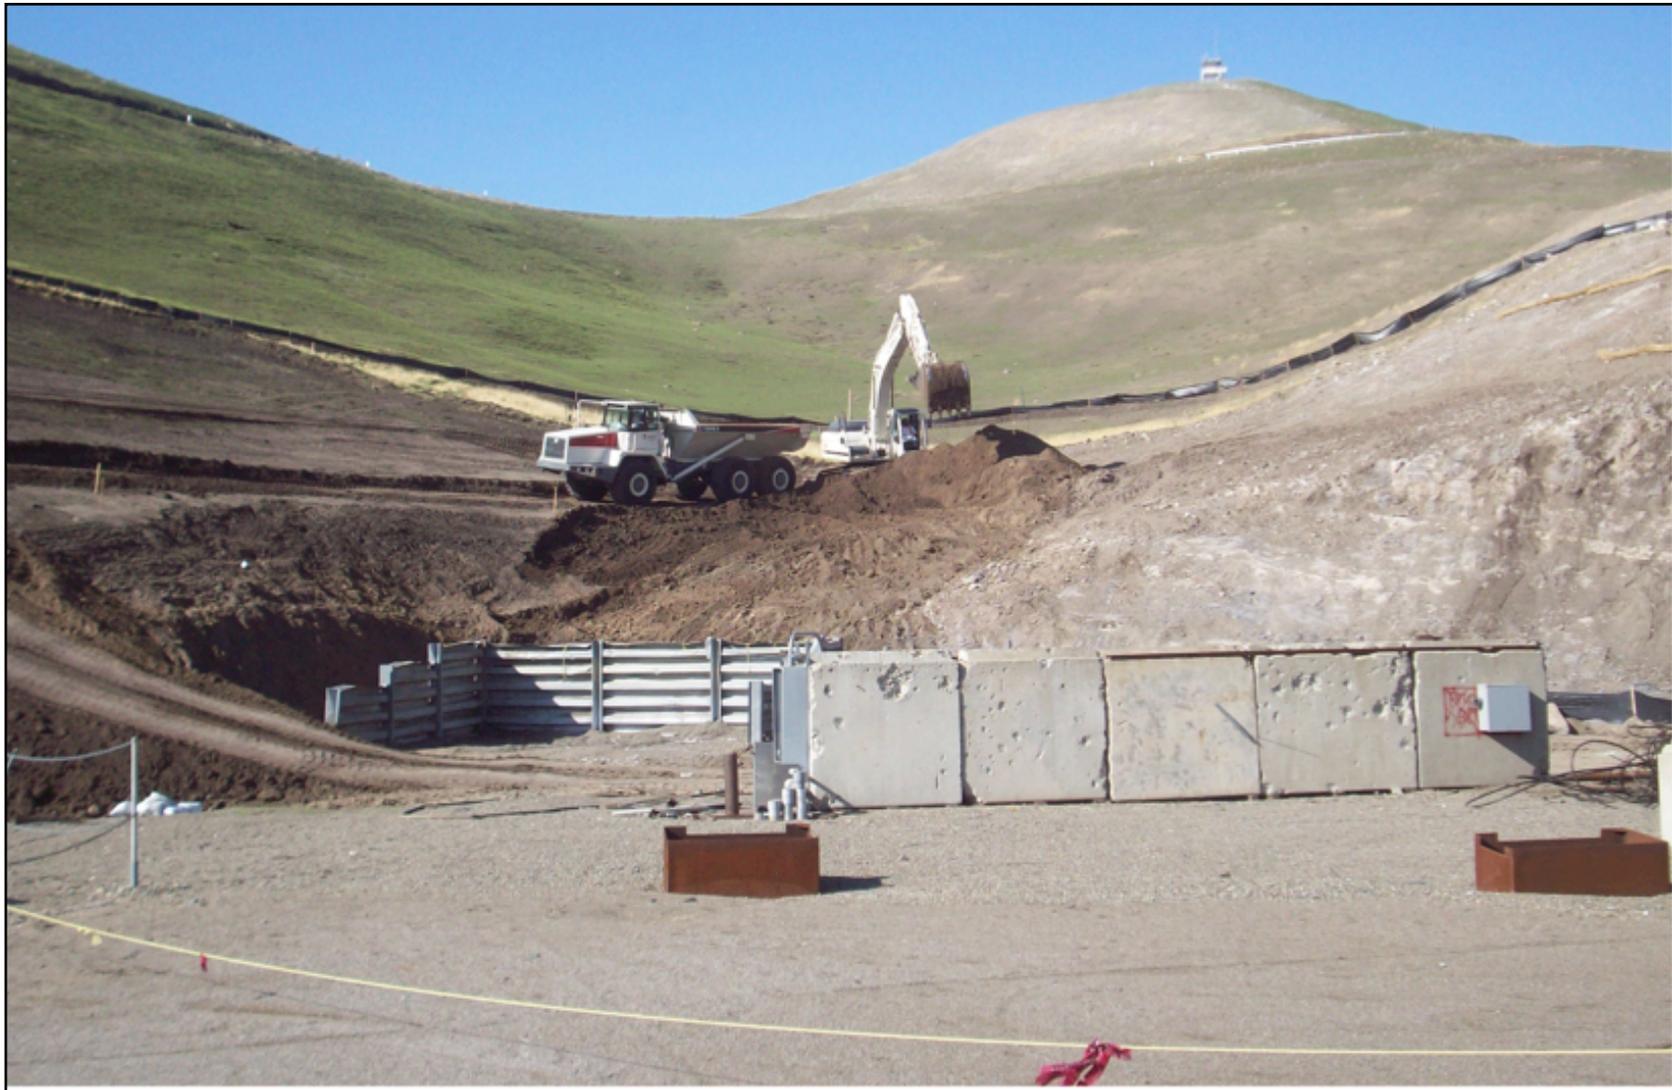
In 2009, 29,000 cubic yards of PCB-, dioxin-, and furan-contaminated soil was excavated from the Building 850 Firing Table area as a CERCLA removal action.

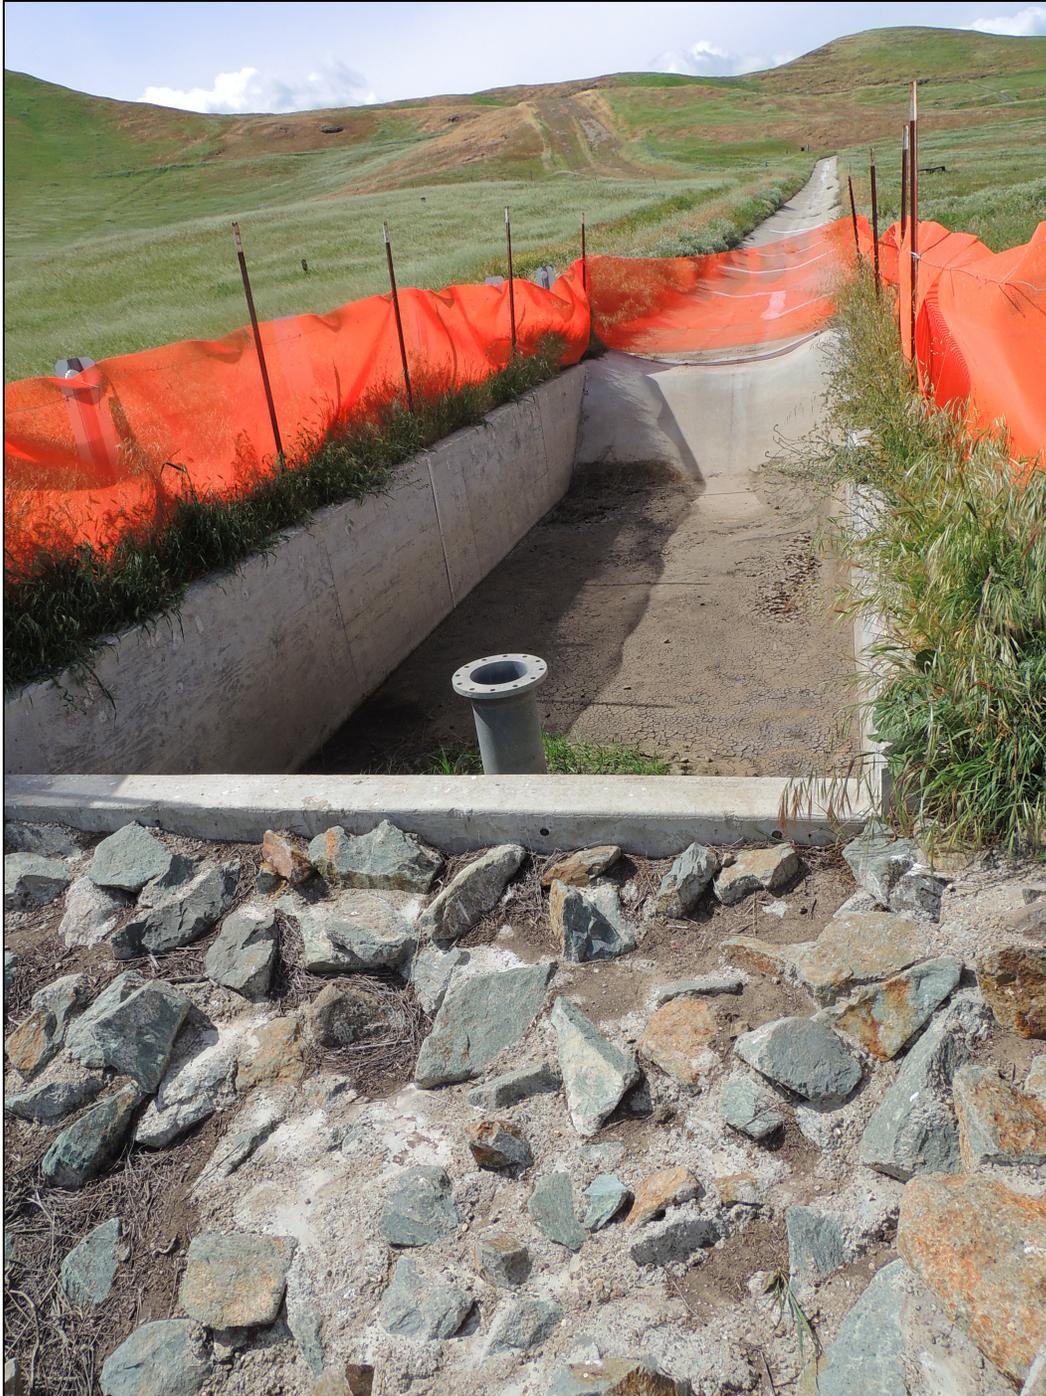
Drainage Diversion System: Southern Settling Basin

Current photographs of the Southern Settling Basin component of the drainage diversion system at the Pit 7 Complex (orange fence is to prevent loose vegetation (i.e., tumbleweeds from accumulating in the basin).

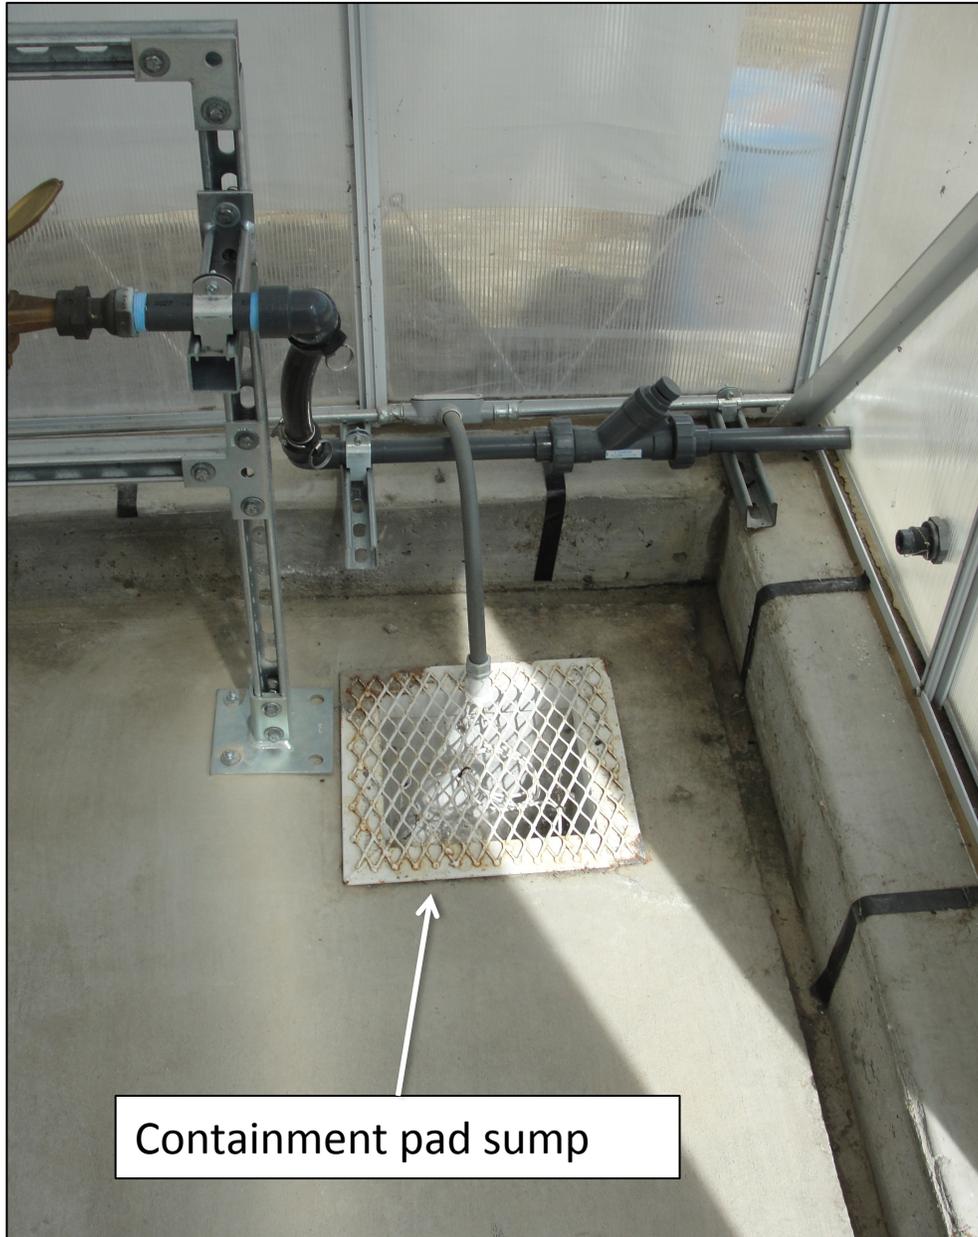
Pit 7 – Source concrete containment pad sump

A sump is located at the southeast corner of the containment pad for the Pit 7-Source ground water treatment system. The containment pad floor is sloped so that any liquid spills or leaks flow toward the sump. The sump is outfitted with an alarm that, when fluid is detected, triggers shut down of the treatment system.

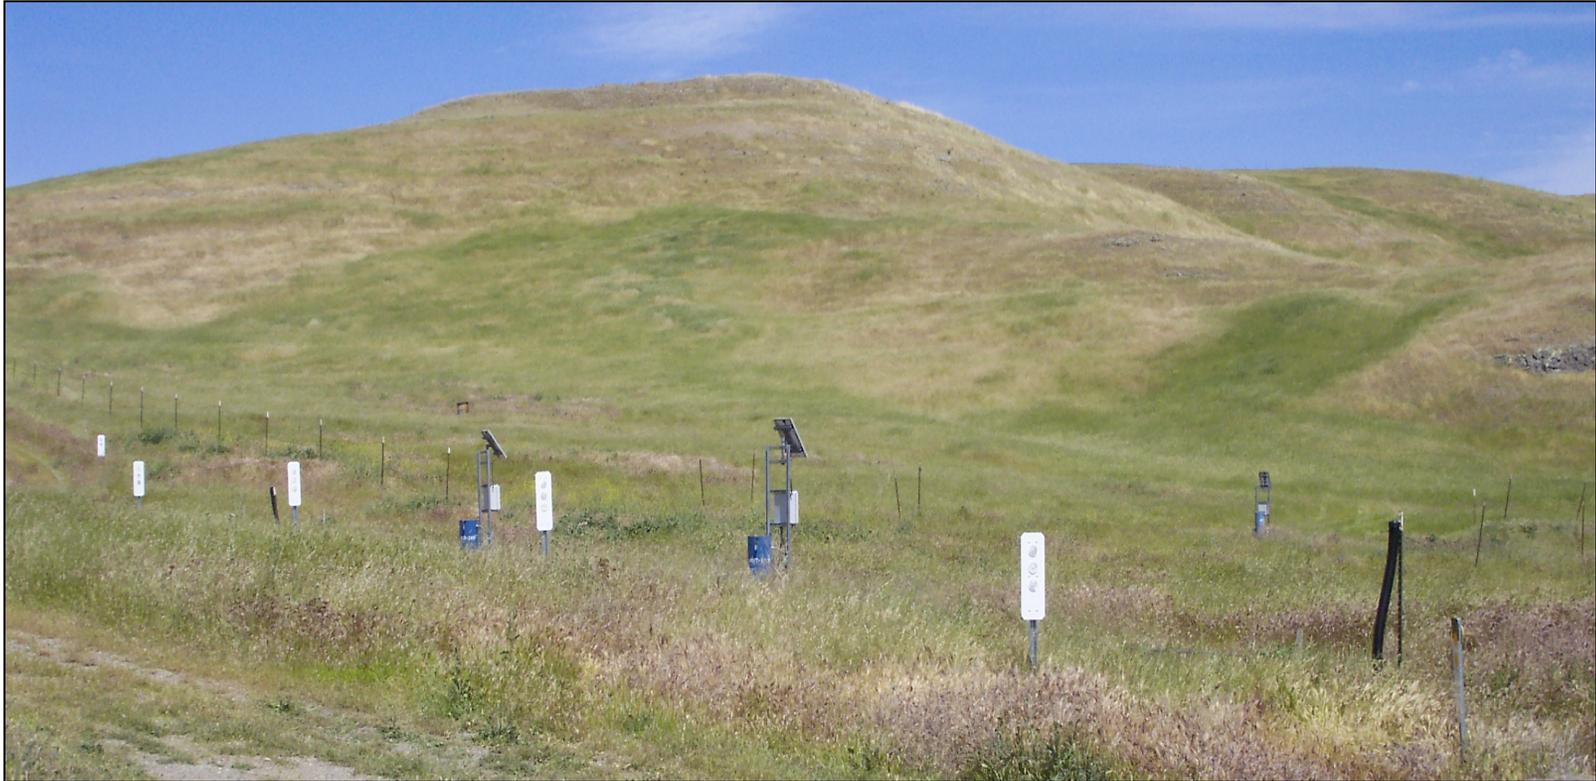
Pit 7 – Source effluent infiltration trench

Tritiated effluent from the Pit 7-Source ground water treatment system discharged to the unsaturated part of the Qal/WBR hydrostratigraphic unit via an infiltration trench to allow tritium to naturally-attenuate in the subsurface.

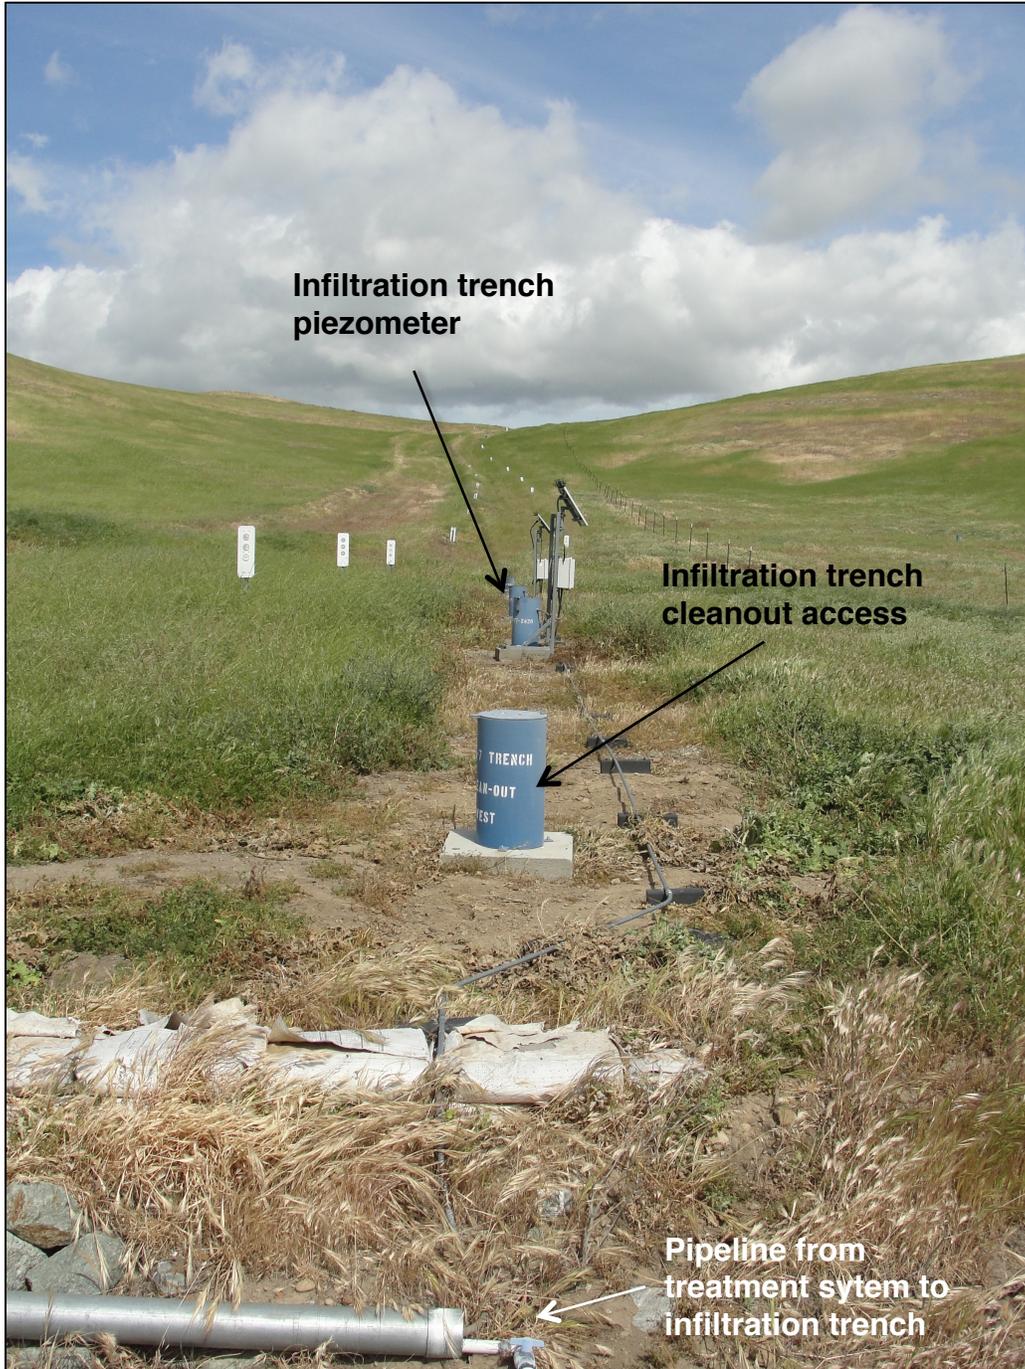
Pit 7 – Source effluent infiltration trench

Piezometers located within the infiltration trench are monitored to ensure the trench capacity is not exceeded.
