Lawrence Livermore National Laboratory Site 300 Process Area HABS/HAER Report

LLNL Site 300, Process Area HABS/HAER Report

Prepared by
Garavaglia Architecture, Inc. and Alisto Engineering Group
January 30, 2015

**LAWRENCE LIVERMORE NATIONAL LABORATORY
SITE 300: PROCESS AREA DISTRICT**

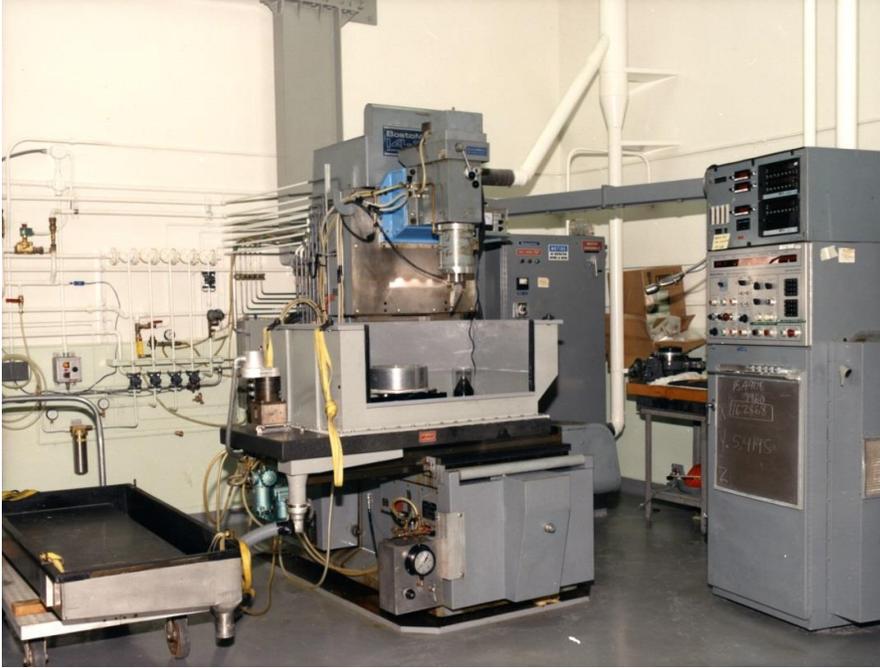
Figure 14. Bostomatic machine in Building 806B (LLNL Archives, ca. 1980)

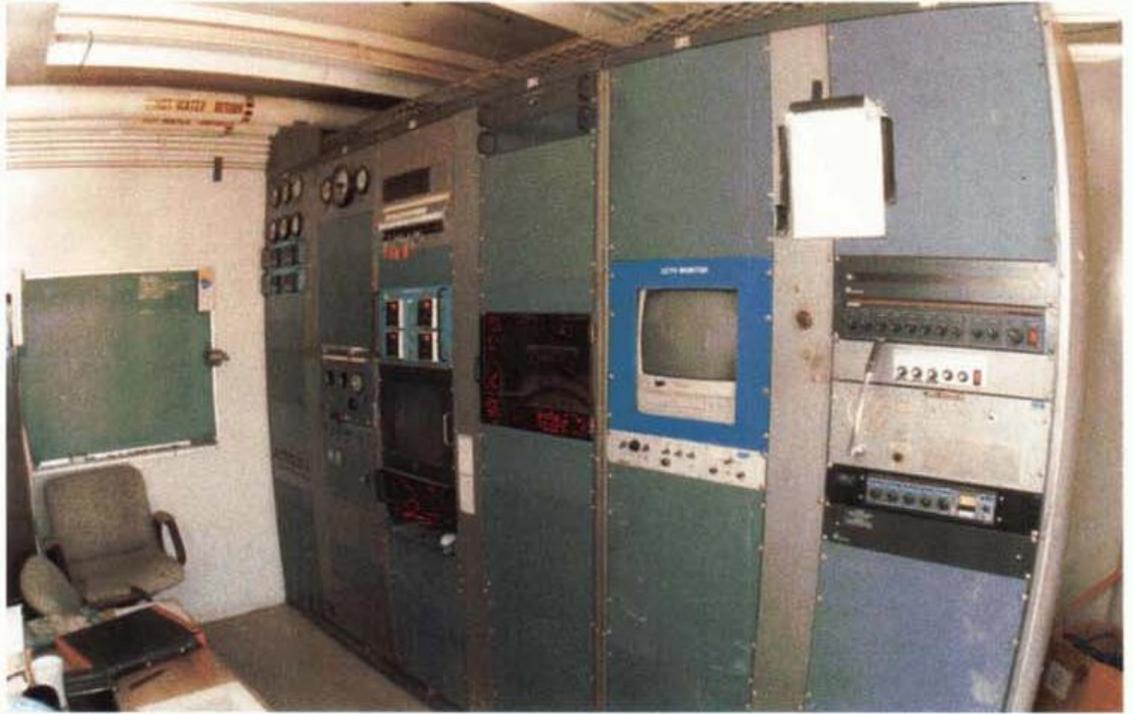
Figure 22. Building 817A Control Room for remote controlled ovens and presses. (LLNL Archives 2003)

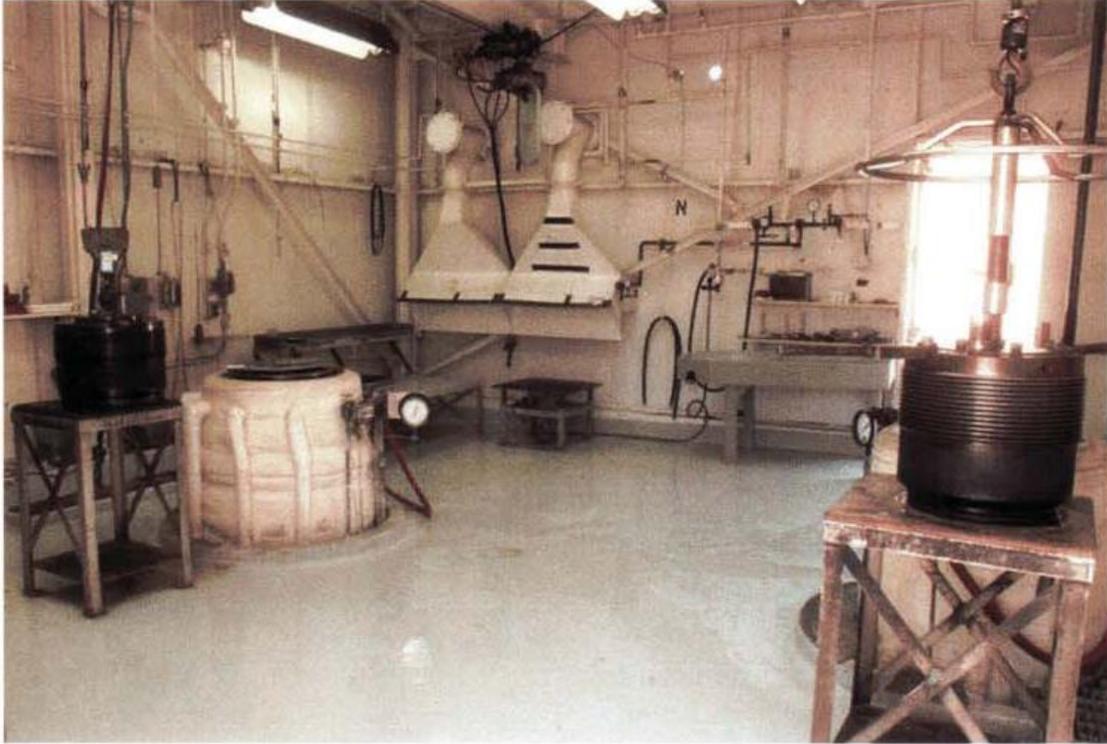
Figure 23. Isostatic Presses in Building 817B, (LLNL Archives, 2003)

Building 817B contains isostatic presses. Building 817F contains ovens.

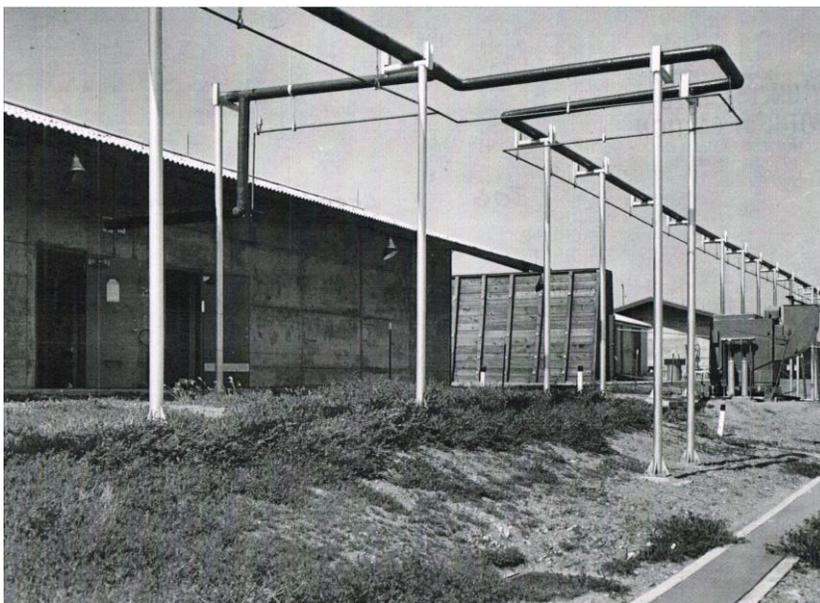
Image 6. Building 806B in the foreground with wooden blast barrier at center and Building 806A in the background, ca. 1959.

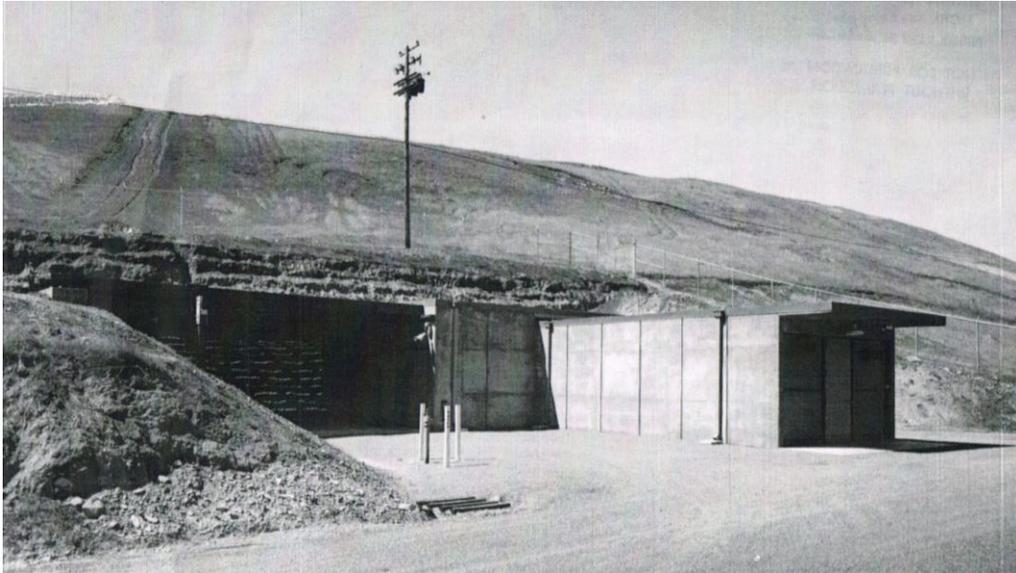
Image 18. View of Building 825 looking northwest just after construction, note the shrapnel baffles extending to the hillside, ca. 1959.

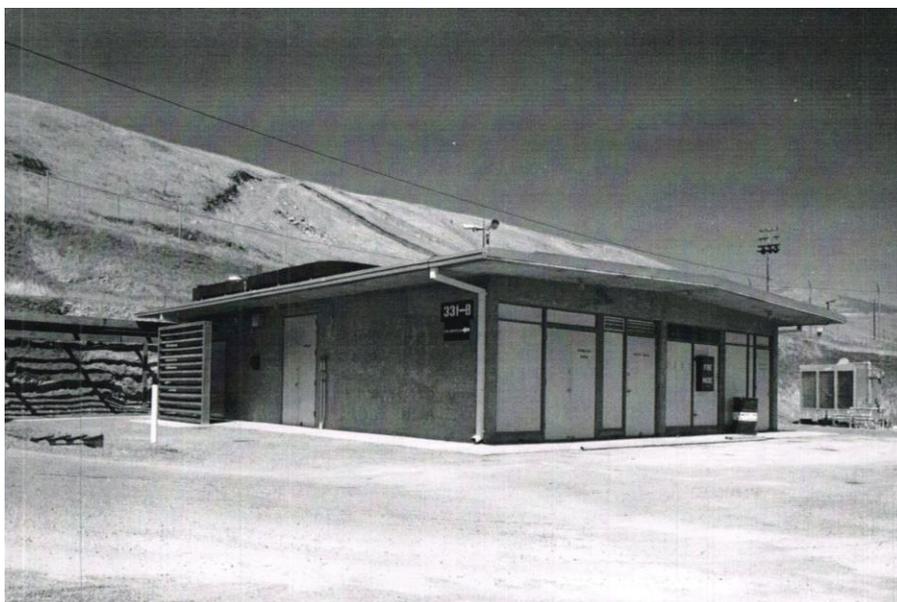
Image 20. View of Building 826 just after construction looking northwest, note the shrapnel baffles extending to the hillside ca. 1960.

Building 826 was built into the surrounding hillside, and as such, contours to the earth. This feature serves as extra site protection in the event of an accidental explosion within the building.
