UCRL-AR-144744-DR

Draft
Five-Year Review Report
for the
Building 834 Operable Unit
at Lawrence Livermore National Laboratory
Site 300

August 2001

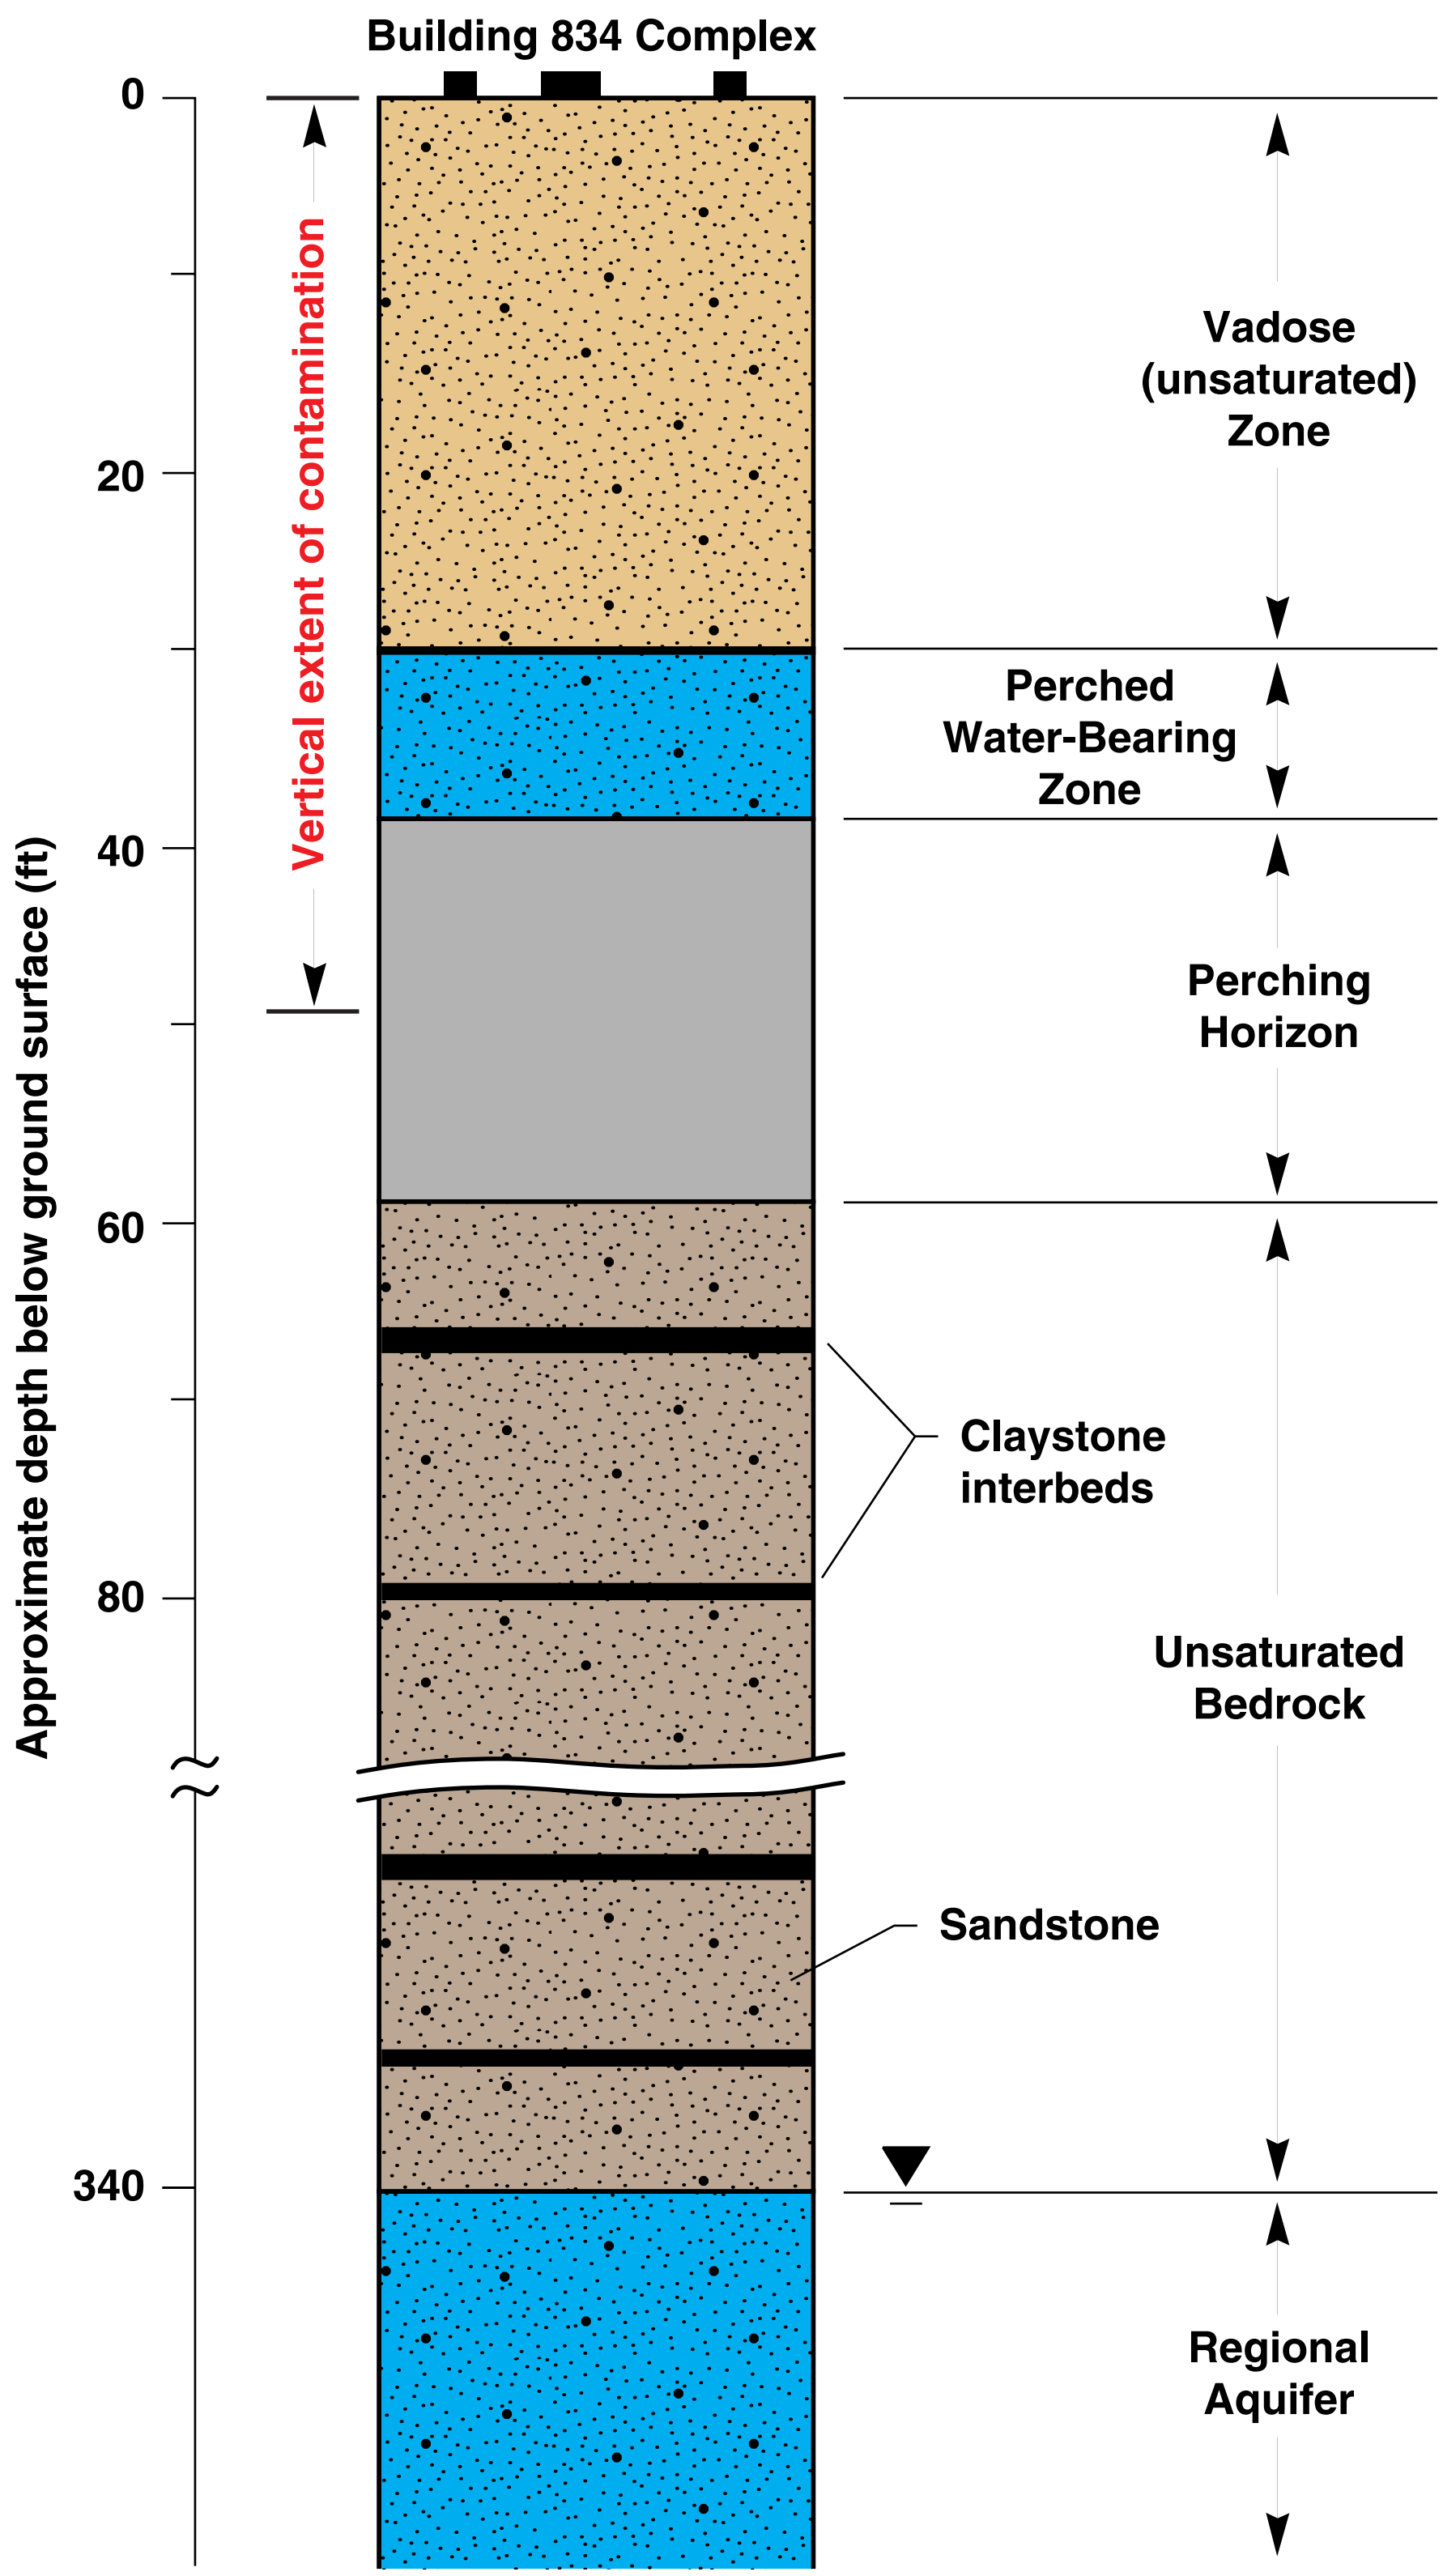
Figure 3. Conceptual hydrostratigraphic column for the Building 834 OU.

The primary hydrogeologic units in the Building 834 area are described below, from shallow to deep. A conceptual hydrostratigraphic column is shown on Figure 3.

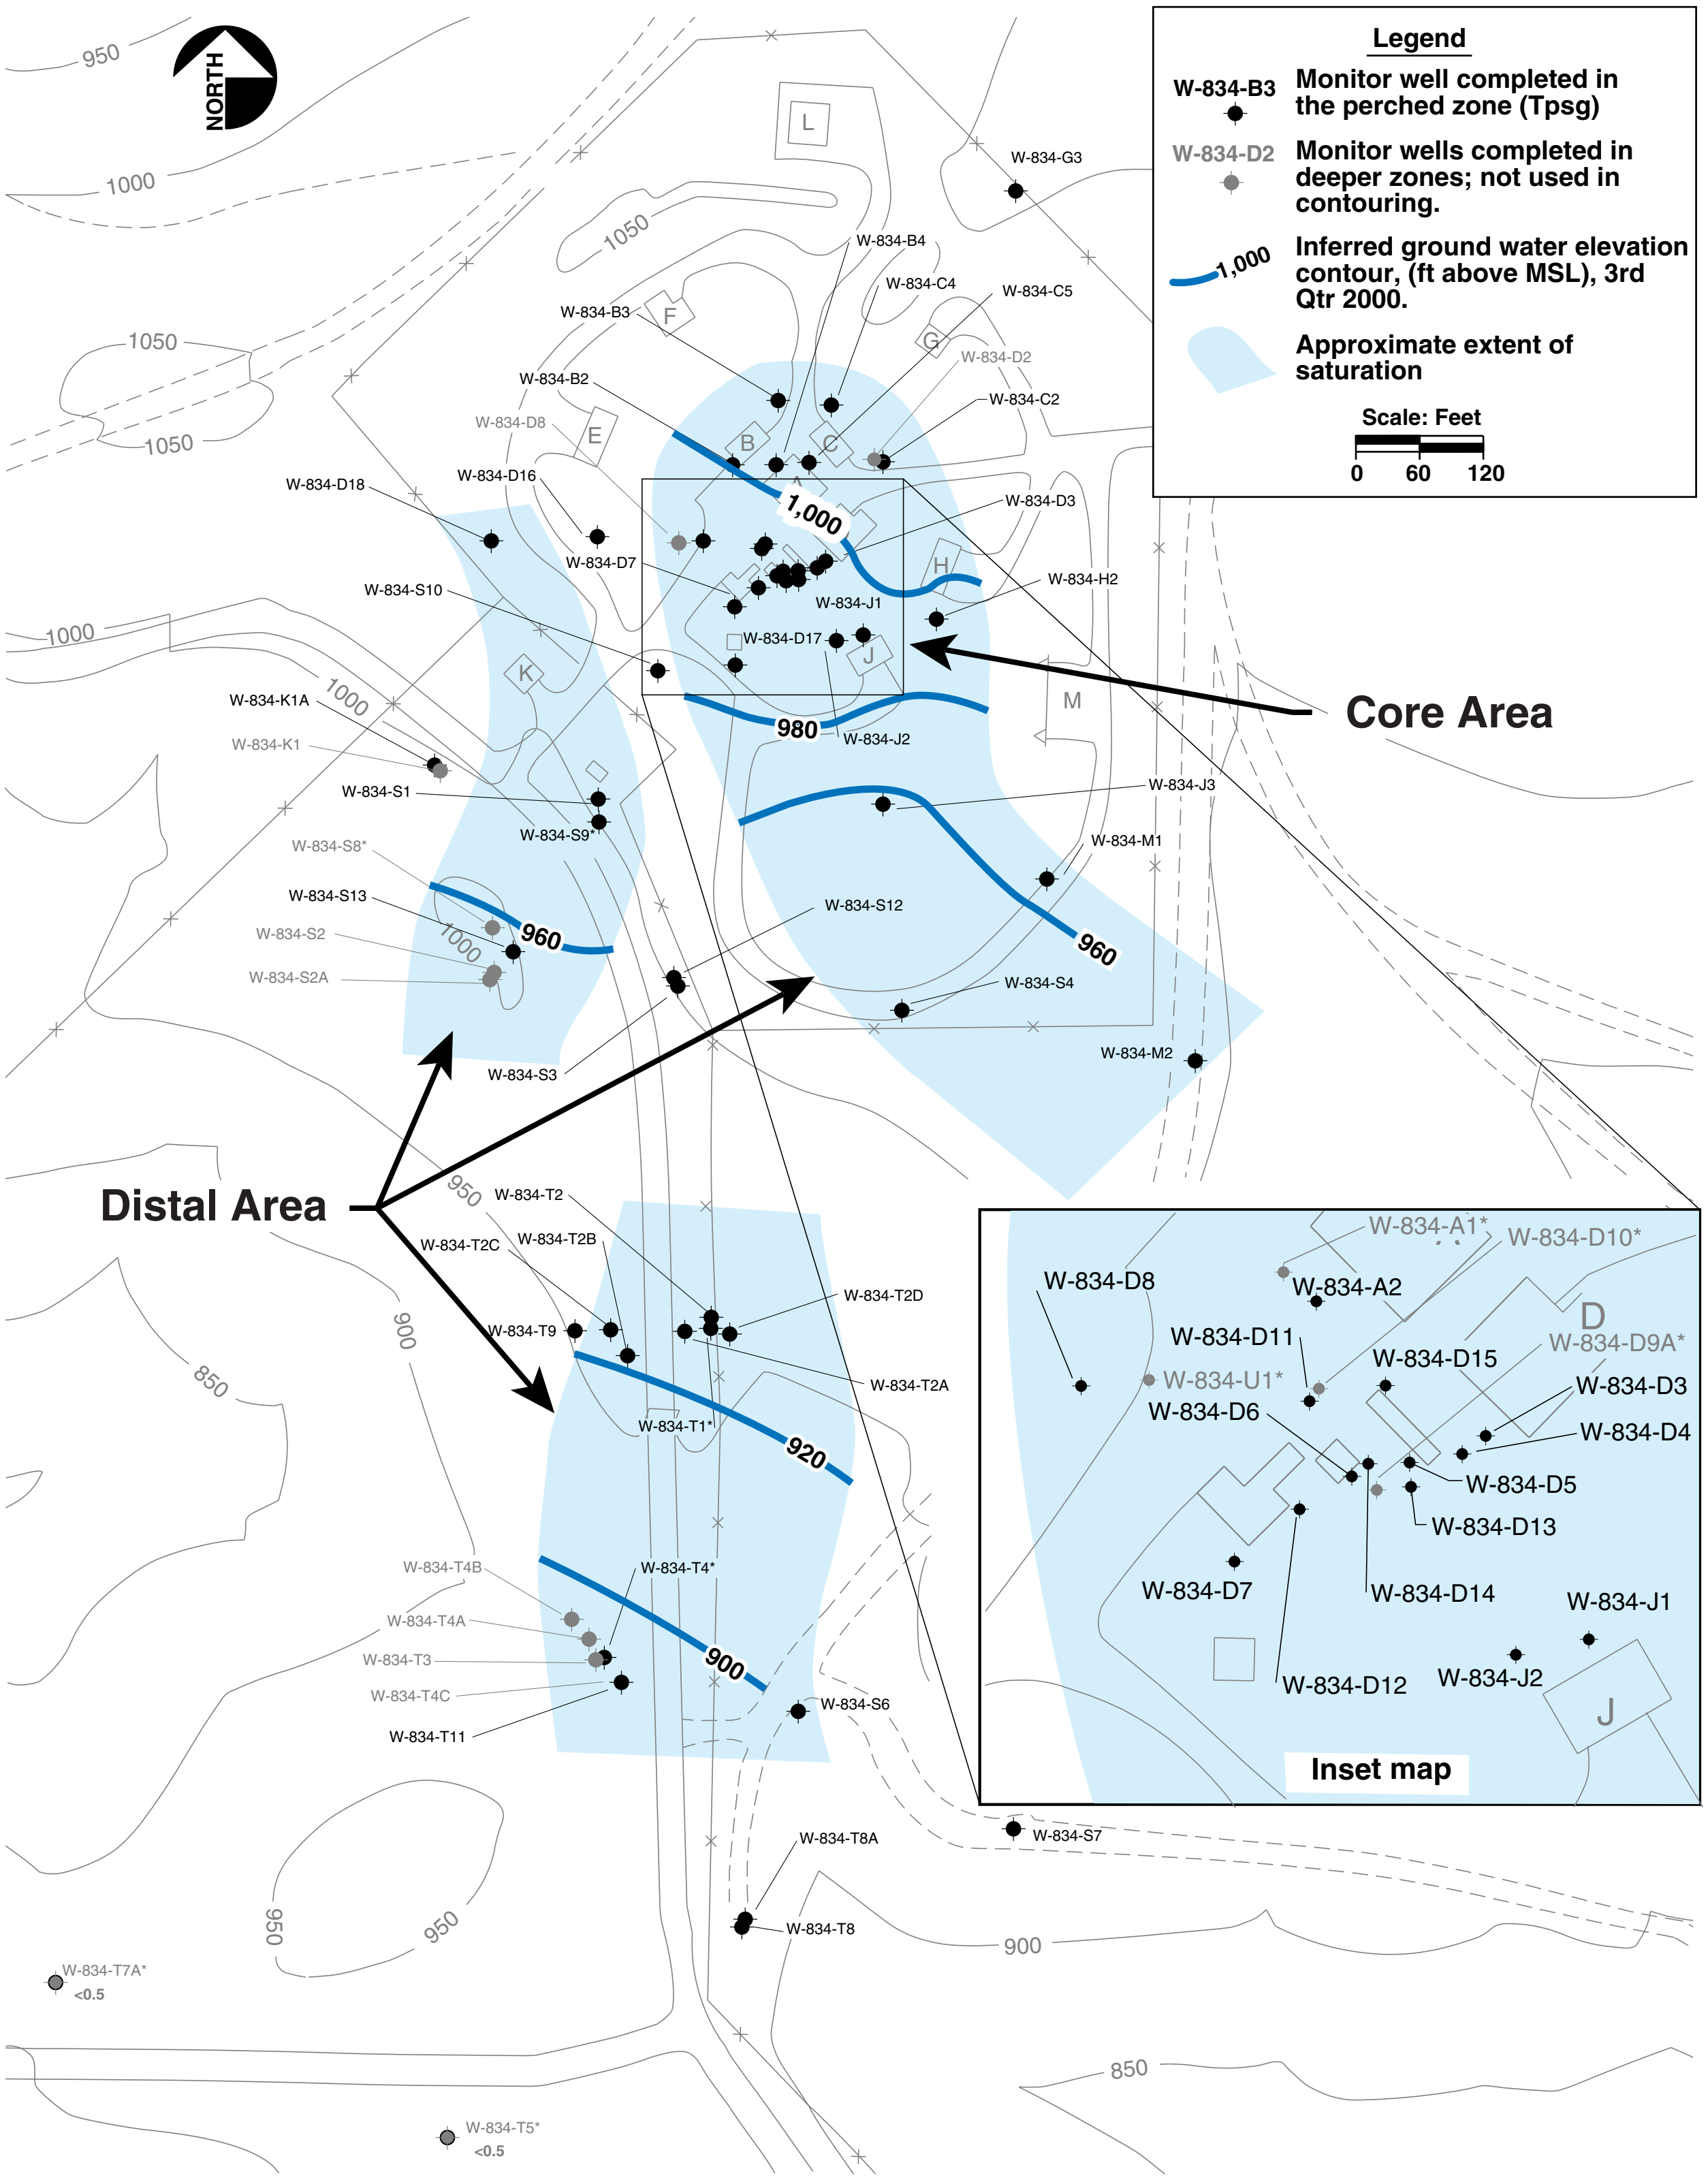
Figure 4. Potentiometric surface elevation contour map of the perched water-bearing zone.

Perched Water-Bearing Zone - A variably saturated, discontinuous perched water-bearing zone occurs in sand and gravel lenses below the vadose zone. The perched zone can be up to 8 feet thick. Ground water in the perched aquifer generally flows toward the south. Figure 4 shows potentiometric surface elevation contours of the perched water-bearing zone. Perched ground water is not laterally continuous except for short periods of time following heavy rainfall events. The lateral extent of the perched zone is limited by the steep slopes to the north, east, and west of the Complex. The perched water-bearing zone is highly contaminated below the Core Area and discontinuous plumes of contaminants extend into the Distal Area.

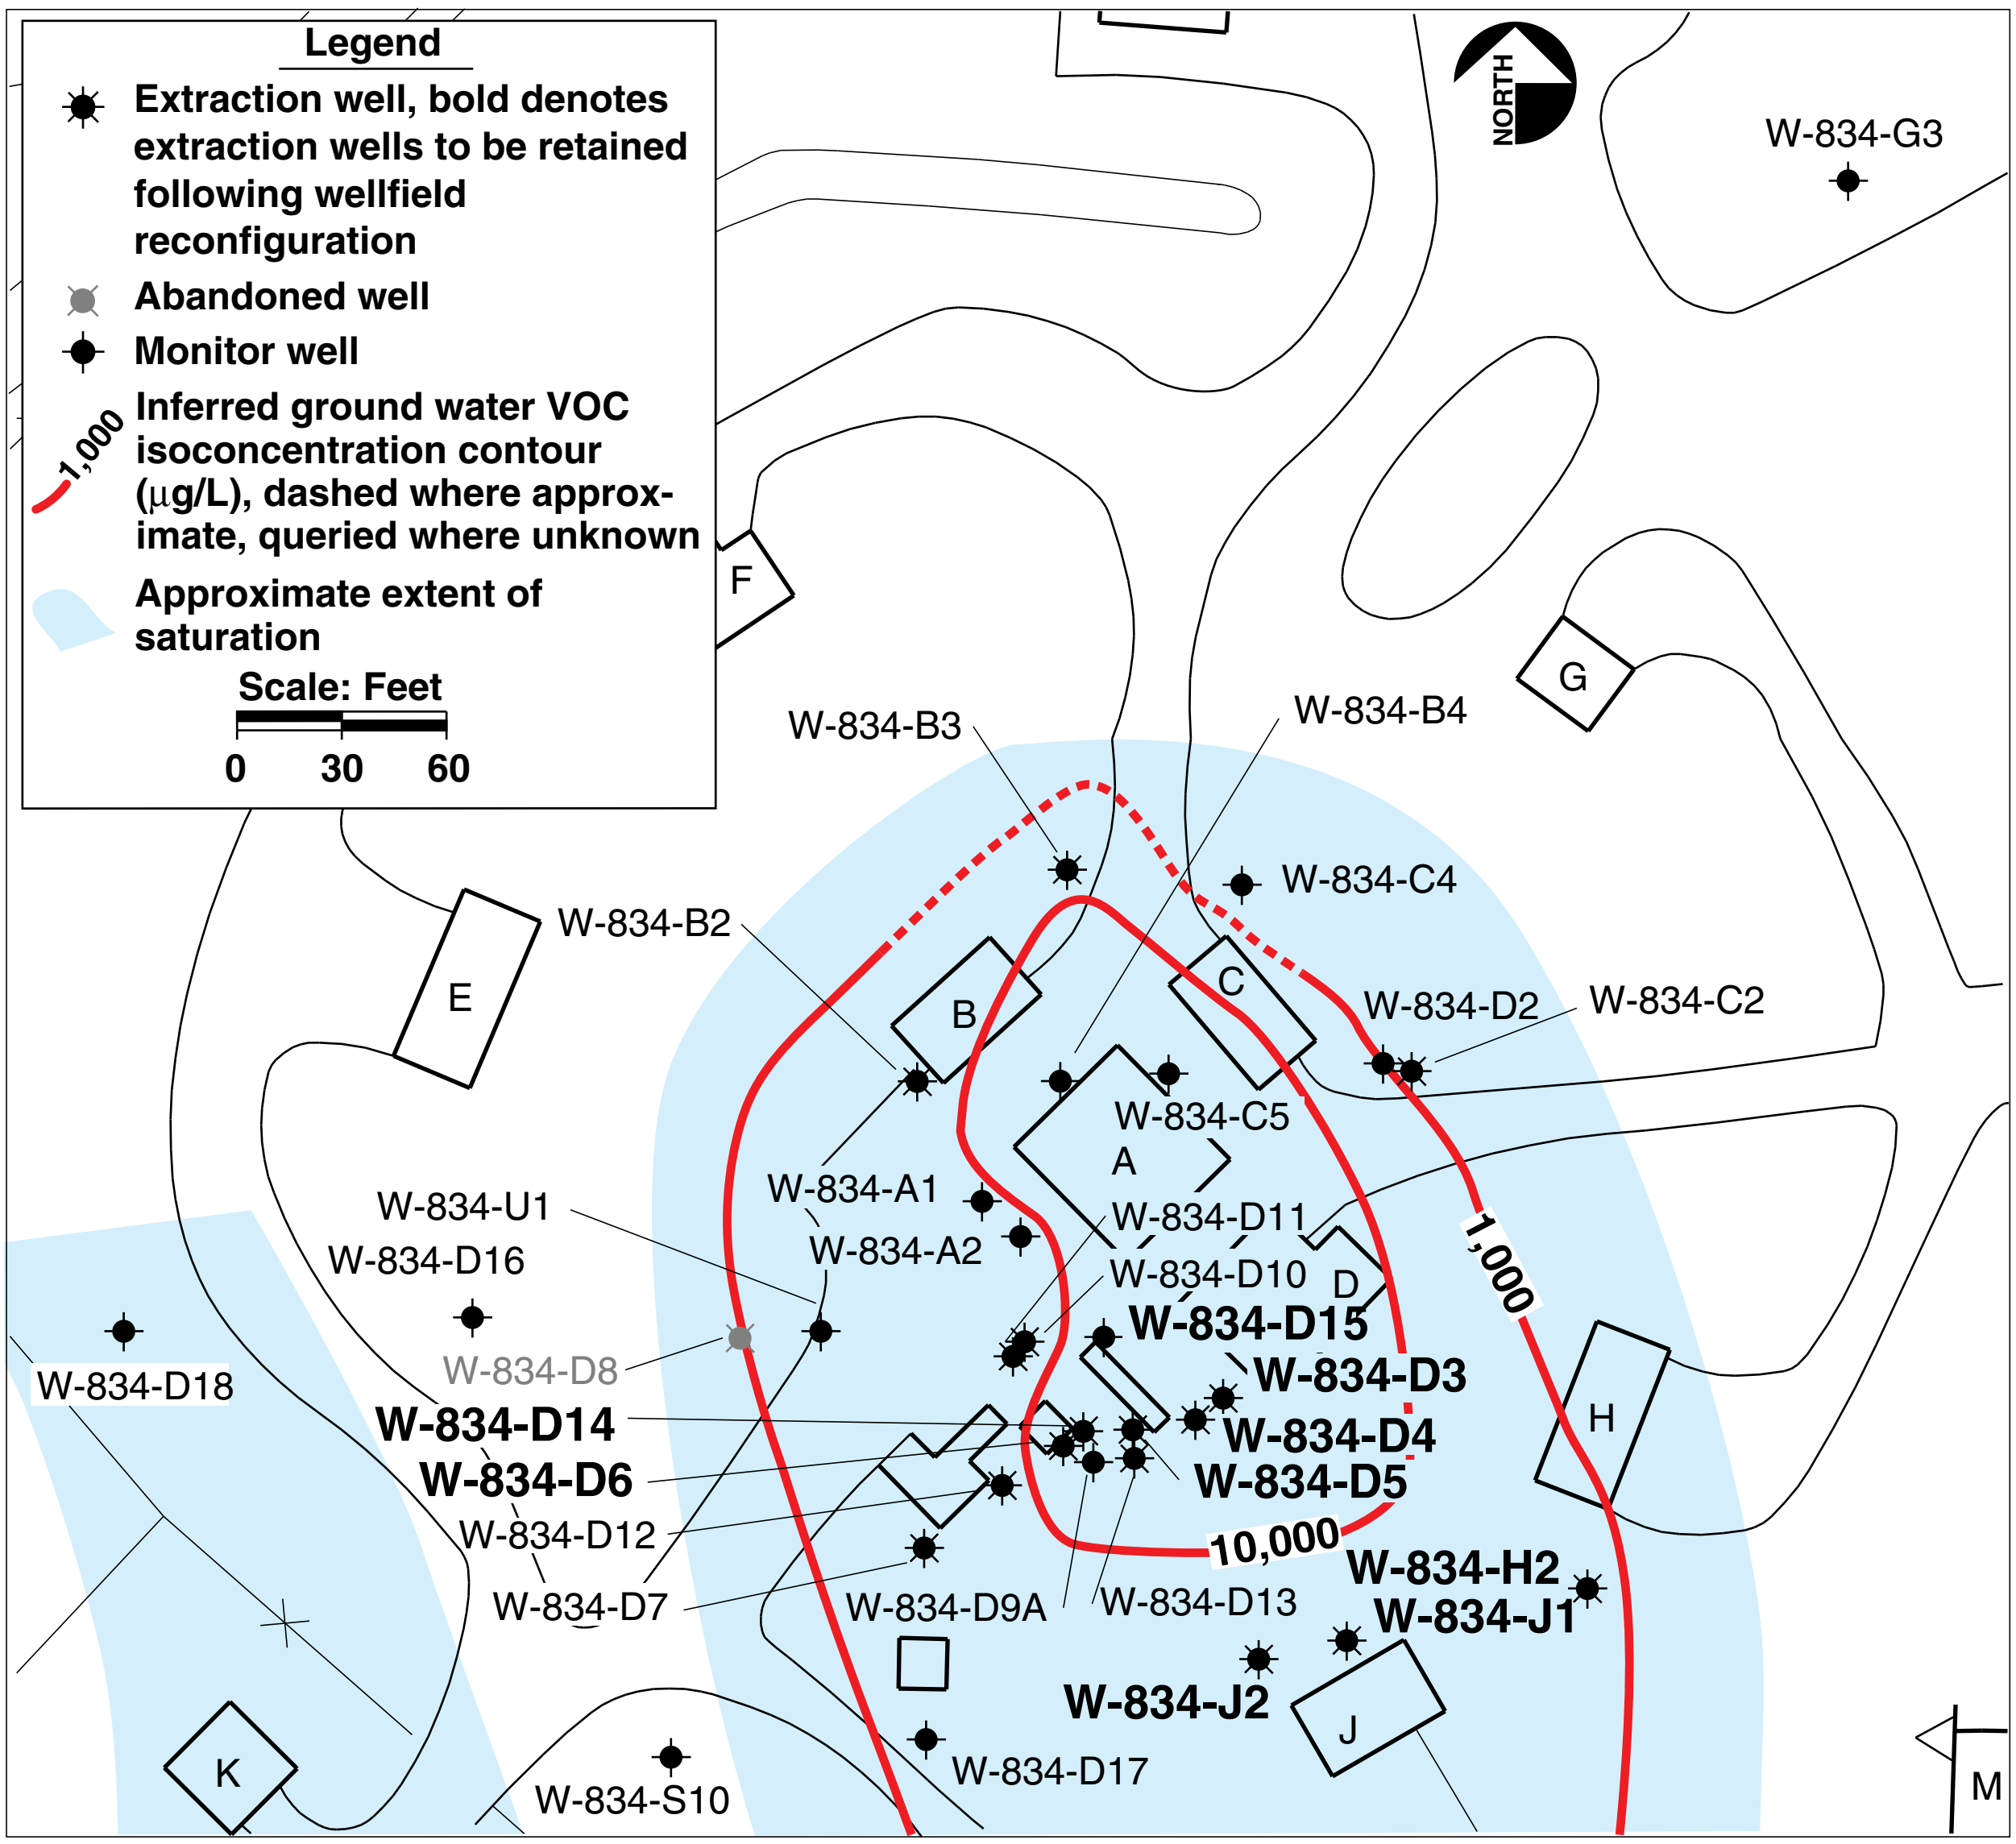
ERD-S3R-01-0149

- Mass removal efficiency in the Core Area wellfield will be improved. The number of extraction wells will be reduced from 16 to 9. DOE will discontinue extraction from seven wells because of the extremely low well yield, low VOC concentrations in both ground water and soil vapor, and small capture zones; these wells will then be used to monitor ground water and soil vapor during cleanup. The extraction and monitor wellfield in the Core Area is shown on Figure 5.

Figure 5. Extraction and monitor wellfield in the Building 834 Core Area.

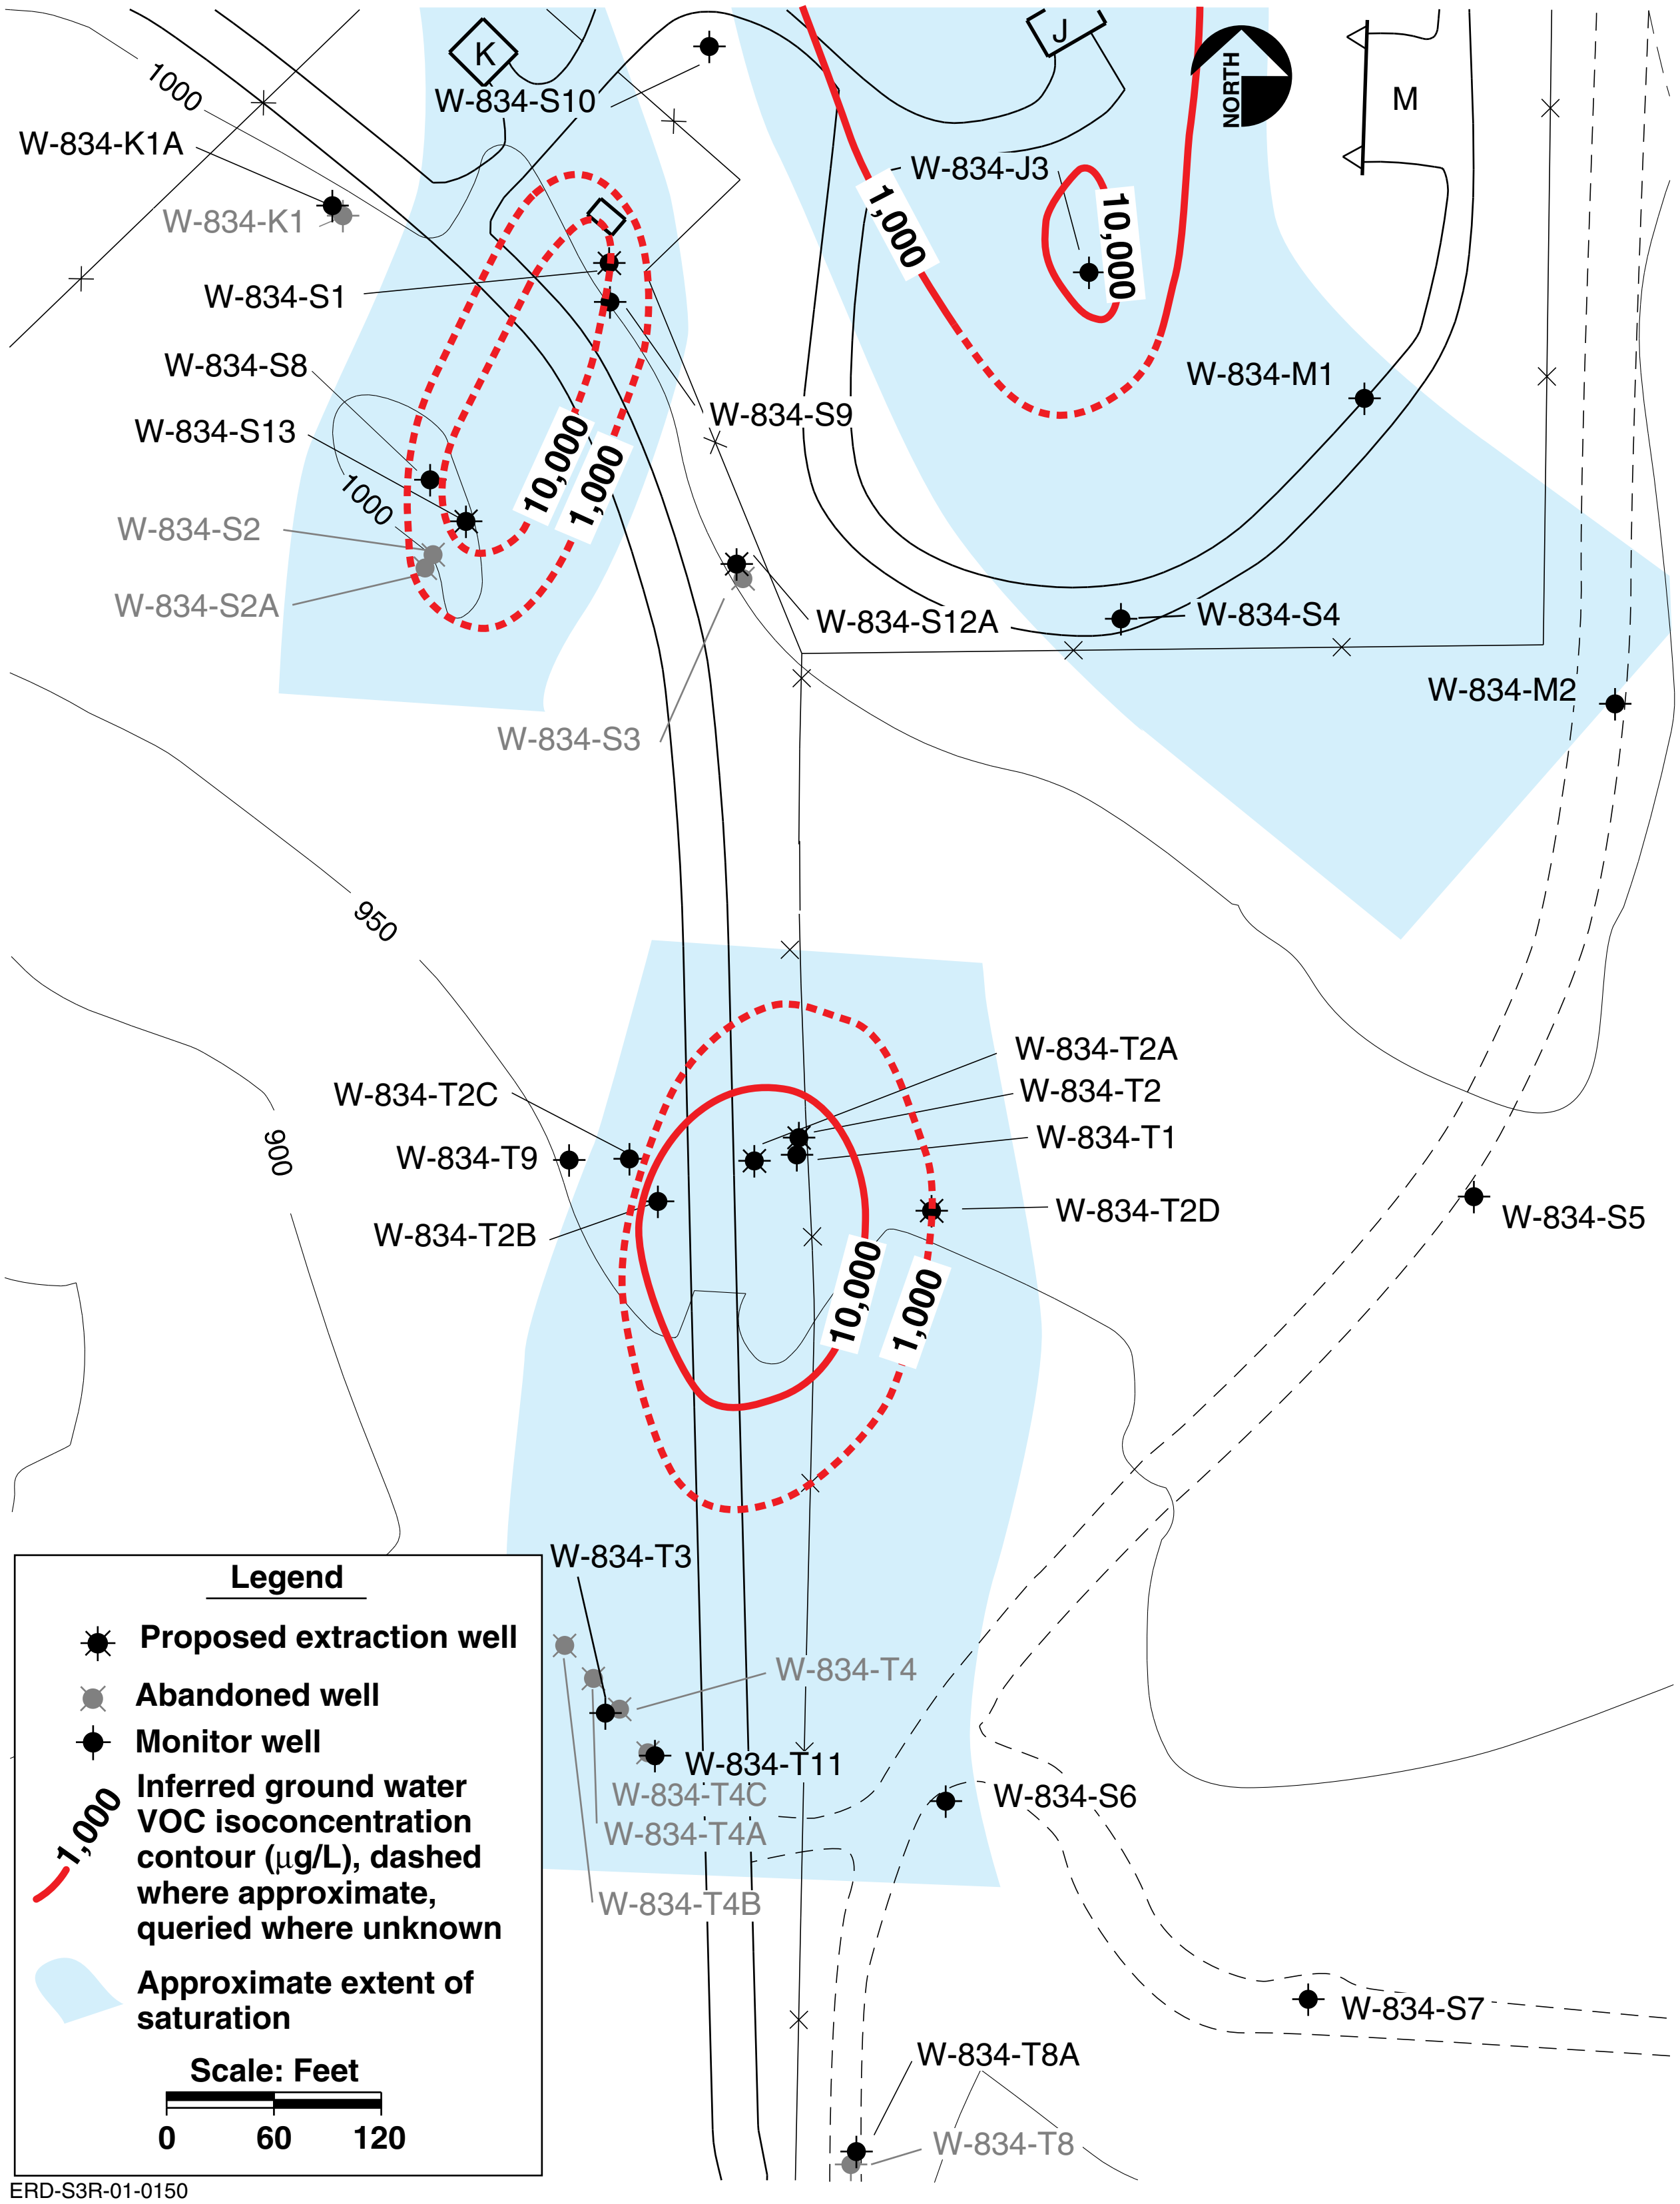
Figure 6. Extraction and monitor wellfield in the Building 834 Distal Area.

- Ground water and soil vapor extraction will be expanded into the Distal Area. Six existing monitor wells will be converted to extraction wells. The extraction and monitor wellfield in the Distal Area is shown on Figure 6. Although the vadose zone is not contaminated in the Distal Area, ground water extraction will be used to dewater the perched zone, allowing remaining VOC contaminants to be removed by the more efficient soil vapor extraction process.

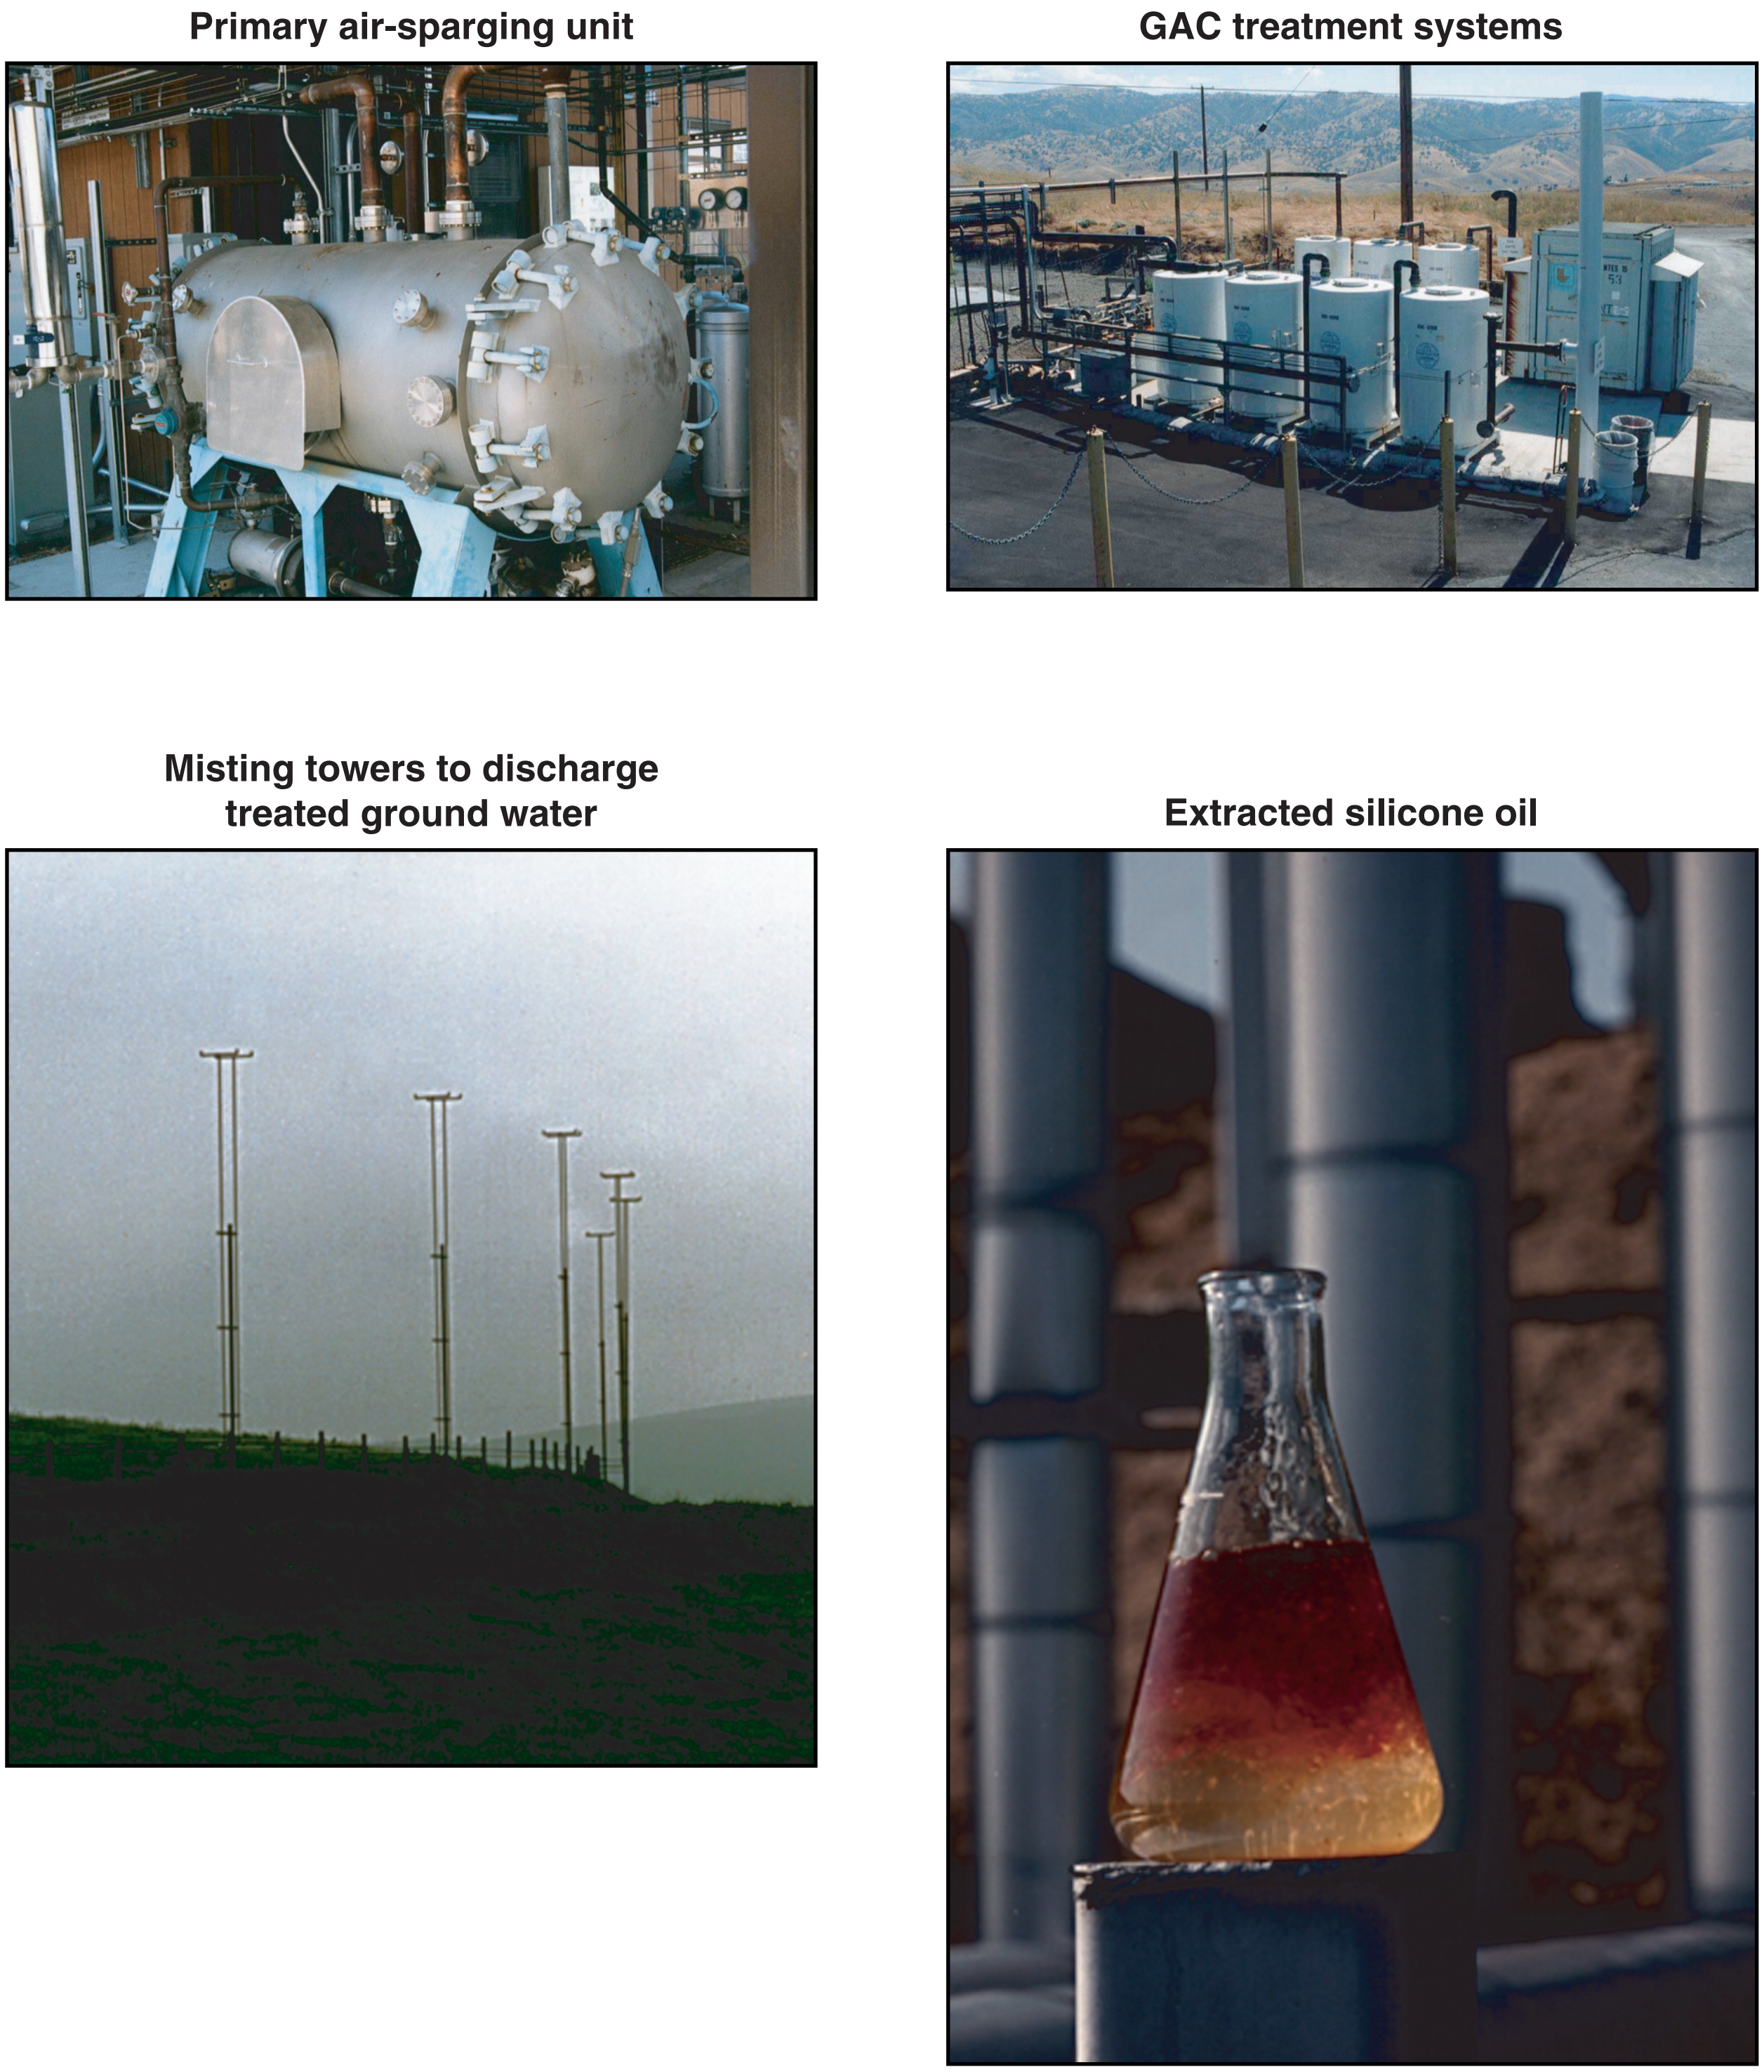
ERD-S3R-01-0151

Photographs of the existing treatment system are shown in Figure 7.

Figure 7. Photographs of the Building 834 treatment system.

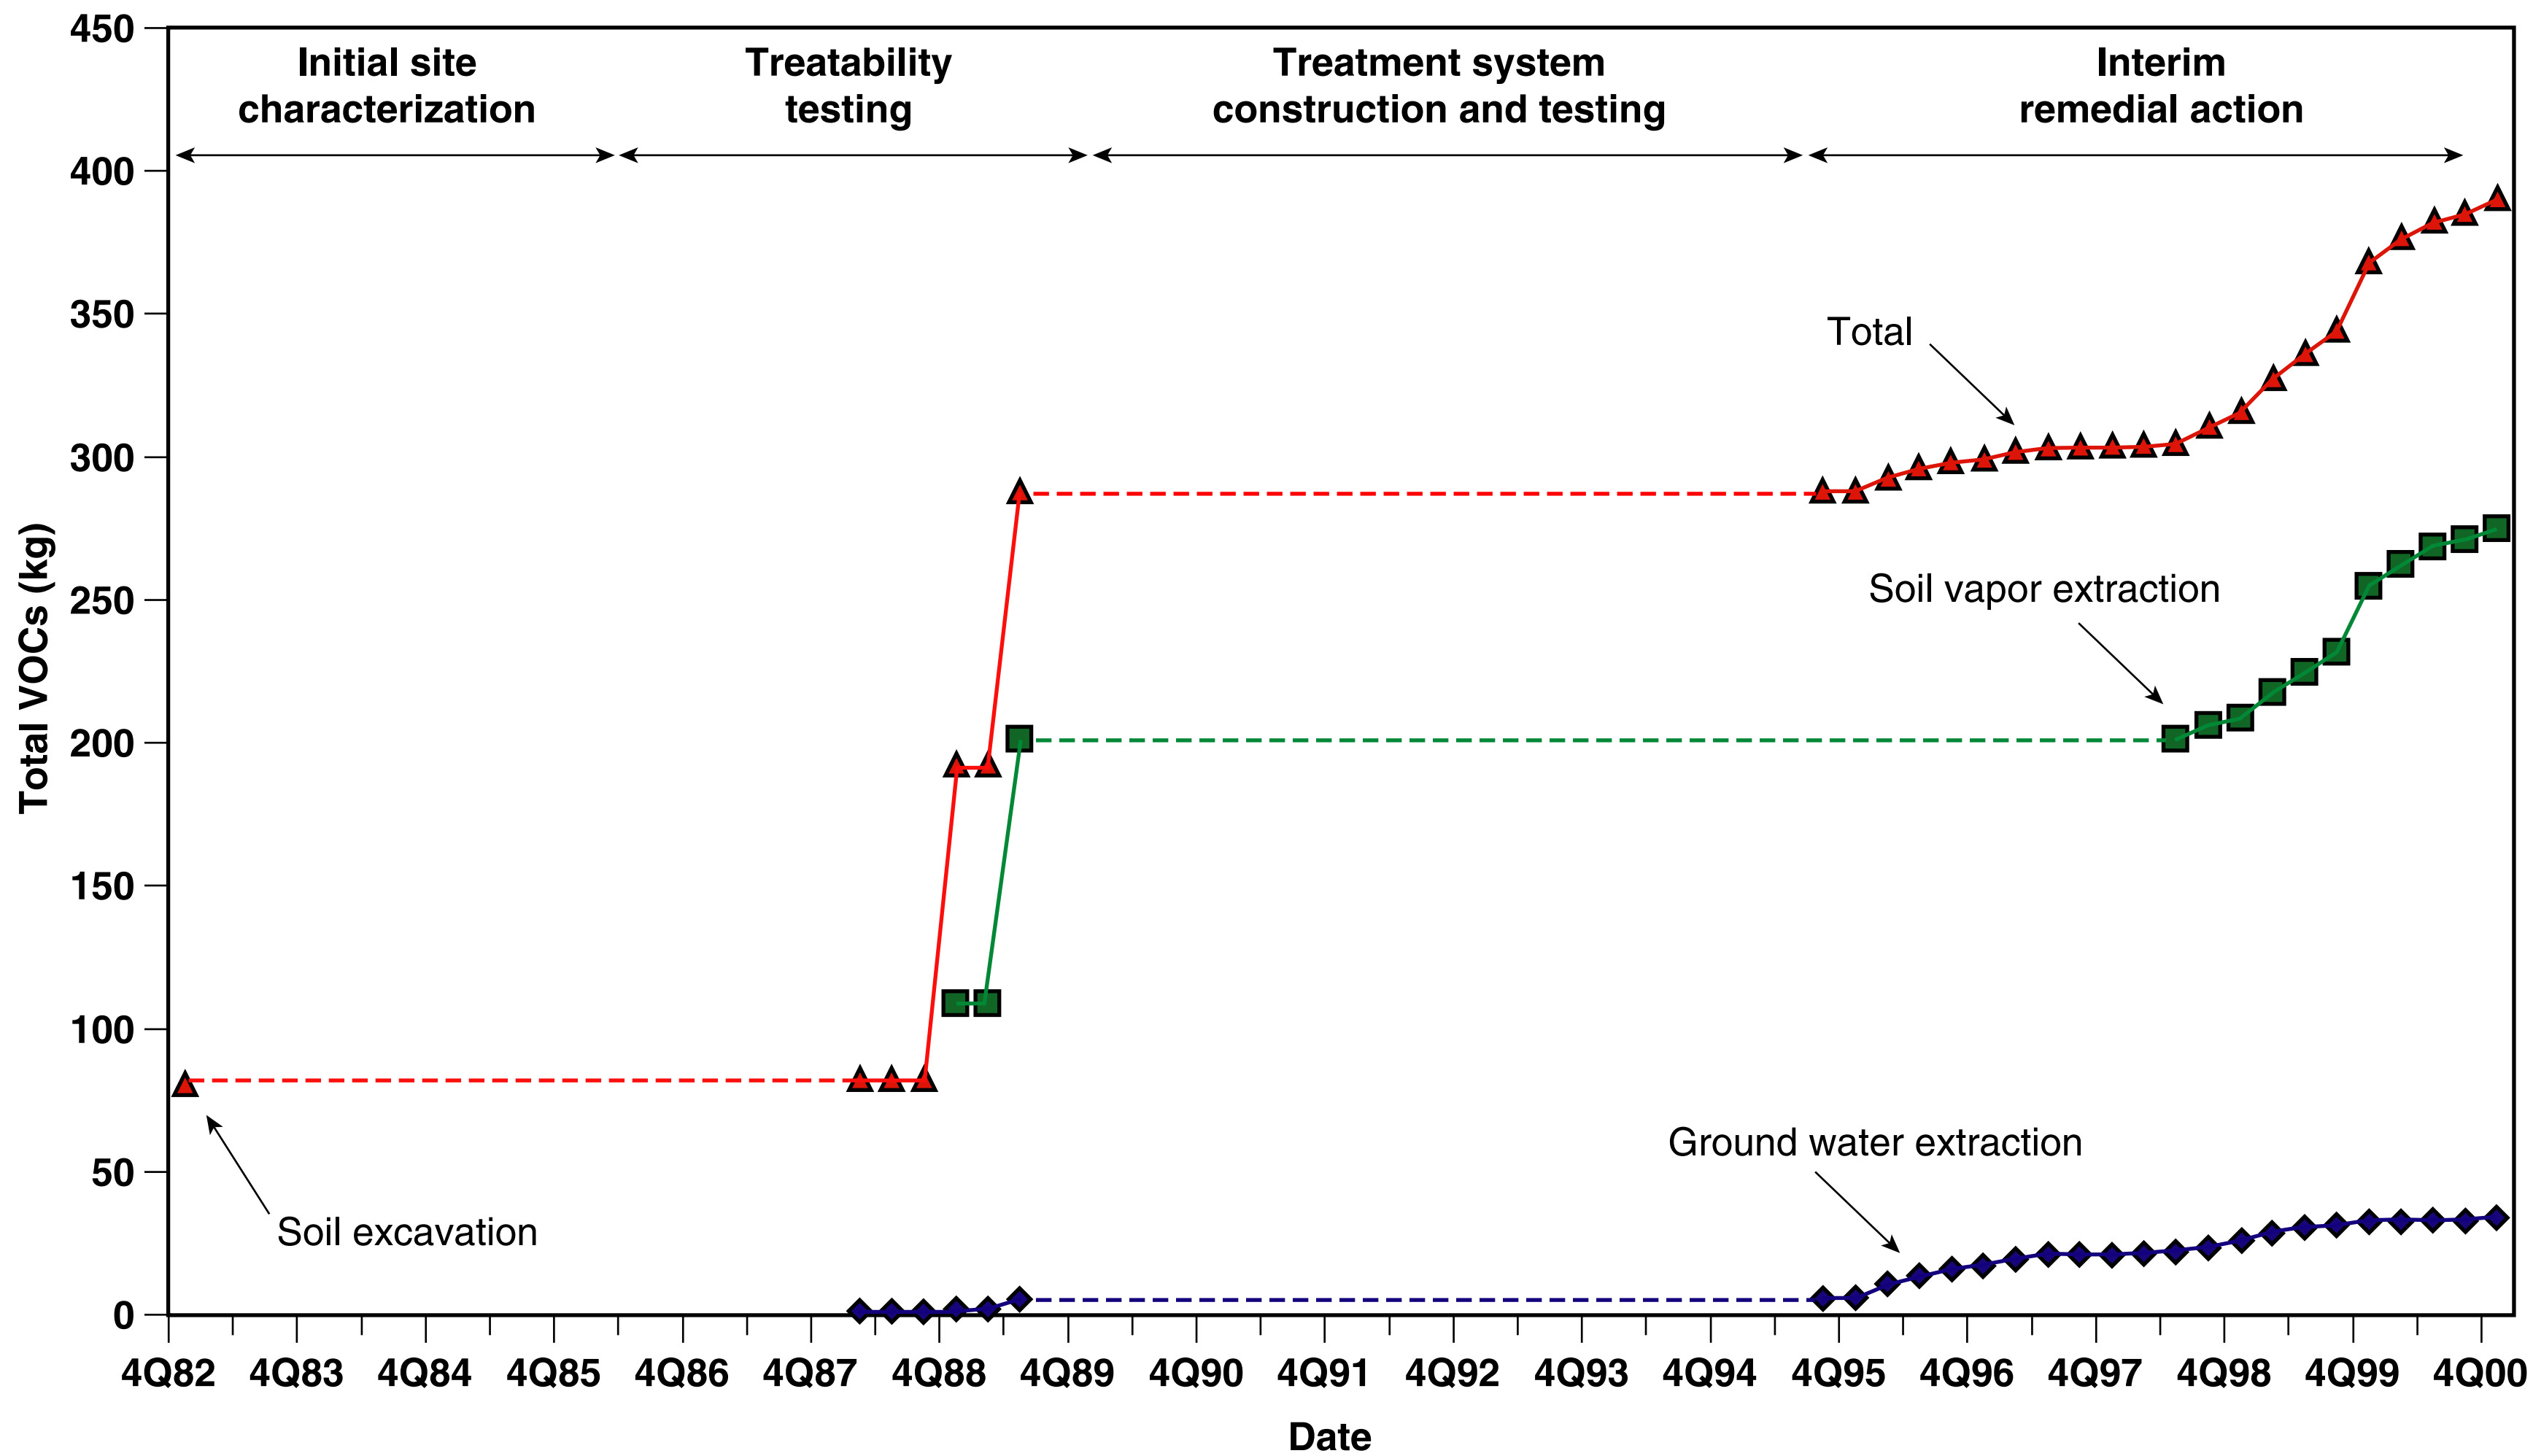
Figure 8. Time-series plot of cumulative mass of total VOCs removed from the subsurface.

A time-series plot of the cumulative mass of total VOCs removed from the subsurface is shown on Figure 8.
