UCRL-AR-144744-DR

Draft
Five-Year Review Report
for the
Building 834 Operable Unit
at Lawrence Livermore National Laboratory
Site 300

August 2001

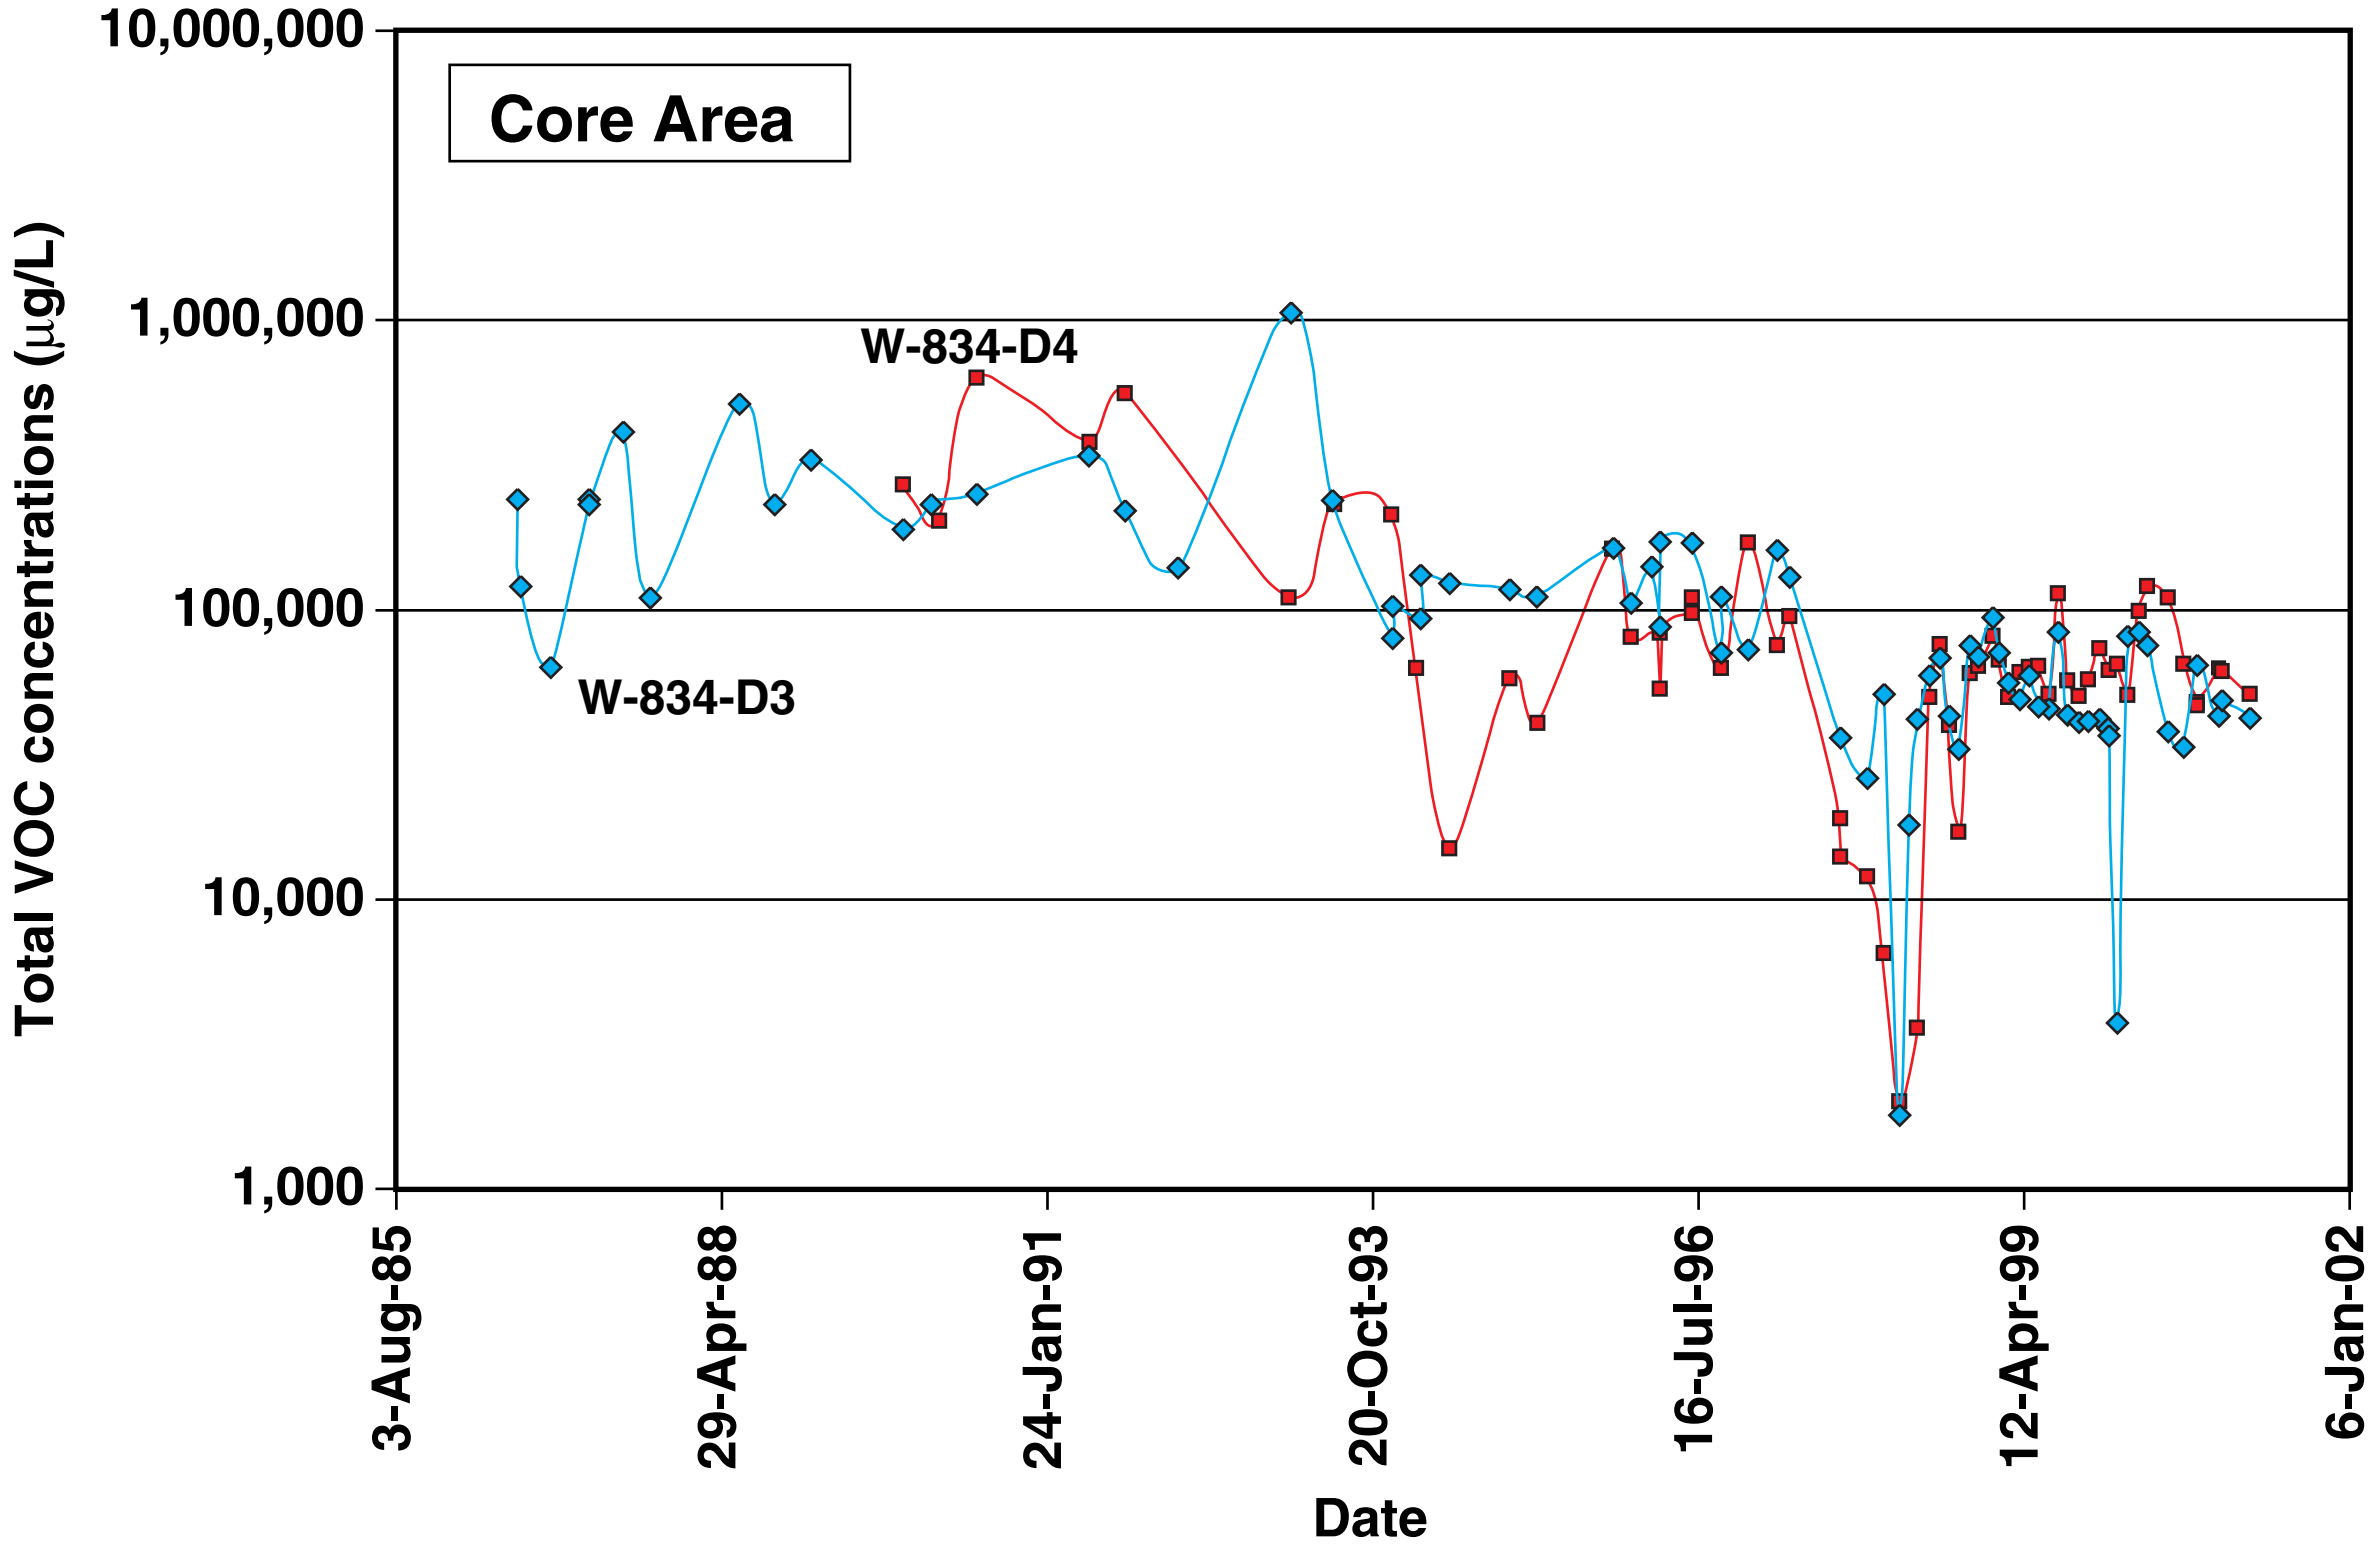
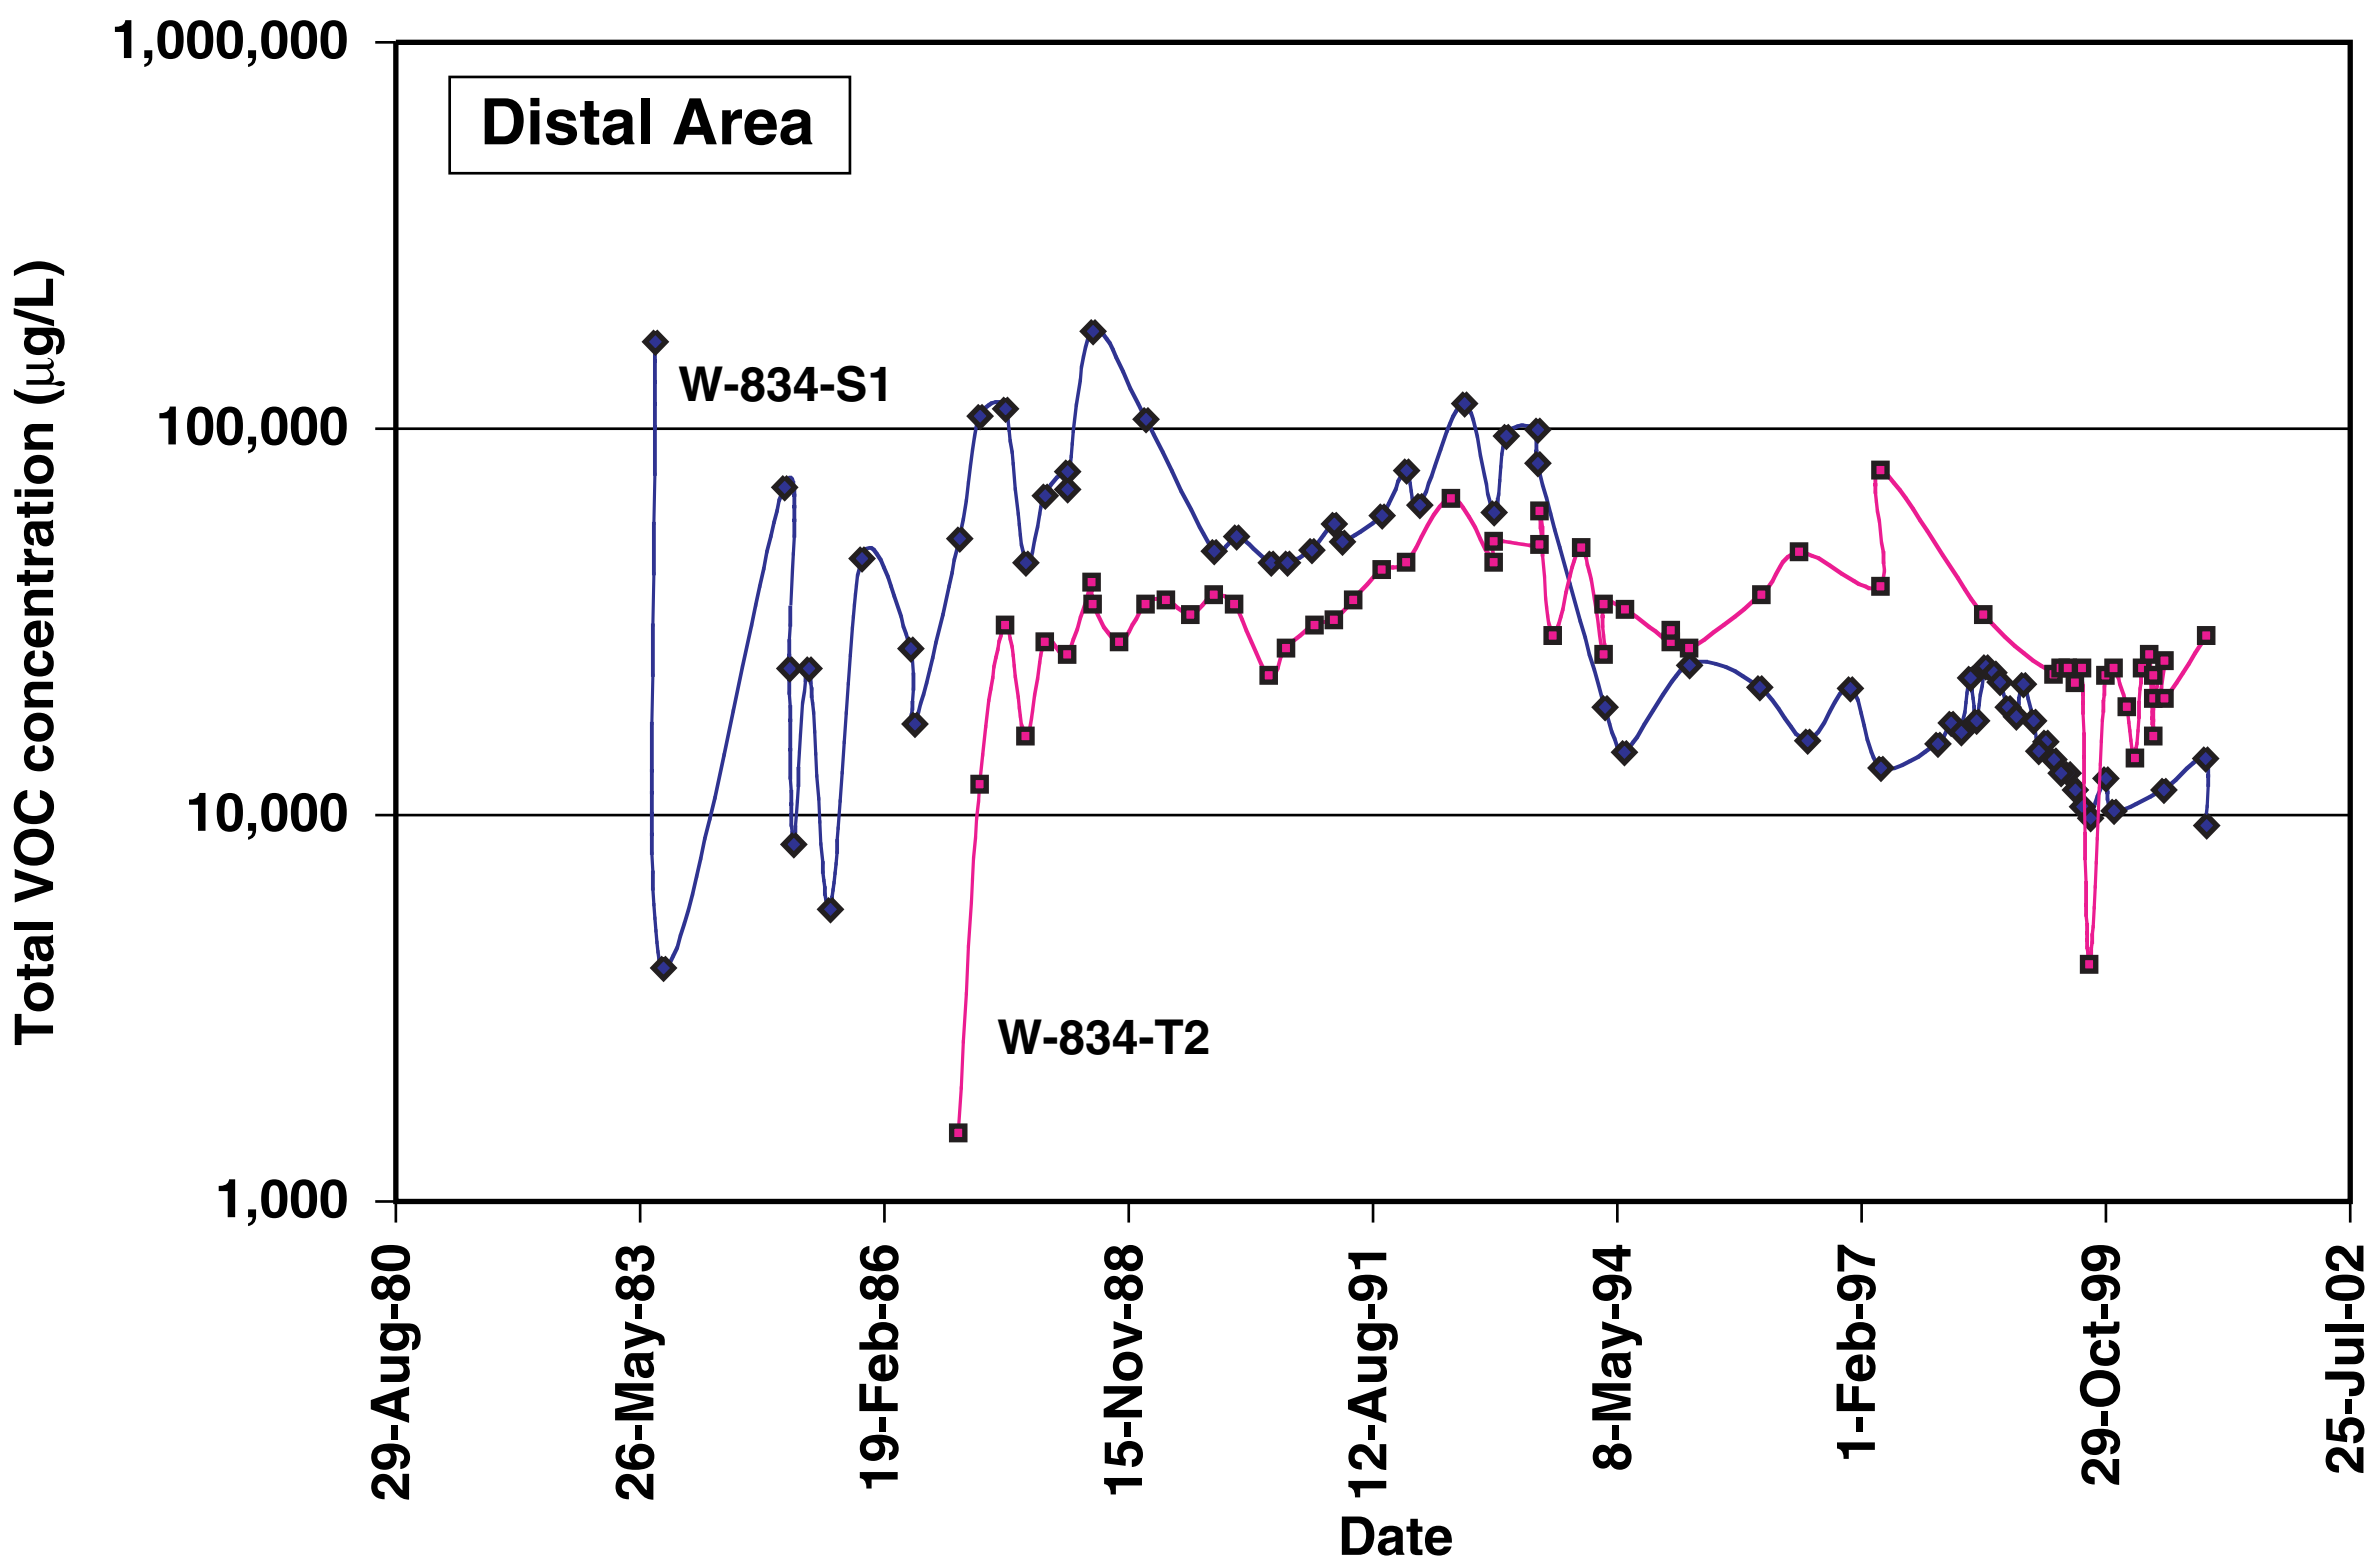
A comparison of the distribution of total VOCs in perched ground water in 1995 and 2000 is shown on Figure 9. The maximum total VOC concentration in ground water has declined from a pre-remediation (1993) value of 1,060,000 micrograms per liter (µg/L) to 34,000 µg/L in late 2000. Time-series plots of total VOC concentration in ground water for selected wells are shown on Figure 10. TCE is typically the predominant VOC present in extracted soil vapor and ground water, but in areas where *in situ* intrinsic biodegradation is taking place the concentration of cis-1-2-DCE in ground water rises dramatically when the soil vapor extraction is not operating, as shown on Figure 11. Although extraction has reduced contaminant mass and concentration in the Core Area, the low hydraulic conductivity, limited recharge, and resulting low well yields limit the size of the extraction well capture zones. Remediation has not appreciably reduced the concentration of VOCs in some parts of the ground water plume, nor caused a decrease in the overall extent of contamination. However, to improve capture of contaminants, DOE is reconfiguring the Core Area wellfield and expanding extraction to include the Distal Area of the VOC plume. A capture zone analysis was included in the Interim Remedial Design document for the OU (Gregory et al., 2002) that indicated … (*Note to reviewers: this analysis is in progress. A summary will be included in the draft final version of this five-year review*).

Figure 9. Comparison of the distribution of total VOCs in ground water in the perched water-bearing zone in 1995 and 2000.

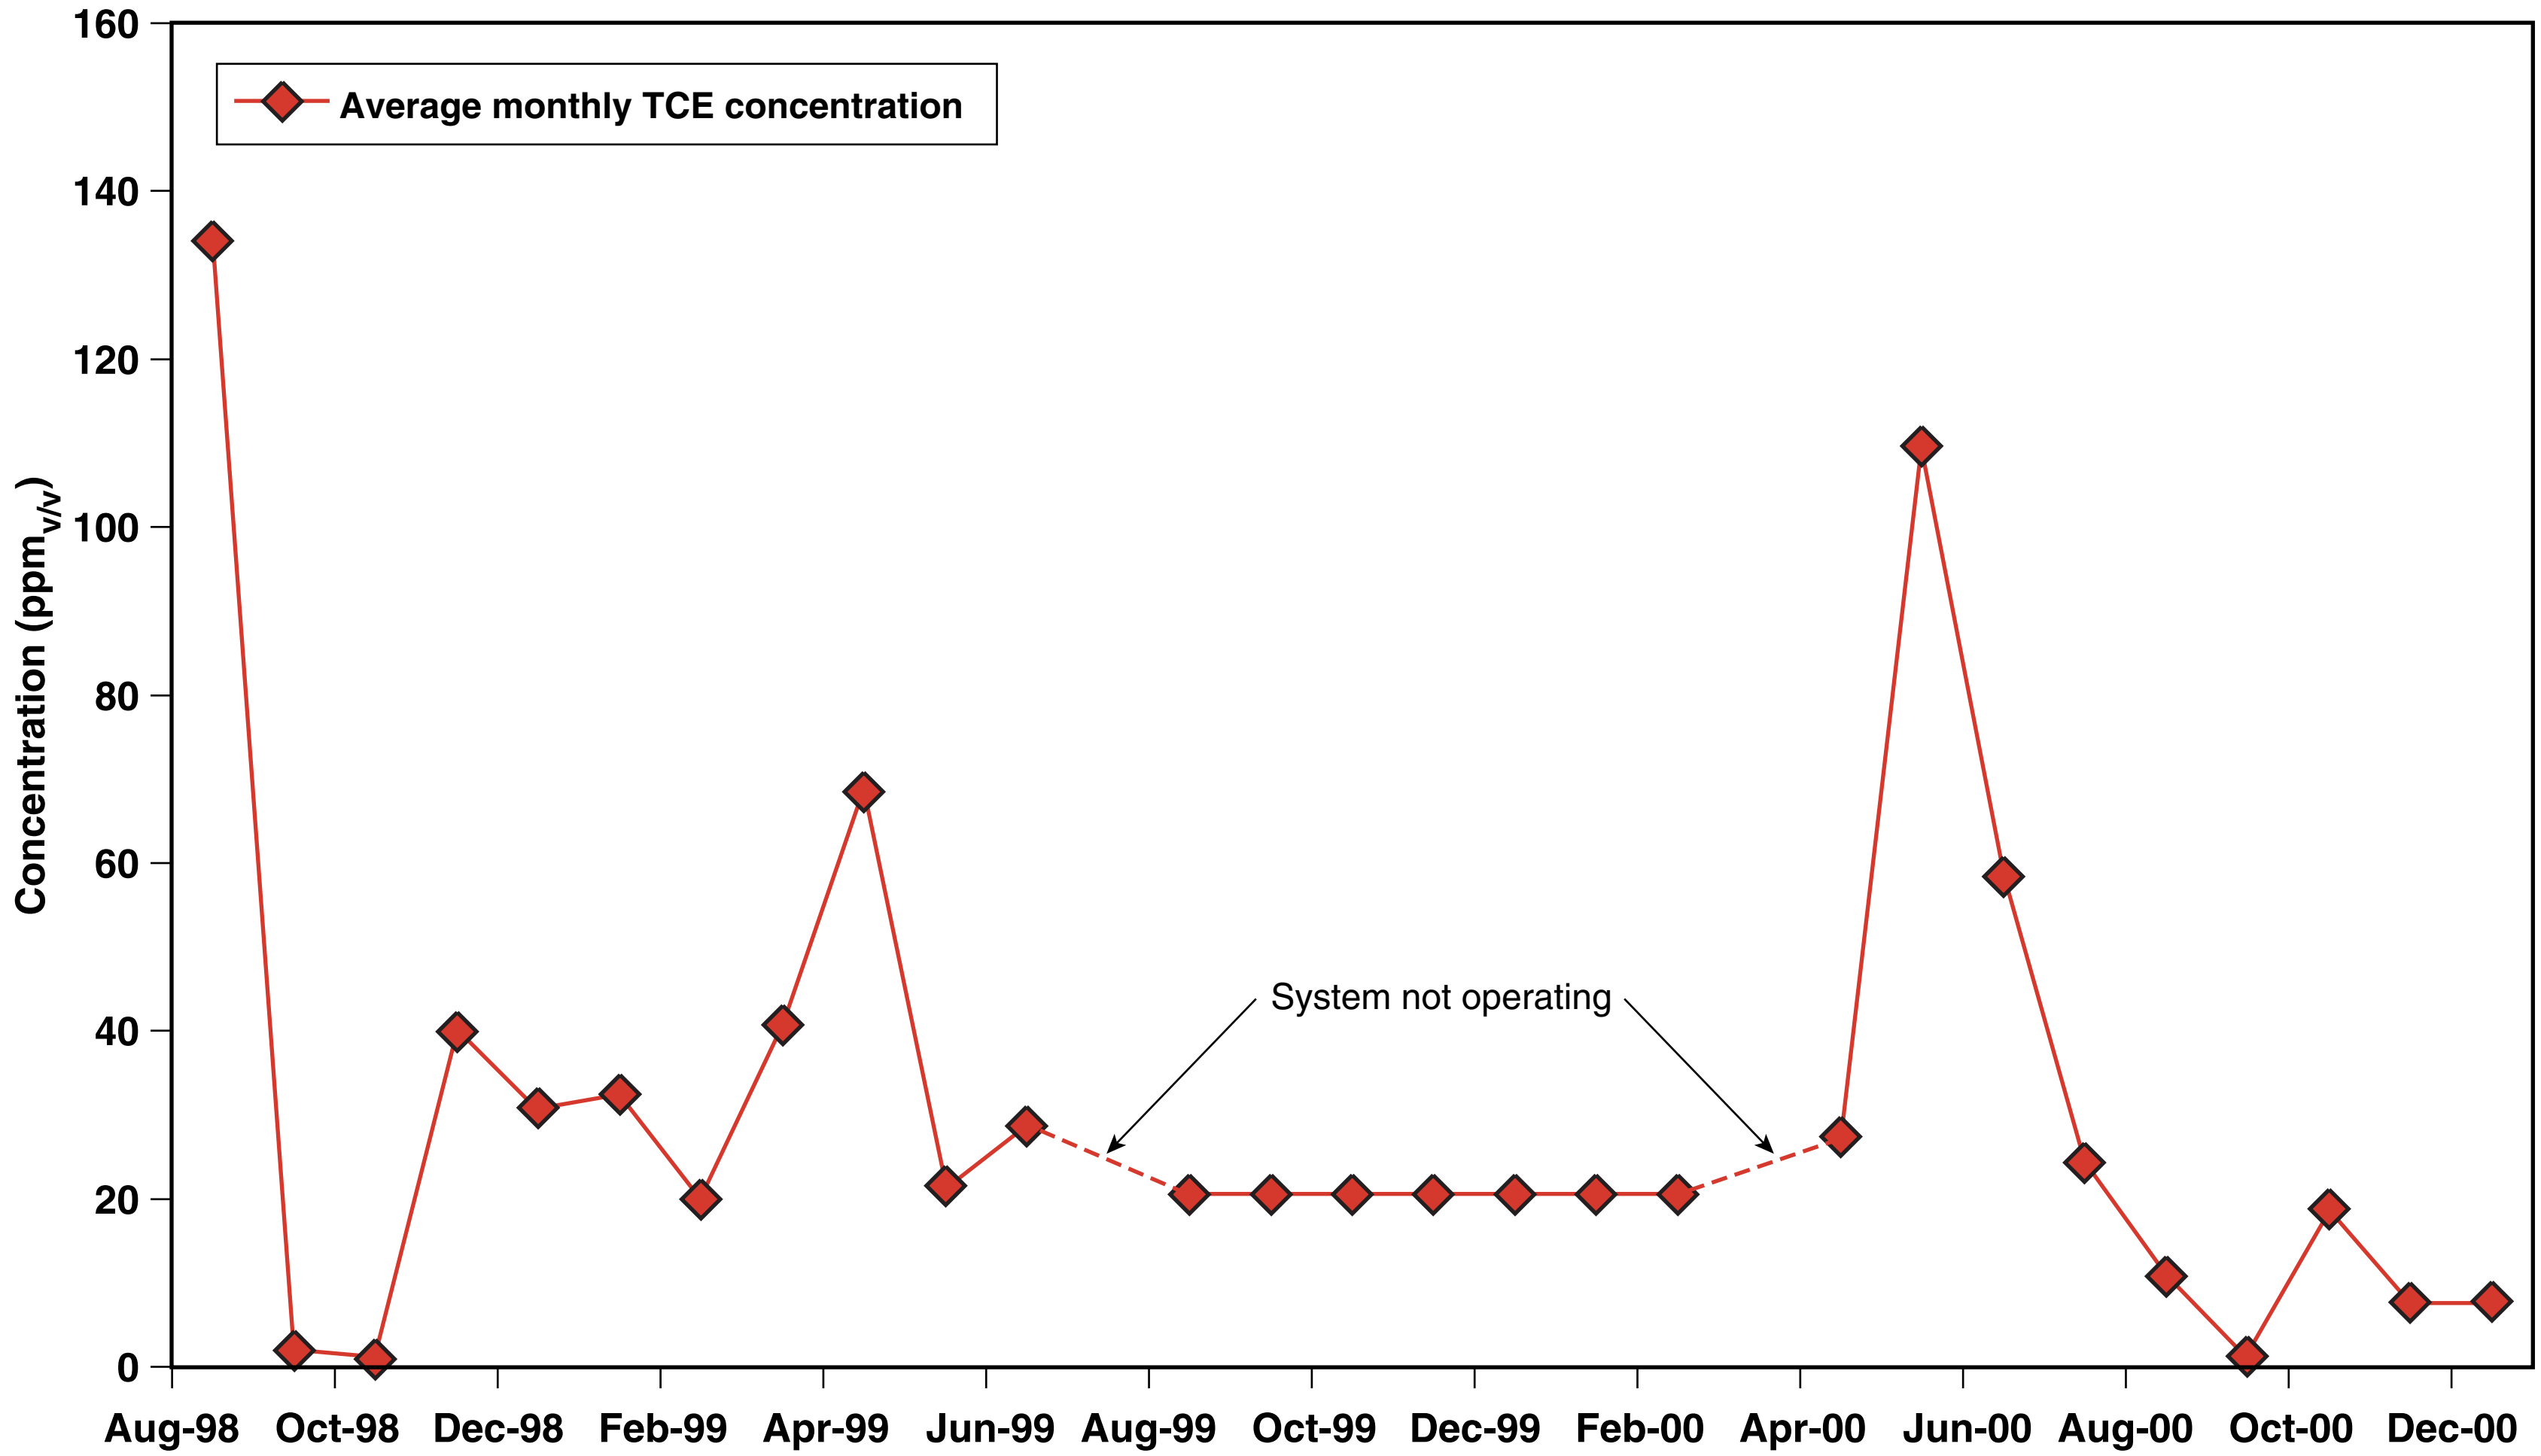
Figure 12. Time-series plot of TCE concentration in soil vapor treatment system influent.

Since full-scale soil vapor extraction began in 1998, the TCE concentration in the soil vapor treatment system influent has been extremely variable, with a maximum of 135 parts per million by volume ($ppm_{v/v}$). This variability is due to changes in extraction well configuration and intermittent operation of the extraction system. A time-series plot of TCE concentration in soil vapor treatment system influent is shown on Figure 12.
