LLNL-AR-670250-DRAFT

Draft First Five-Year Review Report for Operable Unit 5 at Lawrence Livermore National Laboratory Site 300

May 2015

Environmental Restoration Department

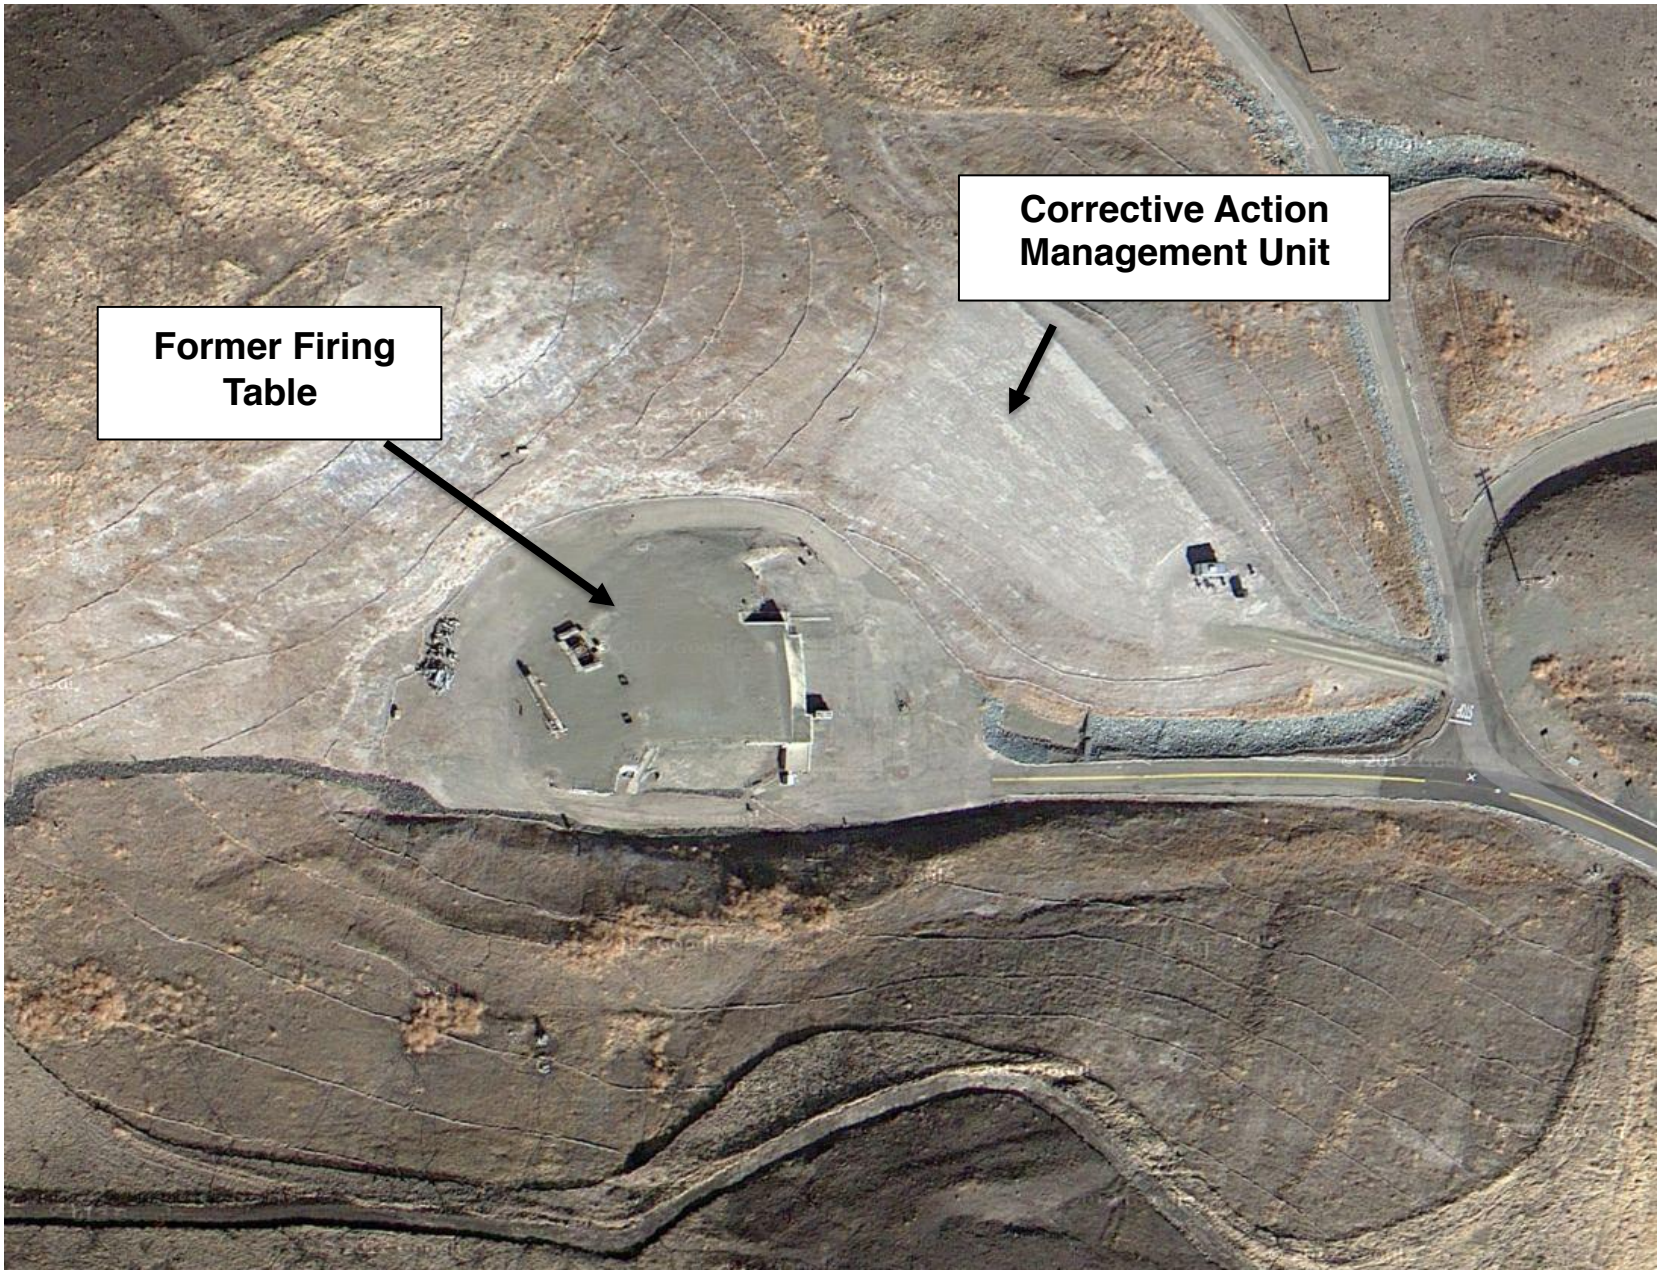
Aerial view of Building 850 CAMU following completion of soil excavation and CAMU construction.

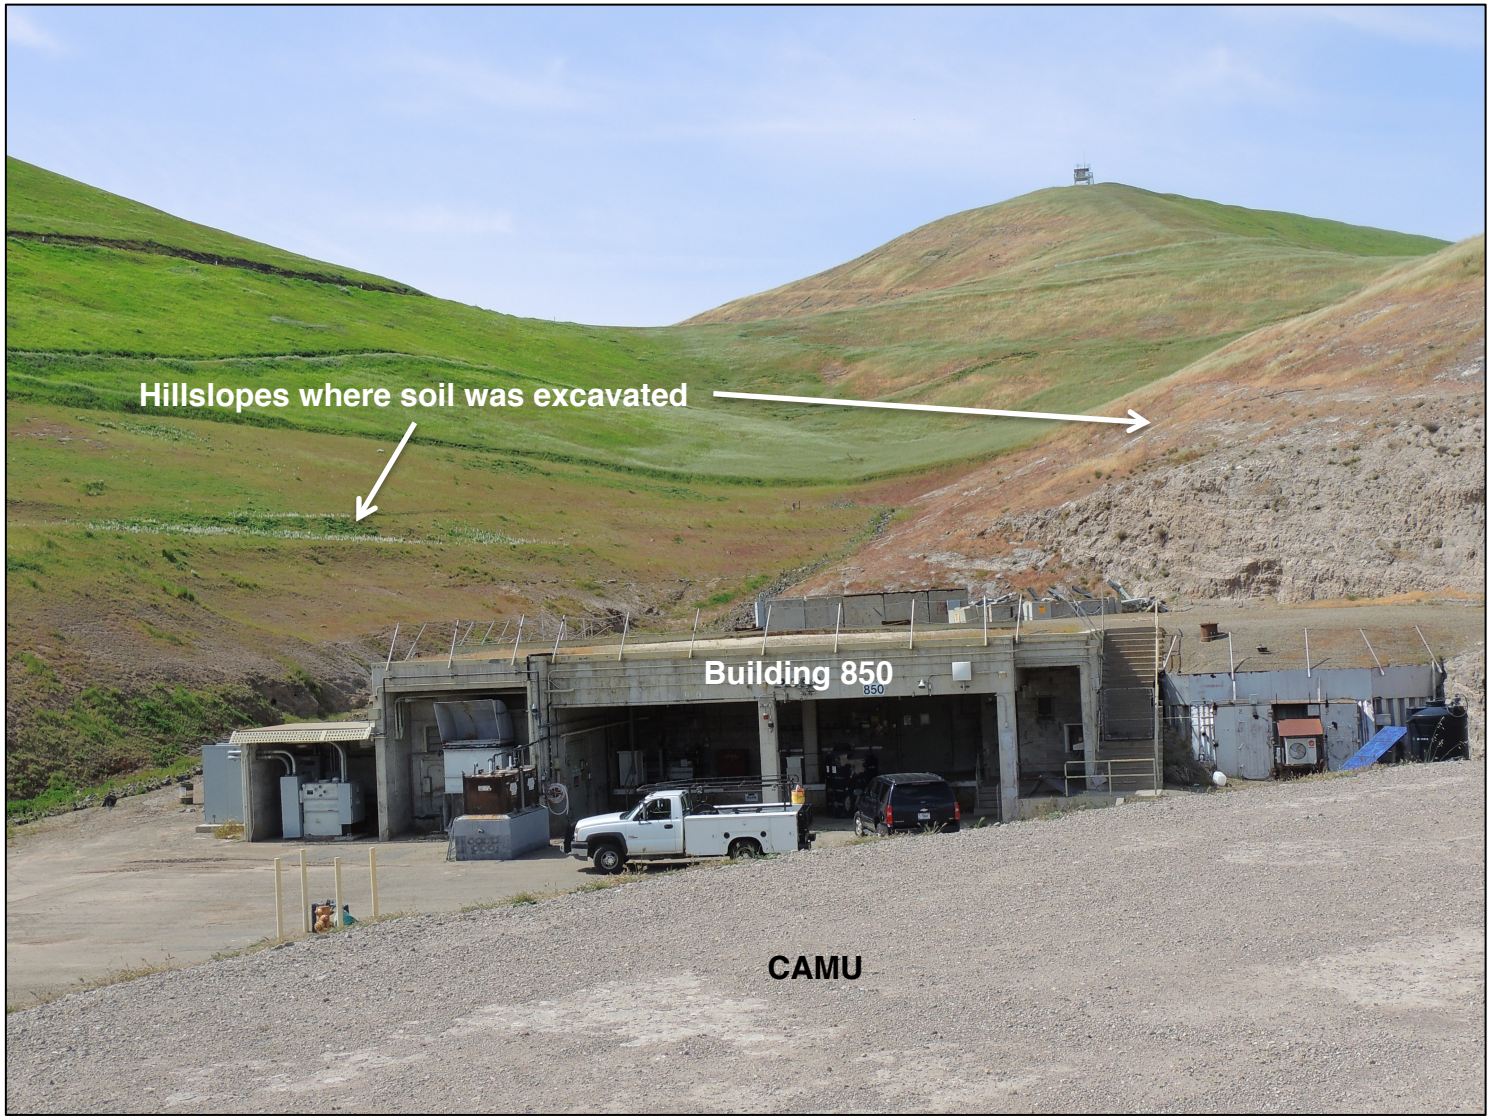
Use of Building 850 and its firing table were discontinued in 2008. The building is "cold and dark".

Photograph of top surface of Building 850 CAMU (looking south).

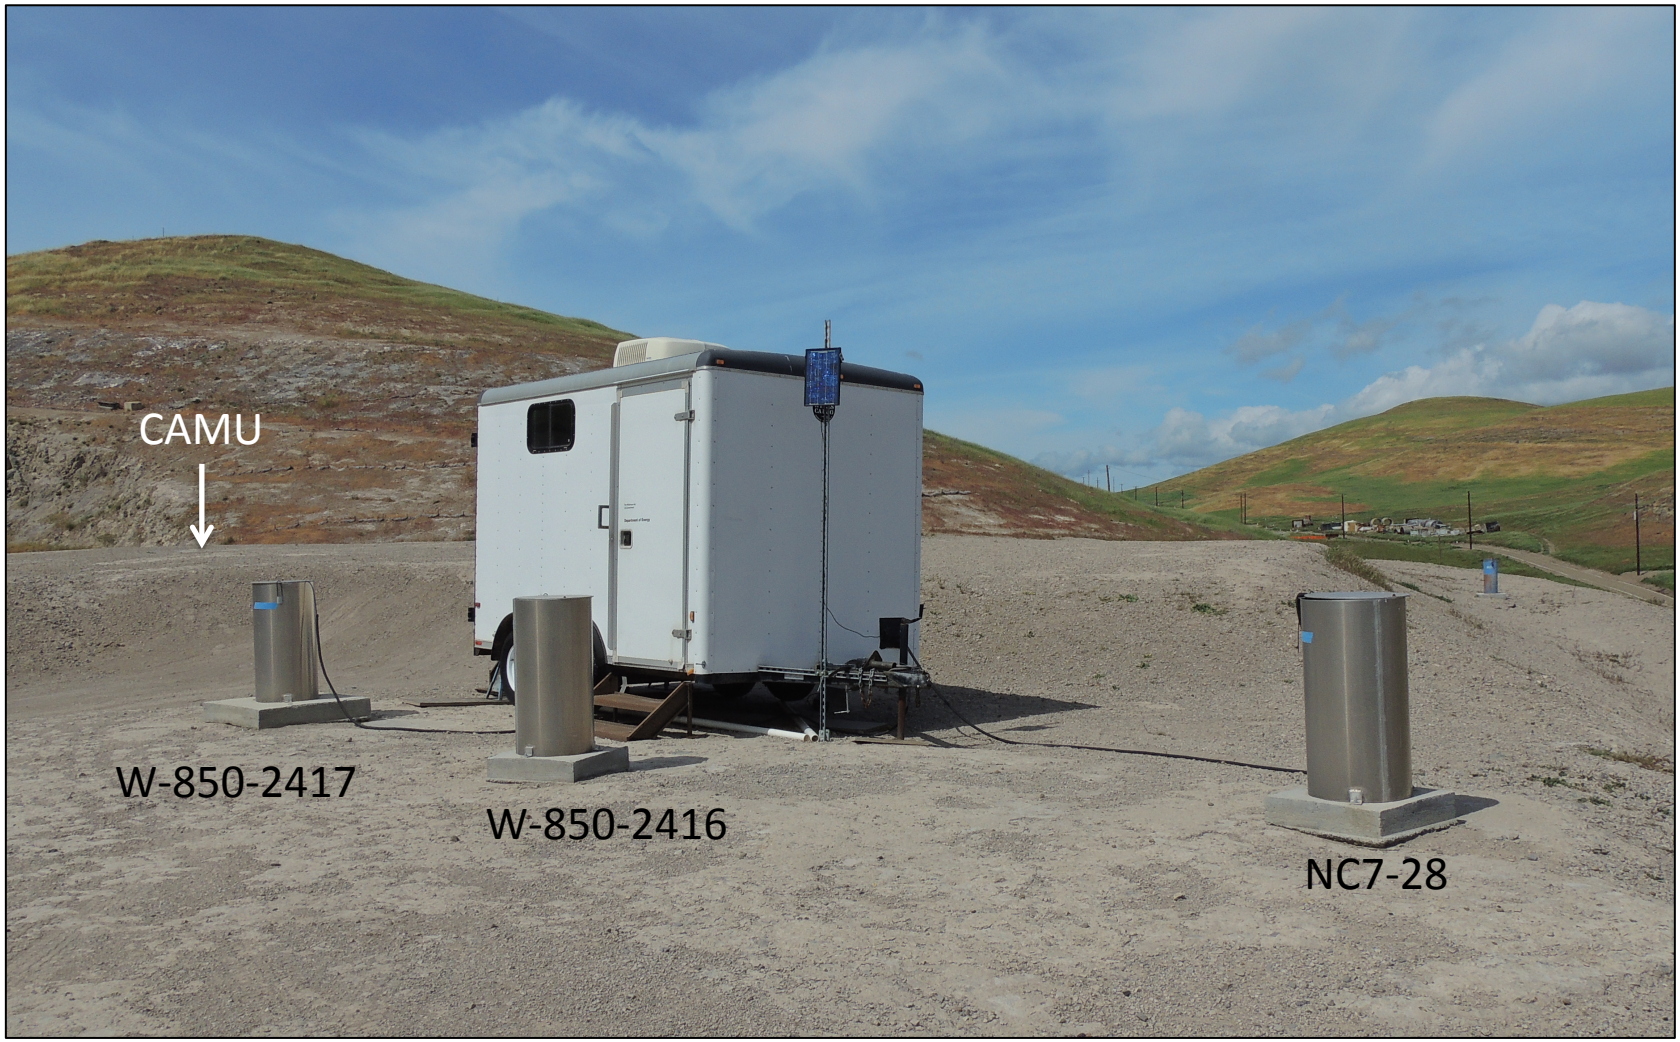
Ground water monitor wells within the CAMU.

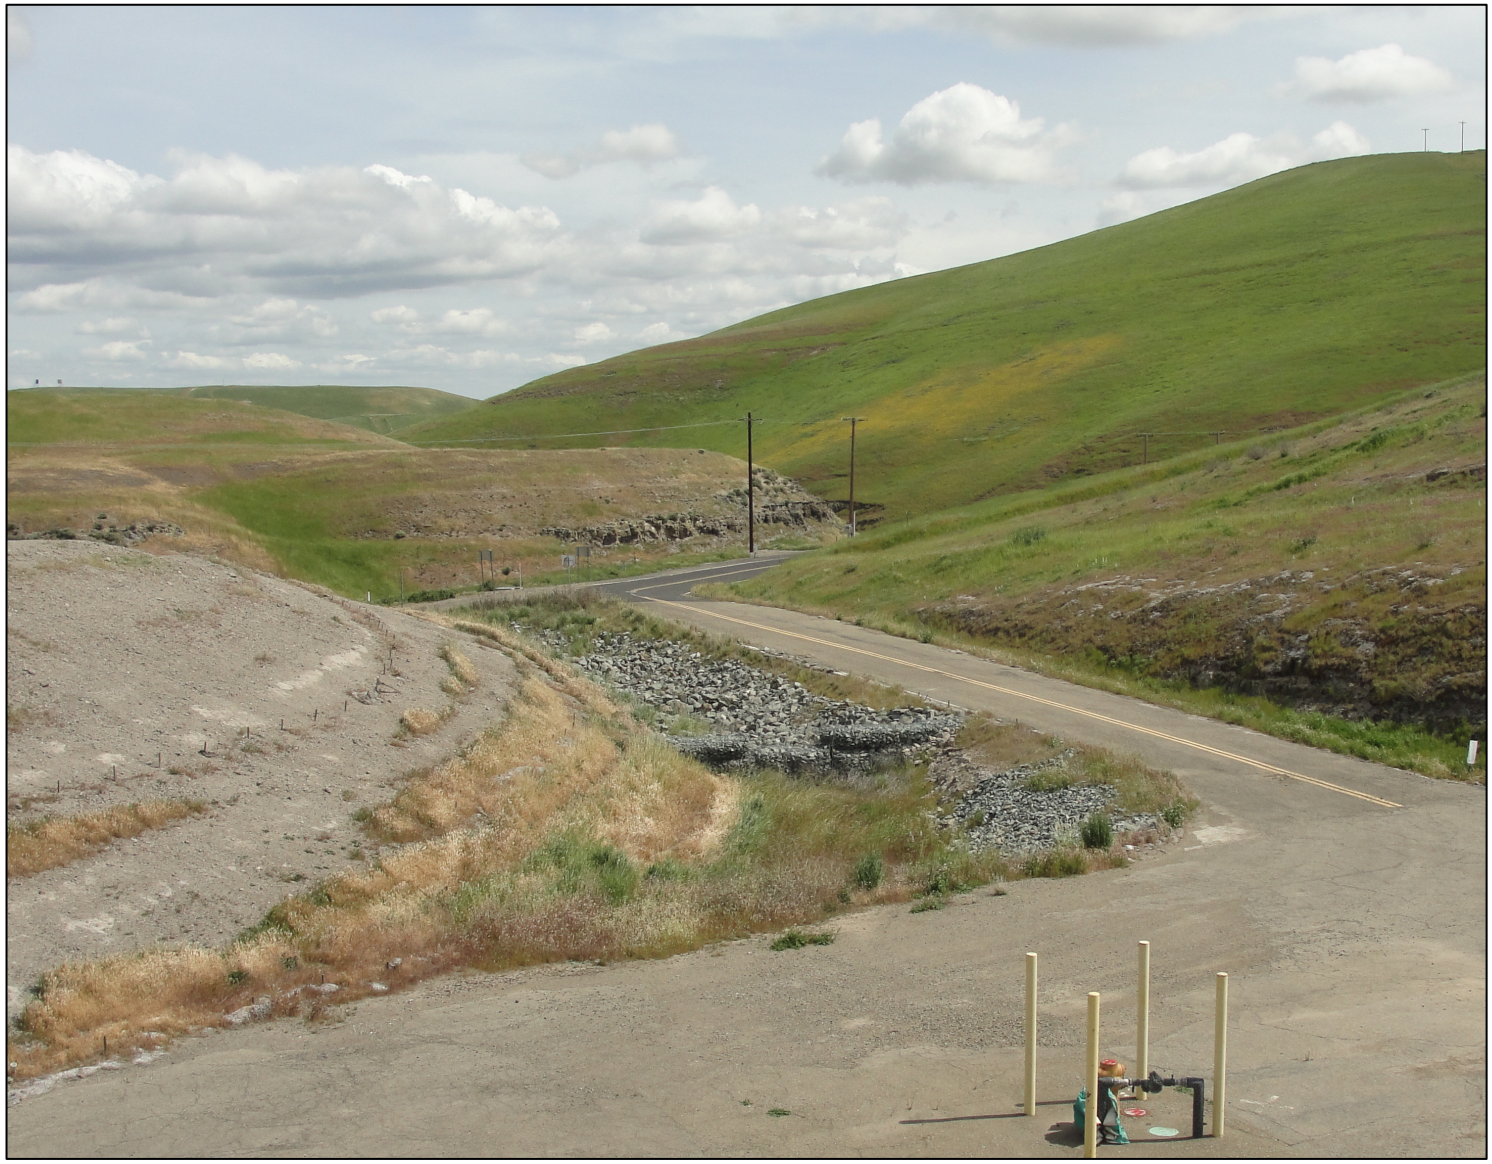
Photograph of drainage channel on south side of CAMU (looking east).

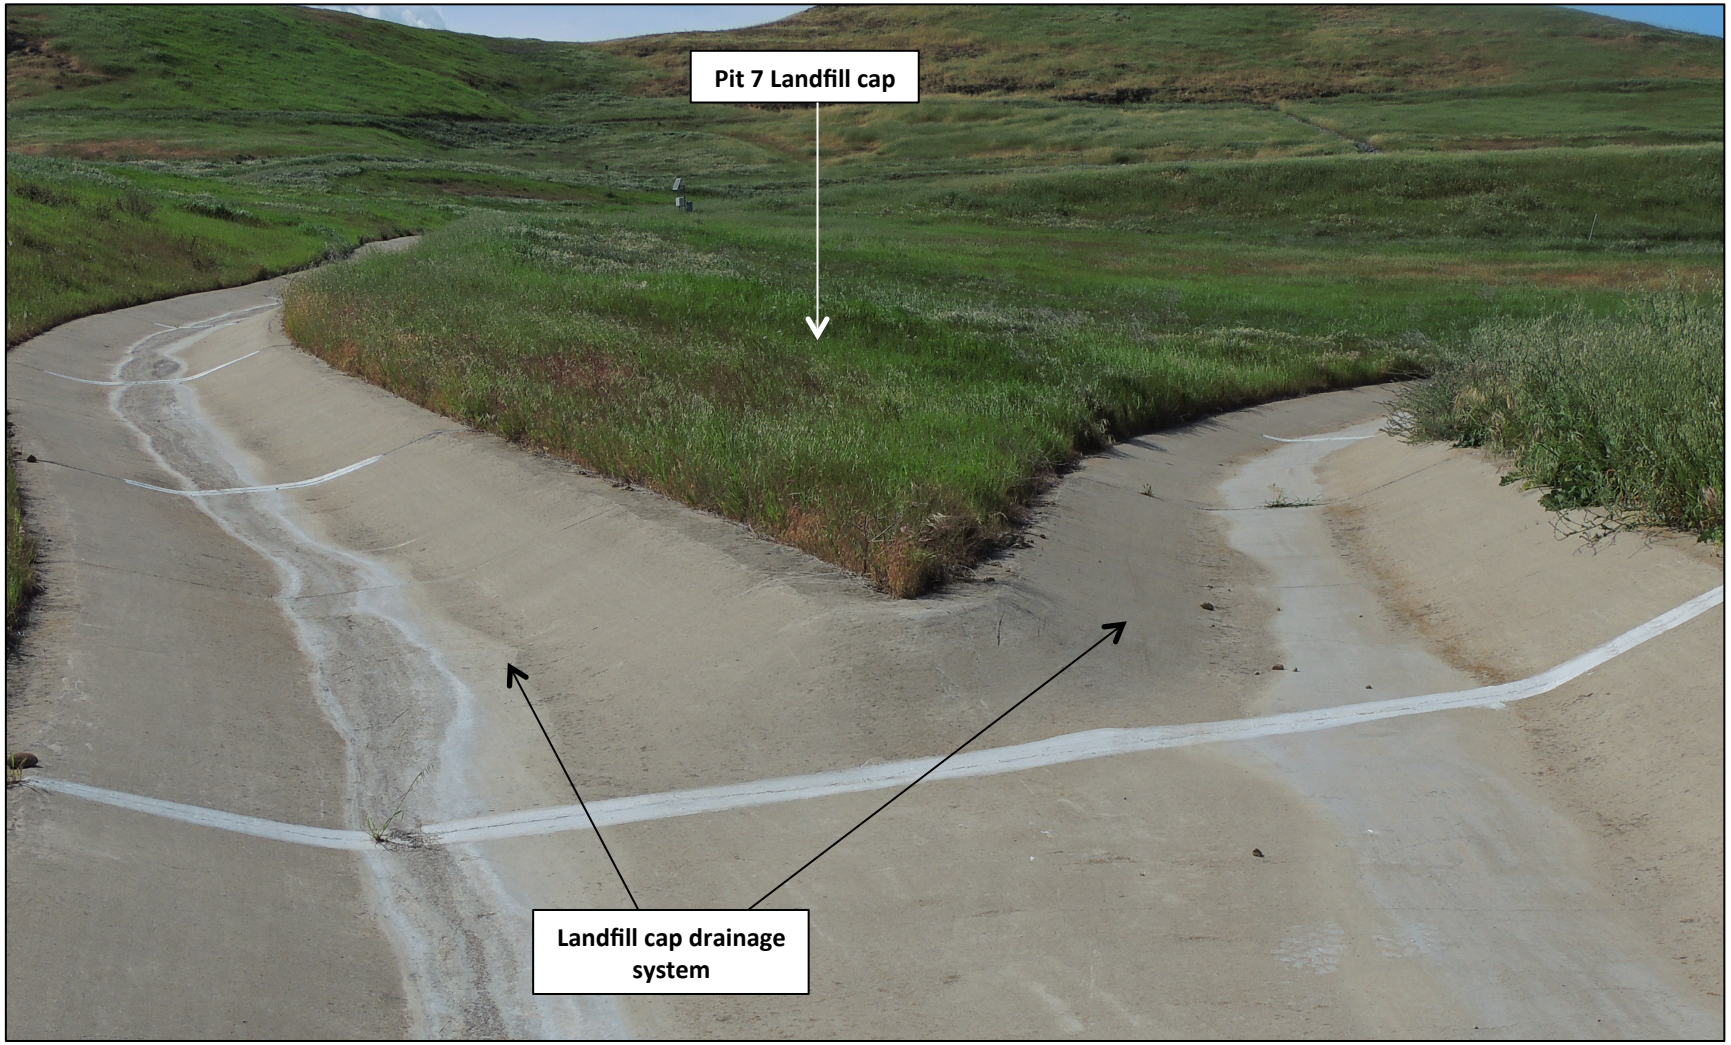
Pit 7 Complex Landfills (post-capping)

Pit 7 Complex Landfill drainage system (looking north).

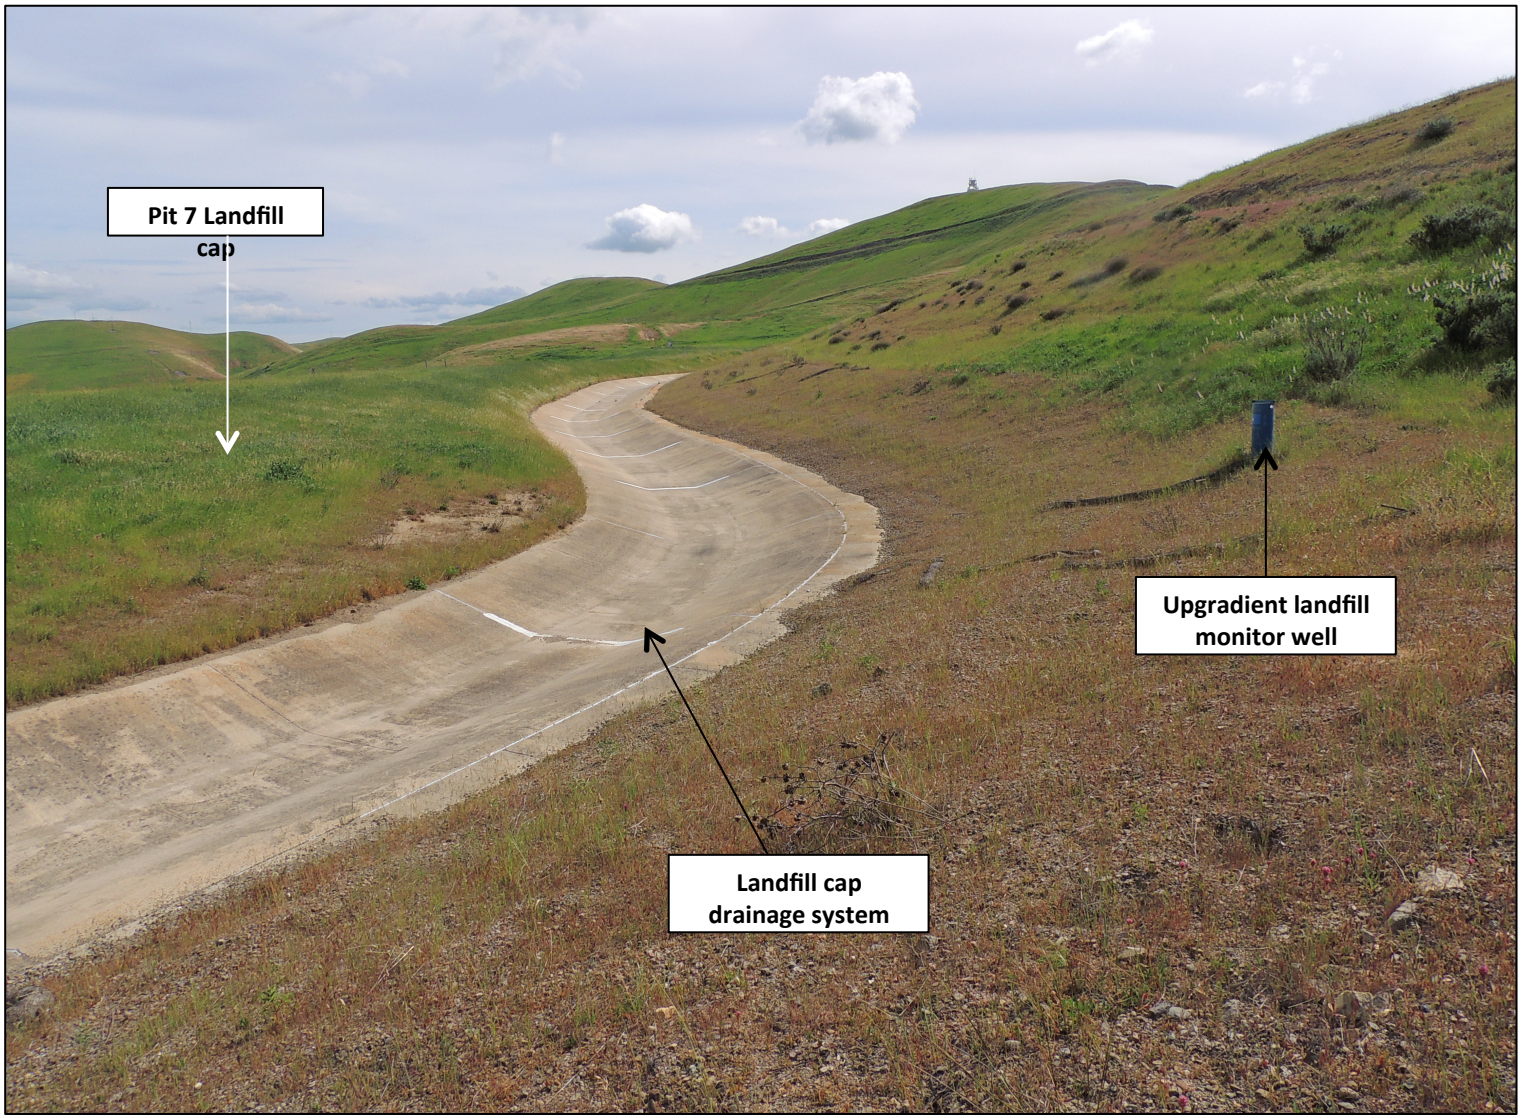
Pit 7 Complex Landfills (post-capping)

Pit 7 Complex Landfill cap, drainage system, and monitor well (looking south).

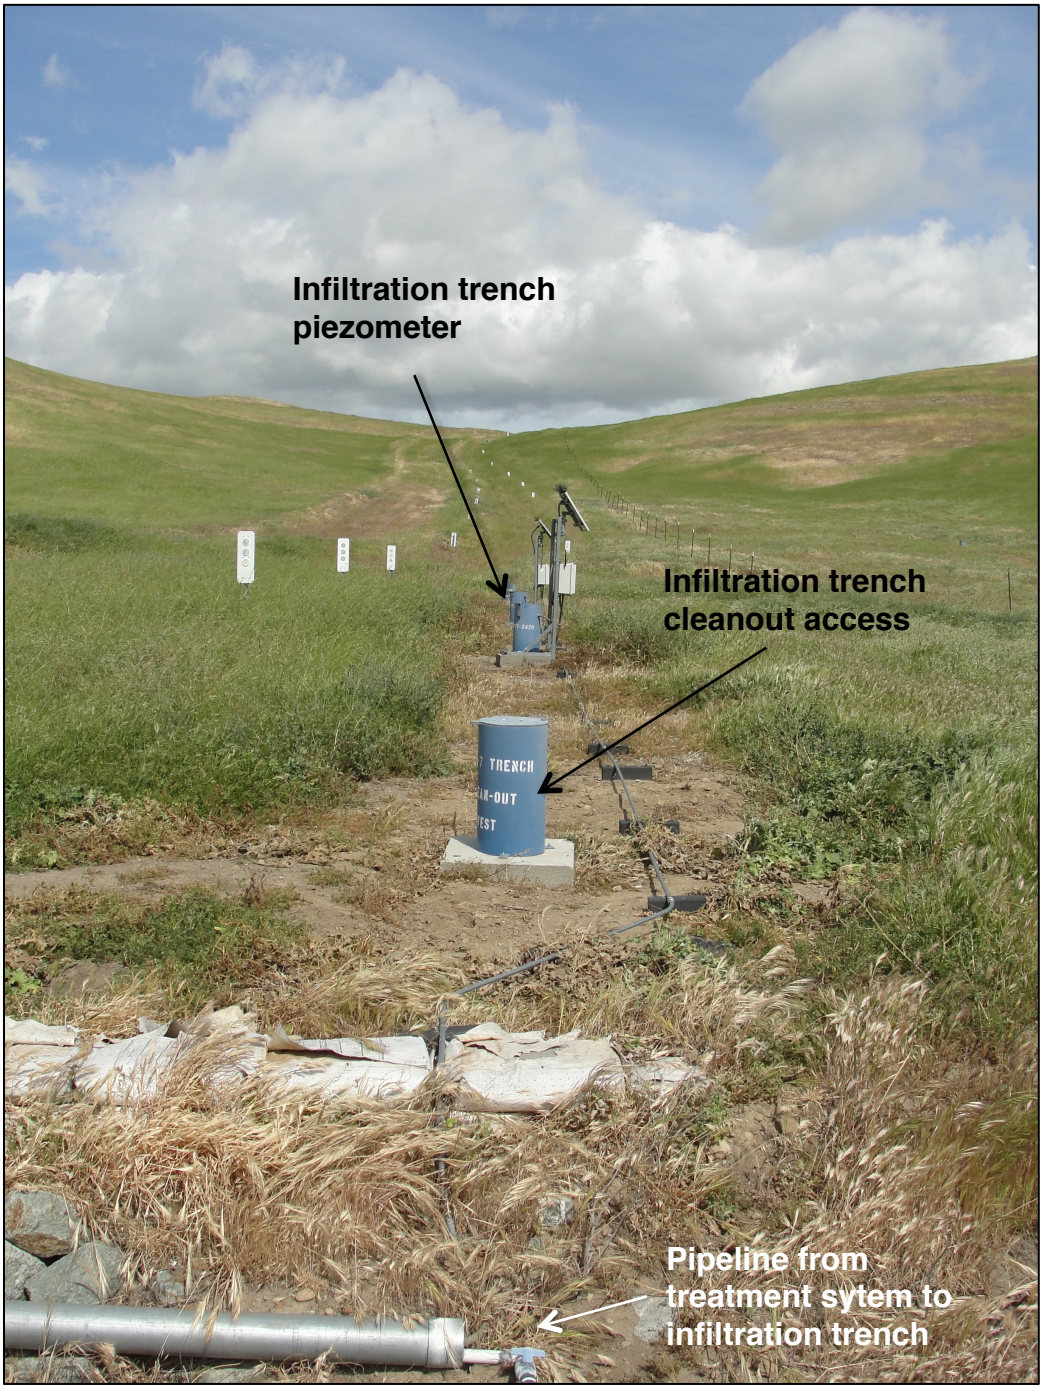
Pit 7 – Source effluent infiltration trench

Piezometers located within the infiltration trench are monitored to ensure the trench capacity is not exceeded.
