U.S. Department of Energy
National Nuclear Security Administration
Livermore Field Office, Livermore, California 94551

Lawrence Livermore National Laboratory

Second Five-Year Review Report for the
Building 854 Operable Unit at
Lawrence Livermore National Laboratory Site 300

January 8, 2014

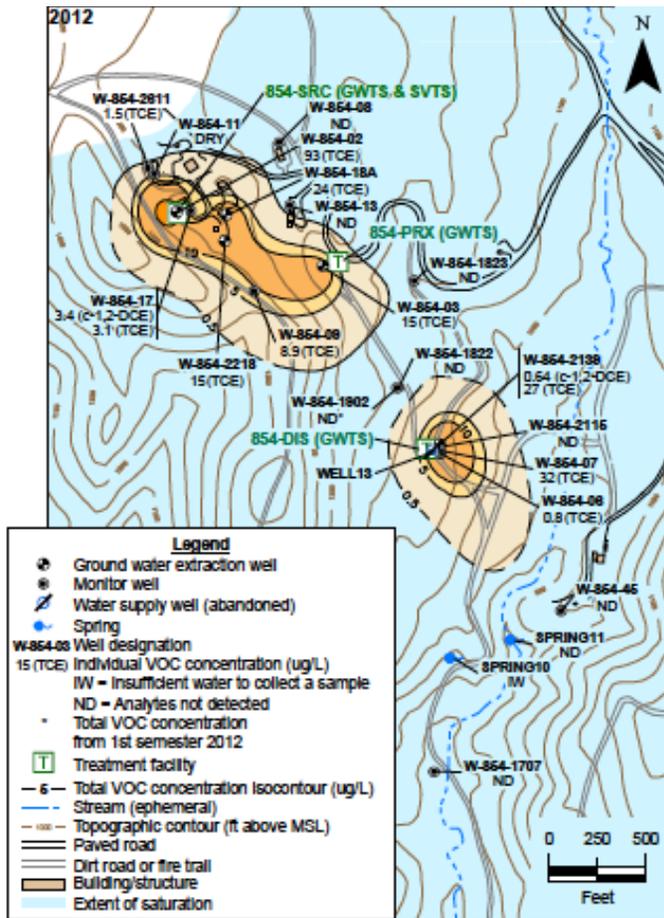
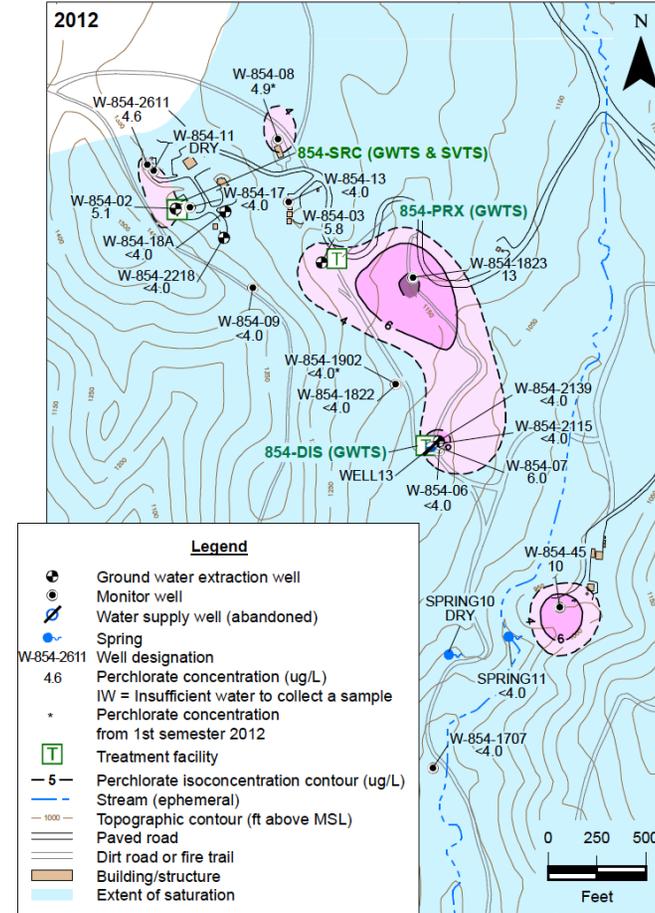
The leading edge of the TCE and perchlorate plumes are bounded

The leading edge of the TCE plumes is bounded by the existing monitoring network:

- Northern Plume: Wells W-854-1902, -1822, & -1823.
- Southern Plume: Wells W-854-45 & -1707, and Spring 11

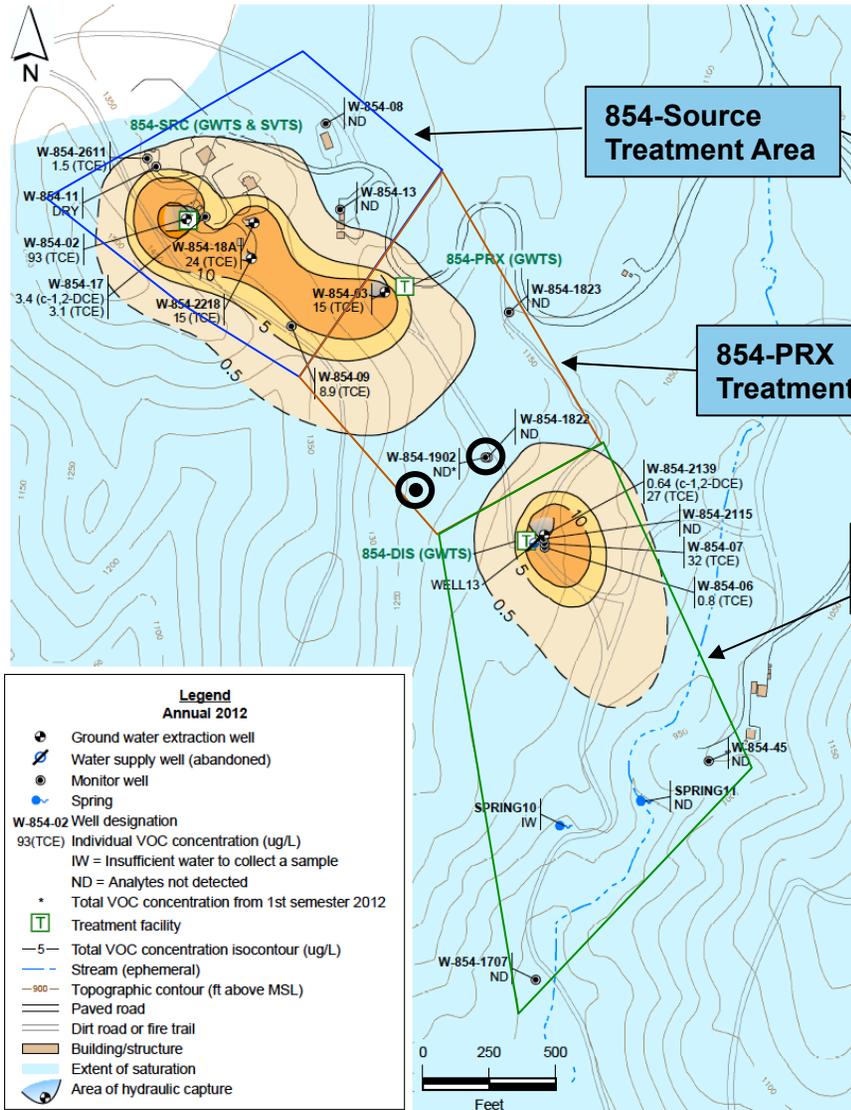
Figure 15. Map showing total VOC isoconcentration contours for the Tnbs₇/Tnsc₀ hydrostratigraphic unit.

Overall, VOC concentrations in Tnbs₁/Tnsc₀ HSU ground water have decreased by two orders-of-magnitude, from an historic maximum of $2,900 \mu\text{g/L}$ in 1997 to $93 \mu\text{g/L}$ in July 2012. A total VOC isoconcentration contour map and individual VOC concentrations in the Tnbs₁/Tnsc₀ HSU are shown on Figure 15.

The southern plume encompasses the 854-DIS area and the former water-supply Well 13 (Figure 15). Figure 13 shows the following changes regarding the southern extent of VOCs impacting Building 854 ground water during the five-year review period:

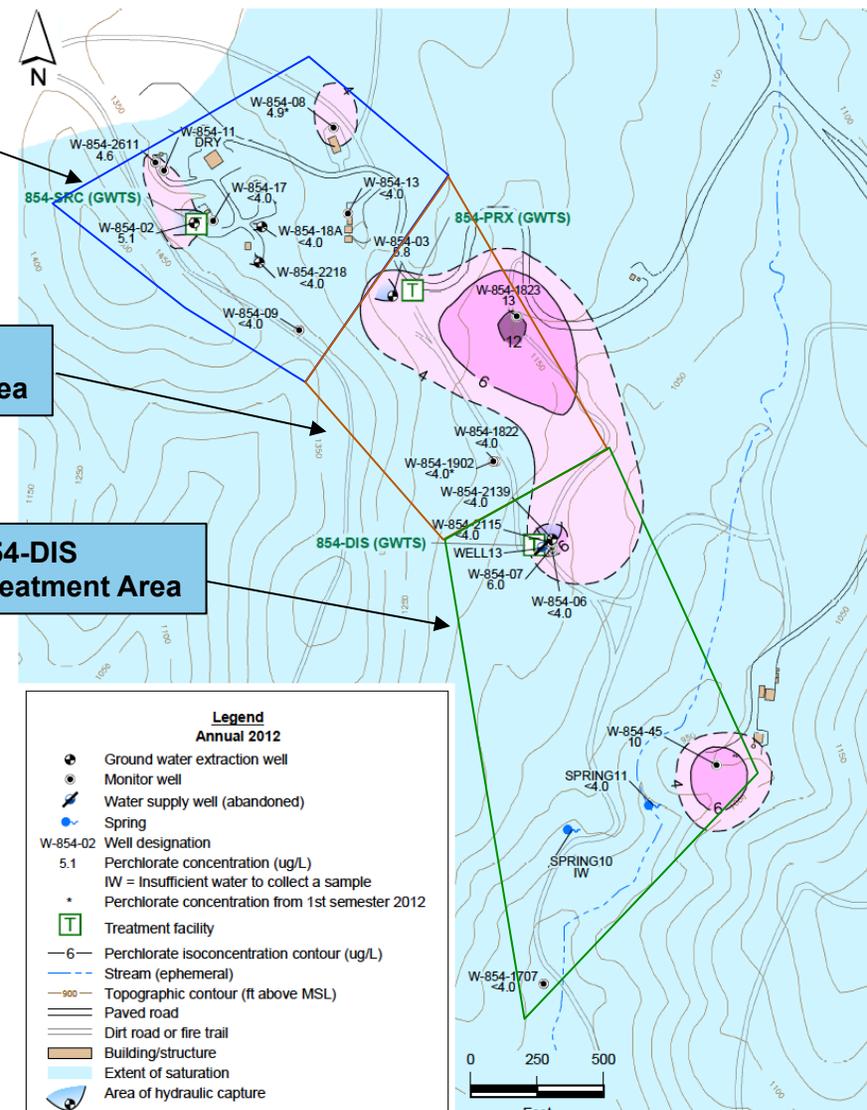
Figure 16. Map showing perchlorate isoconcentration contours for the Tnbs₇/Tnsc₀ hydrostratigraphic unit.

Perchlorate has been detected in Building 854 OU ground water at concentrations exceeding the 6 µg/L MCL cleanup standard in the Tnbs₁/Tnsc₀ HSU. The distribution of perchlorate in Tnbs₁/Tnsc₀ HSU ground water observed during 2012 is similar to its extent in previous years. A perchlorate isoconcentration contour map for the Tnbs₁/Tnsc₀ HSU is presented on Figure 16. Perchlorate concentrations in Tnbs₁/Tnsc₀ HSU ground water have decreased by approximately 50% from a historic maximum of 27 µg/L in 2003 to a 2012 maximum of 13.4 µg/L (May), both detected in monitor well W-854-1823 (located downgradient of the 854-PRX facility) (Figure 18). The five-year review period maximum of 16.6 µg/L (2008) was also detected in this well signifying a general decreasing trend over time.

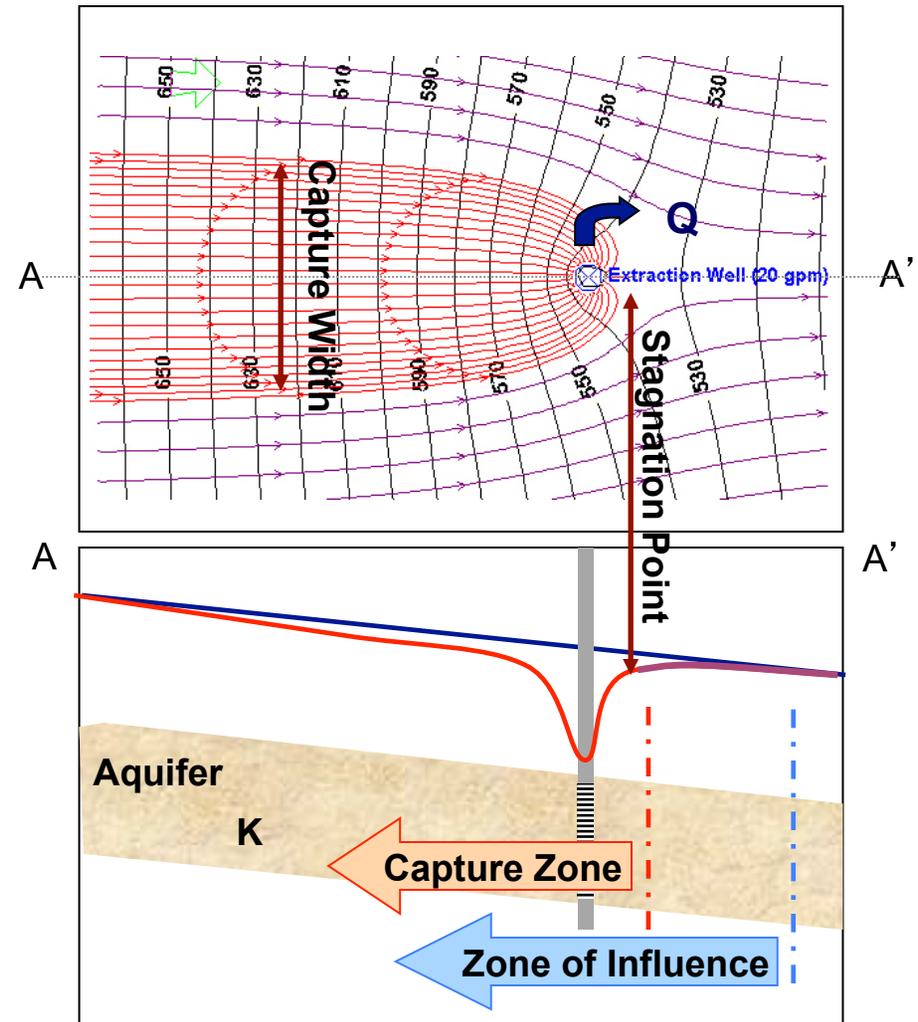
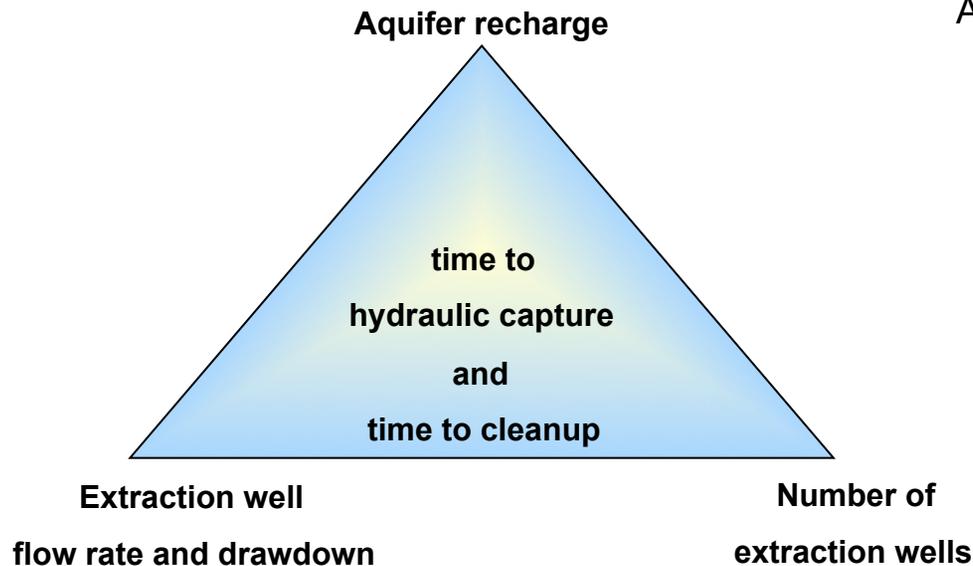
The hydraulic capture of 854-SRC extraction well W-854-02 is larger than depicted due to fracture flow

- **The hydraulic capture zones for extraction well W-854-02 are much larger than shown in the Compliance Monitoring Reports and the 5-Year Review due to fractures (e.g., hydraulic influence on W-854-11 by pumping at W-854-02).**
- **DOE/LLNL plan to increase the flow rate from extraction well W-854-2218 (Five-Year Review Recommendation). This will increase hydraulic capture in this treatment area.**

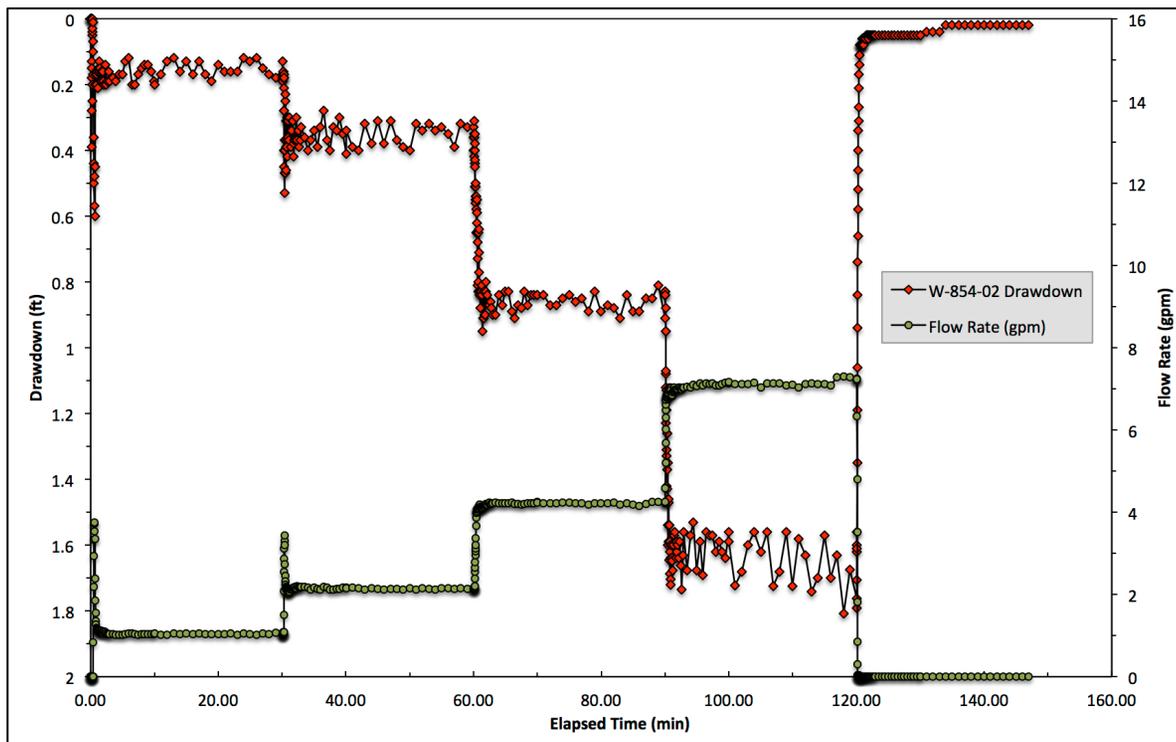
A step-drawdown test of well W-854-02 was conducted in 1999 prior to beginning of pumping at 854-Source

Well W-854-02 was pumped at 1, 2, 4 and 7 gallons per minute (gpm) while monitoring drawdown in the well.

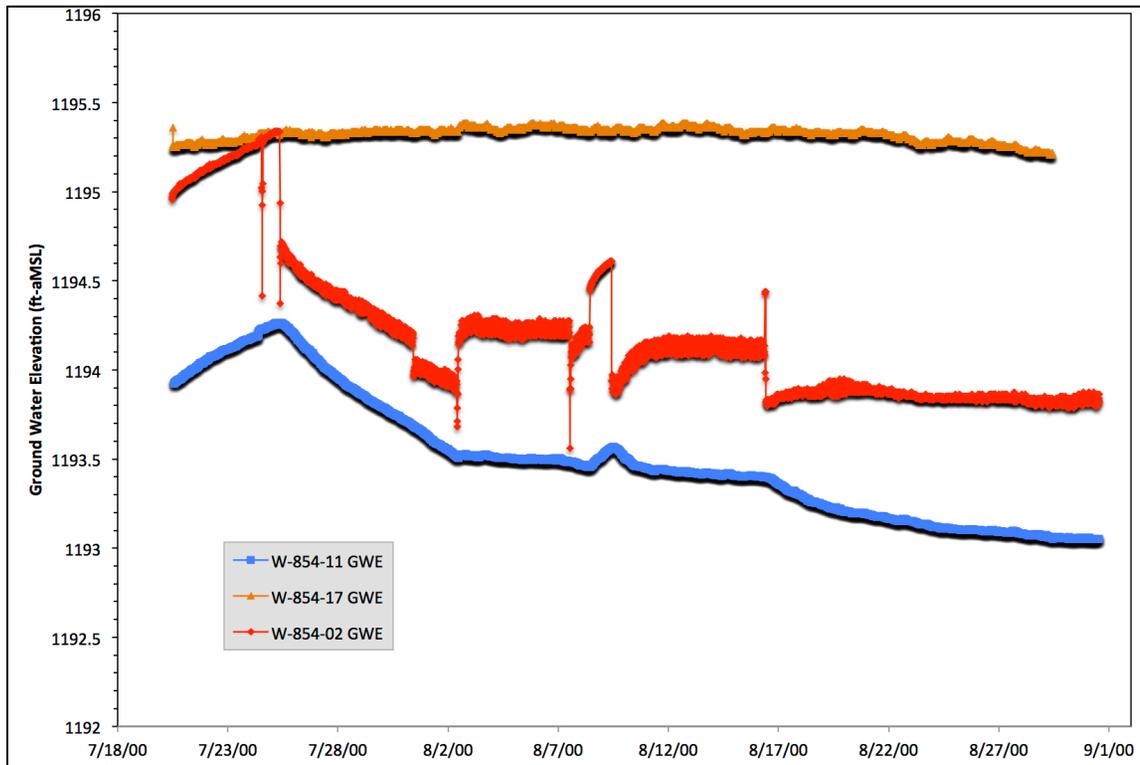
Hydrographs of 854-SRC wells during long-term W-854-02 hydraulic pump test in 2000

Well W-854-02 was pumped at flow rates from 1.5 to 3 gpm for 5 weeks.

Observation well W-854-17 is located ~ 80 ft cross-gradient (east) and W-854-11 is located ~ 225 ft downgradient (northwest) of W-854-02.

Essentially no response was observed in W-854-17 and an immediate large magnitude response was observed in W-854-11.

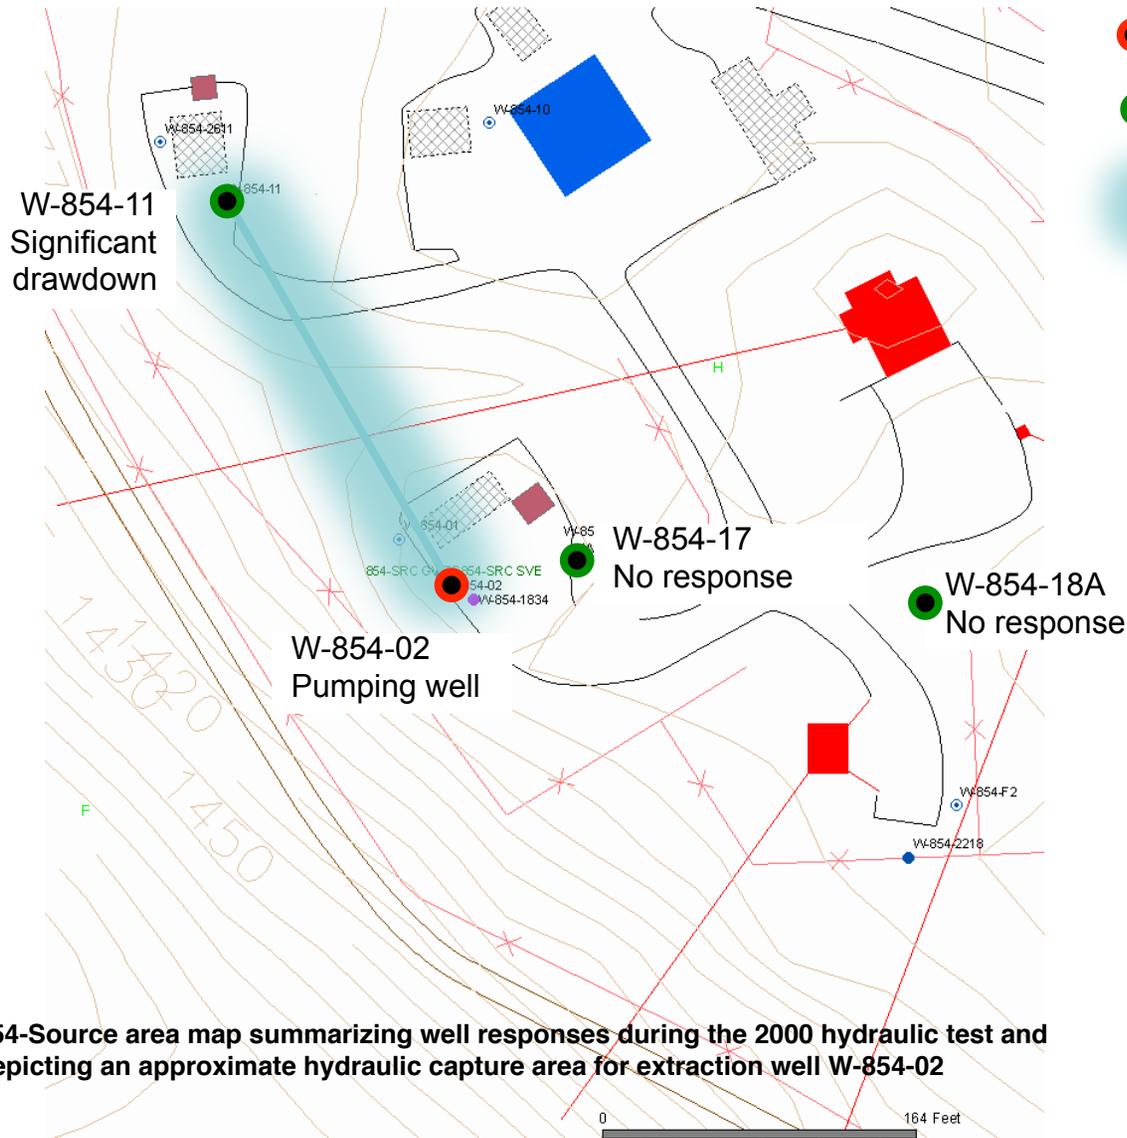
The capture zone for extraction well W-854-02 was estimated based on the 2000 hydraulic test results

The immediate large magnitude response observed in W-854-11 to pumping of W-854-02 suggests a predominantly fractured system.

The capture zone shown on the map is an estimate. The actual capture zone is complex due to the extent, geometry, and interconnectedness of fractures.

- **The magnitude and timing of hydraulic response in well W-854-11 to pumping at W-854-02 confirms the presence of preferential pathway(s), most likely north-northwest-oriented fractures (see slide 27 in October 30th 2013 RPM presentation).**
- **The short and long-term hydraulic response is consistent with either a dual-porosity system dominated by fractures or a discrete fracture system.**
- **The magnitude of immediate response in W-854-11 suggests that flow is dominated by discrete fracture(s).**
- **The hydraulic capture zone for extraction well W-854-02 is significantly different and could be much larger than those shown in the Compliance Monitoring Reports and the 5-Year Review due to the presence of these preferential pathways.**
