**First Five-Year Review Report for the
Building 850/Pit 7 Complex Operable Unit at
Lawrence Livermore National Laboratory
Site 300**

April 2016

Environmental Restoration Department

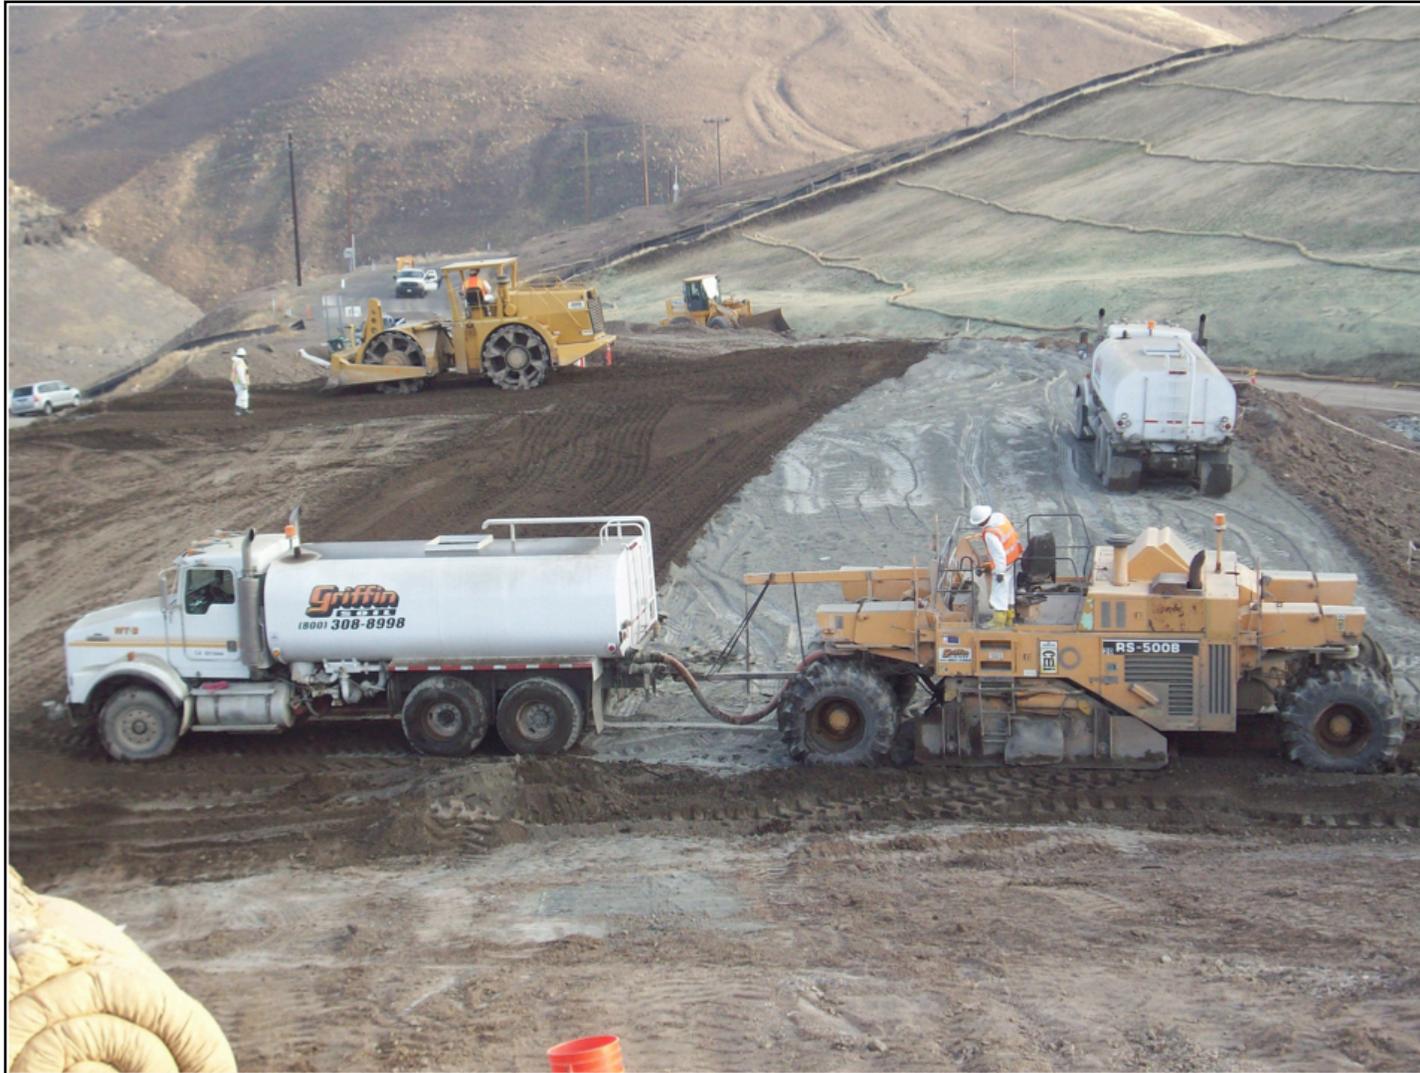
In 2009, 29,000 cubic yards of PCB-, dioxin-, and furan-contaminated soil was excavated from the Building 850 Firing Table area as a CERCLA removal action.

The excavated contaminated soil was mixed with Portland cement and water to solidify the soil, thereby mitigating the exposure risk to onsite workers and ecological receptors.

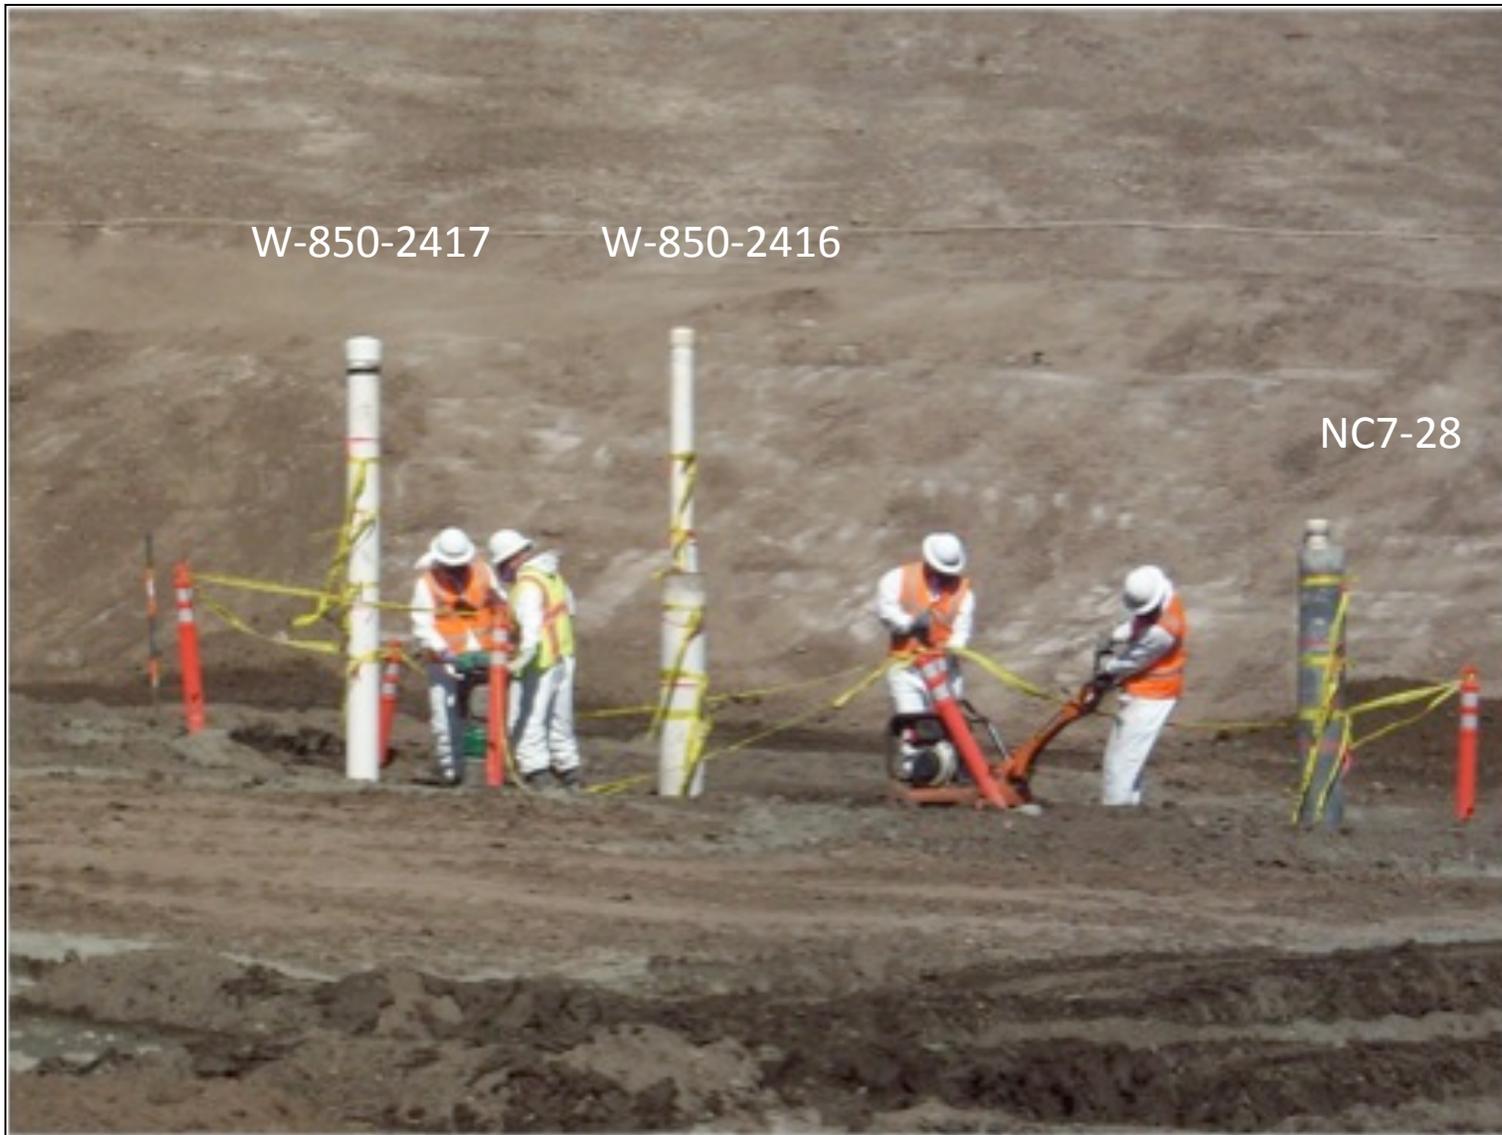
The mixing and compaction of soil and cement was conducted manually around existing ground water monitor wells located within the footprint of the CAMU to protect the integrity of the wells.

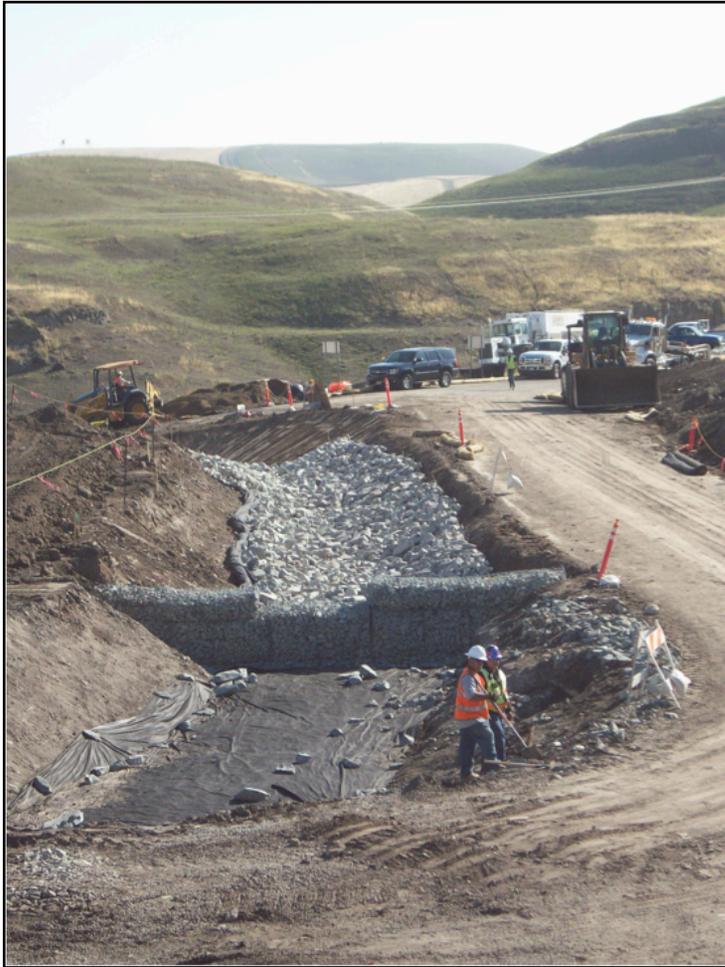
Surface water drainage on the east side of the CAMU.

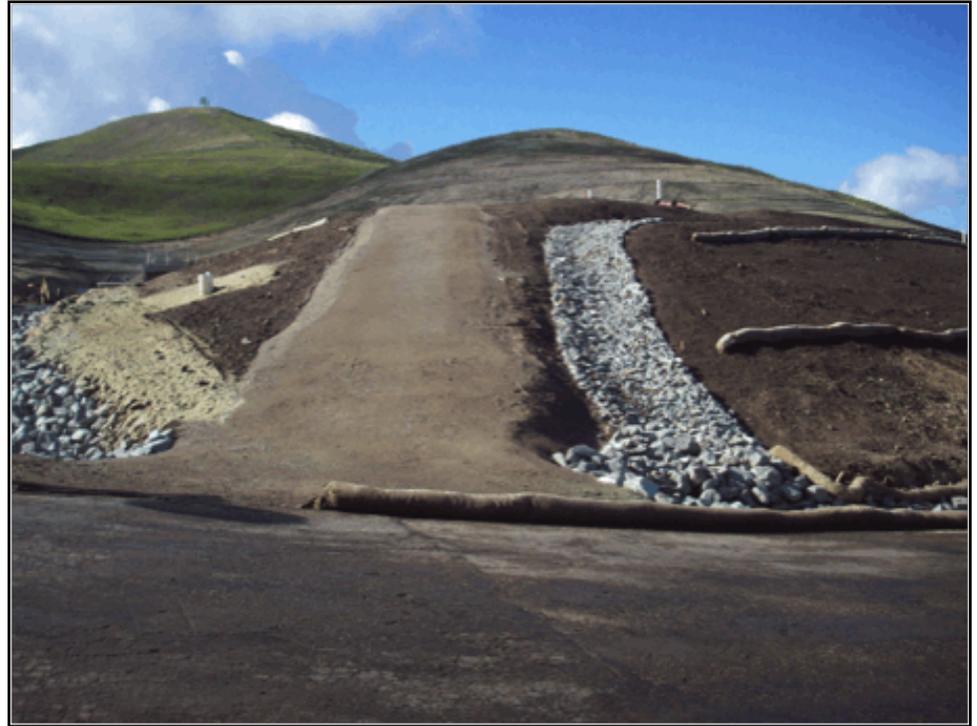
Surface water drainage from the top to the base of the CAMU.

A drainage system was constructed on and around the perimeter of the CAMU to convey surface water runoff away from the CAMU.

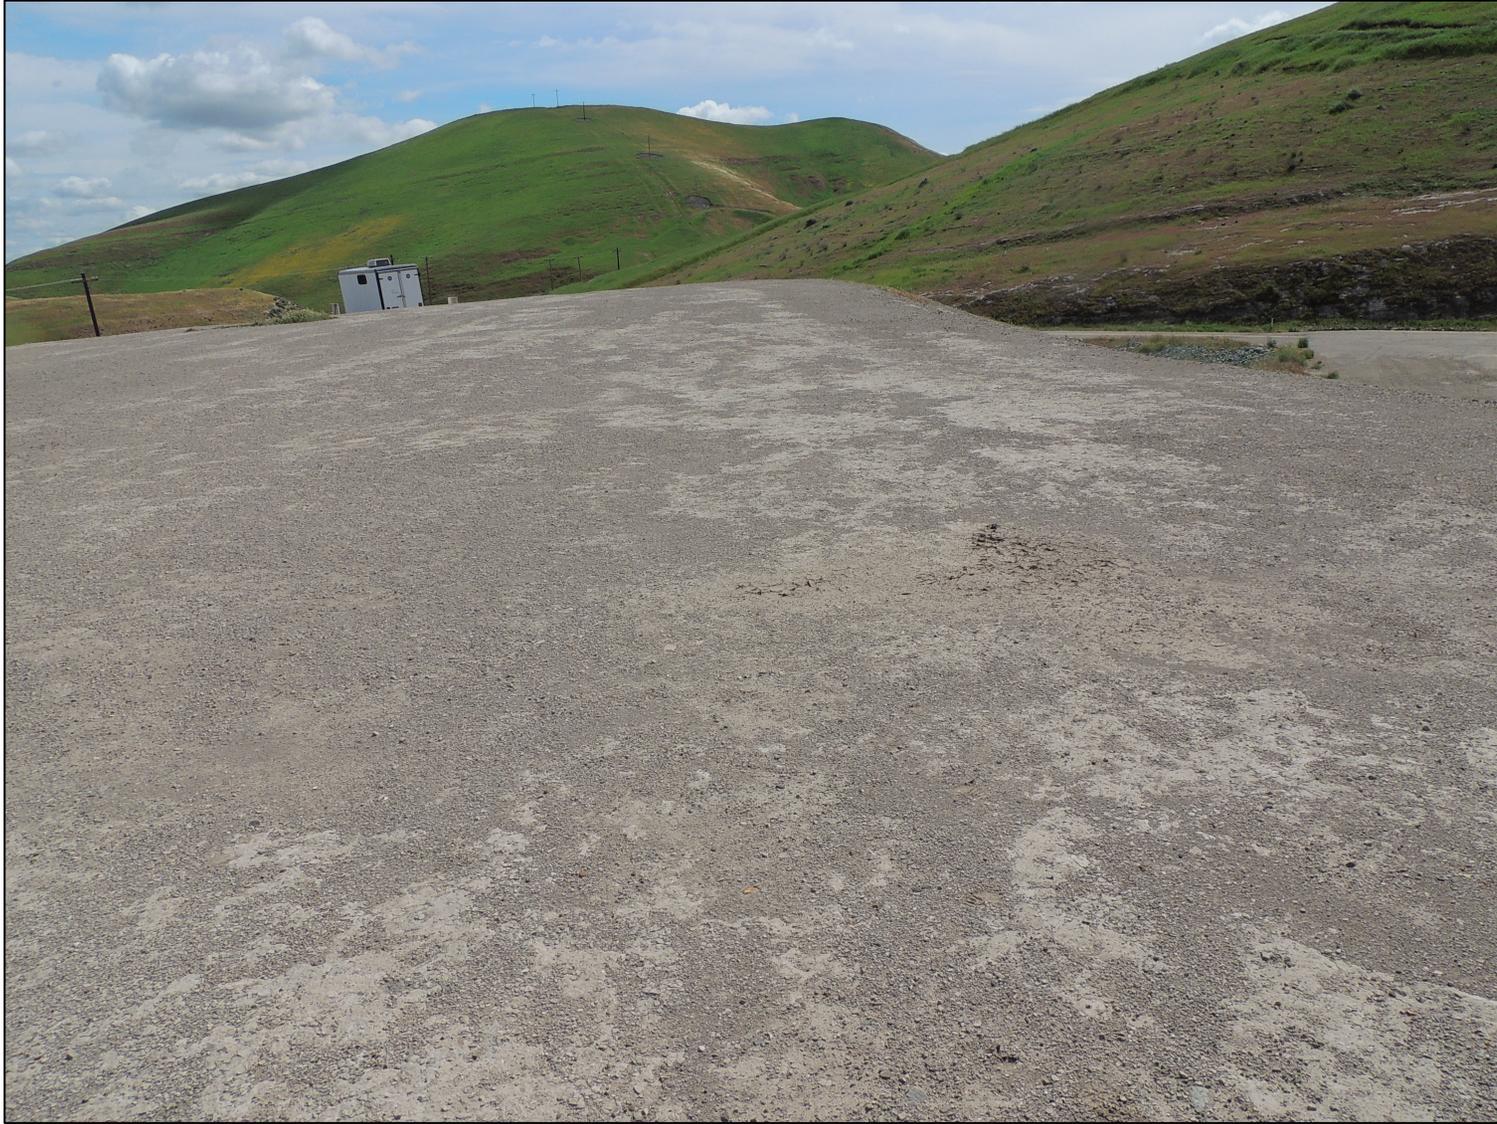
Photograph of top surface of Building 850 CAMU (looking south).

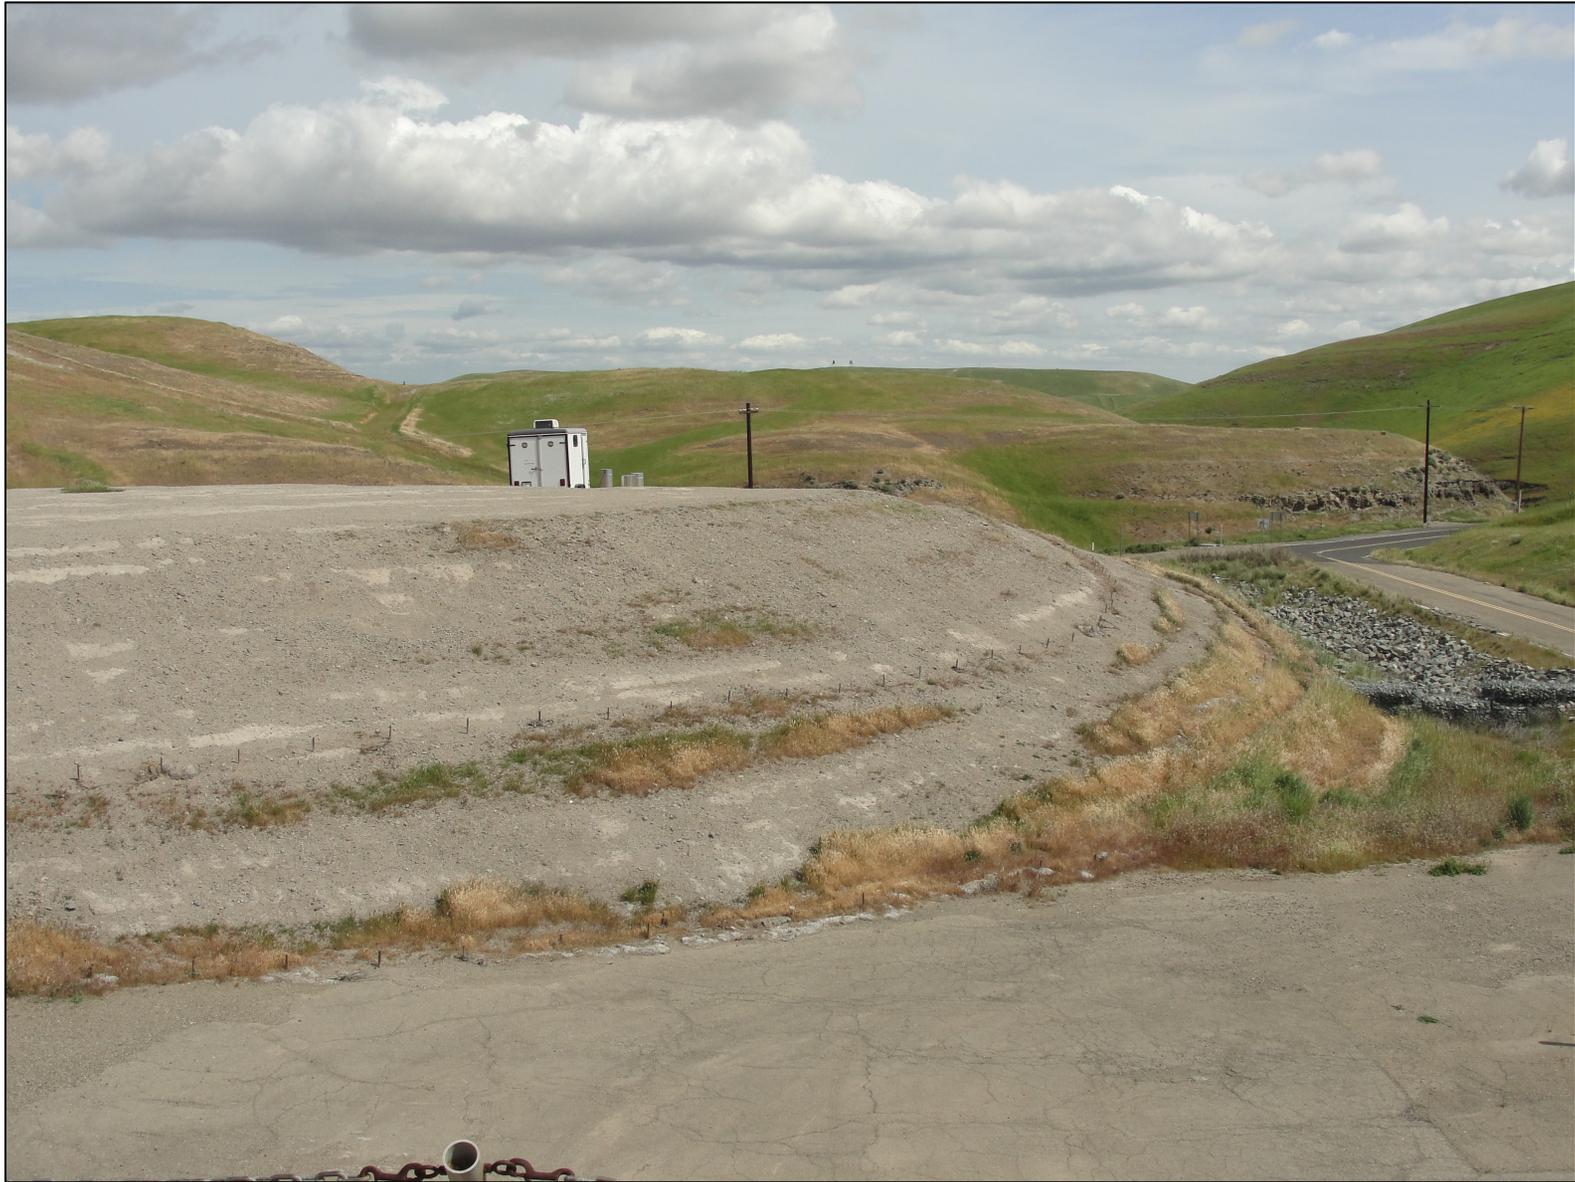
Photograph of Building 850 CAMU (looking east).

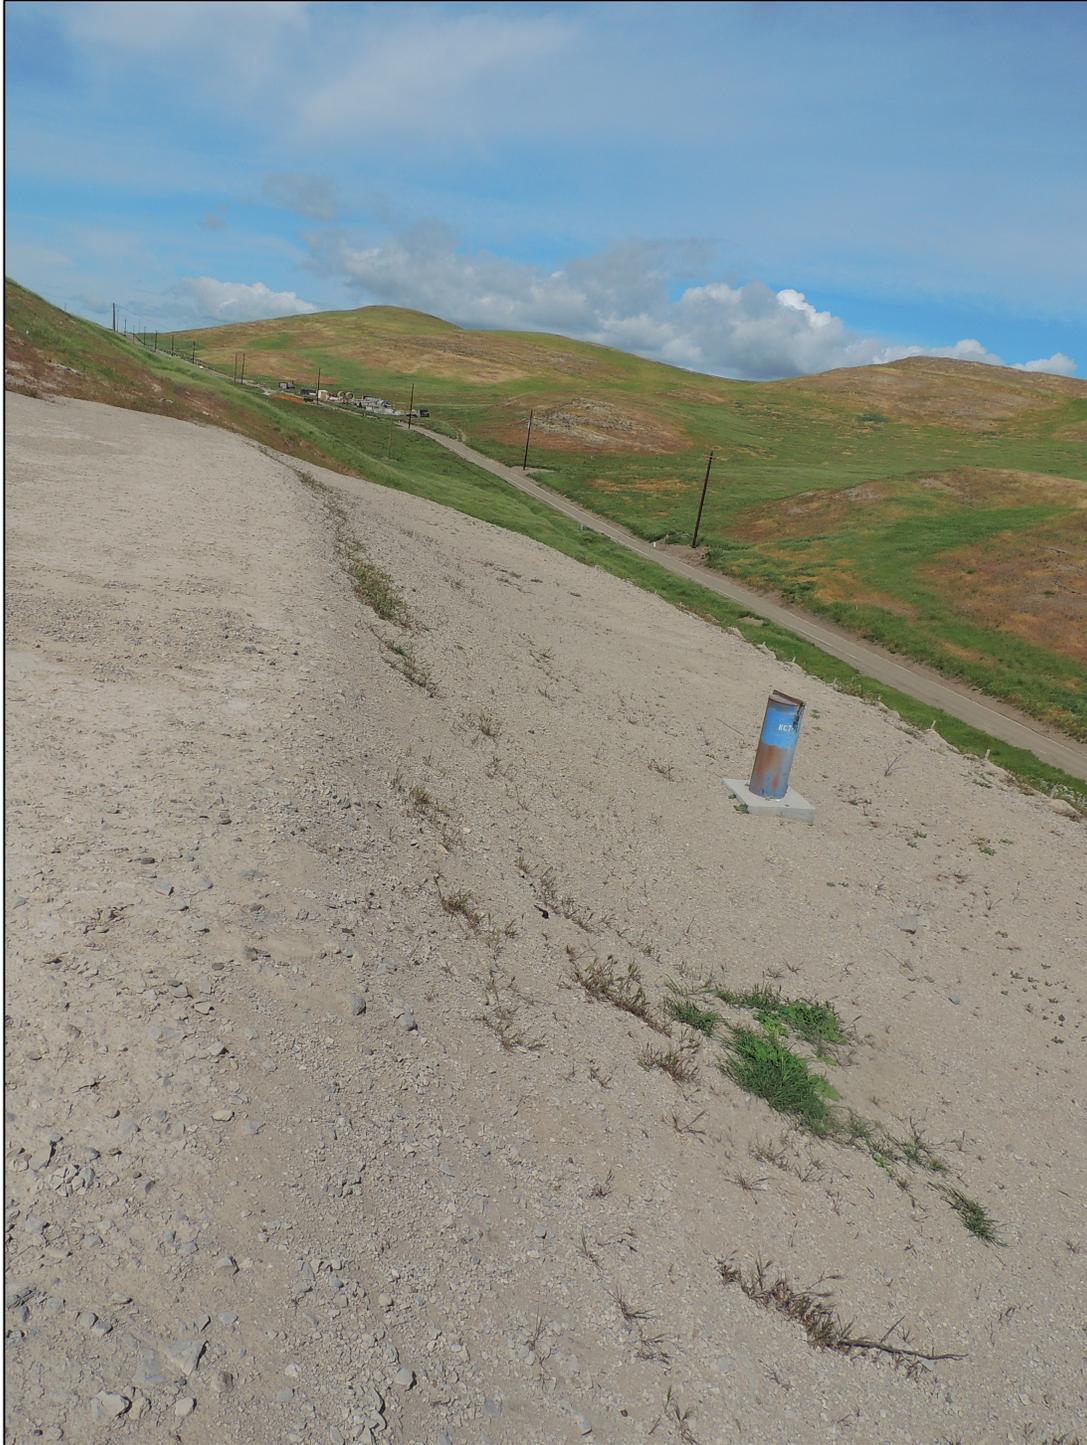
East side of Building 850 CAMU from the top of the CAMU (Looking north).

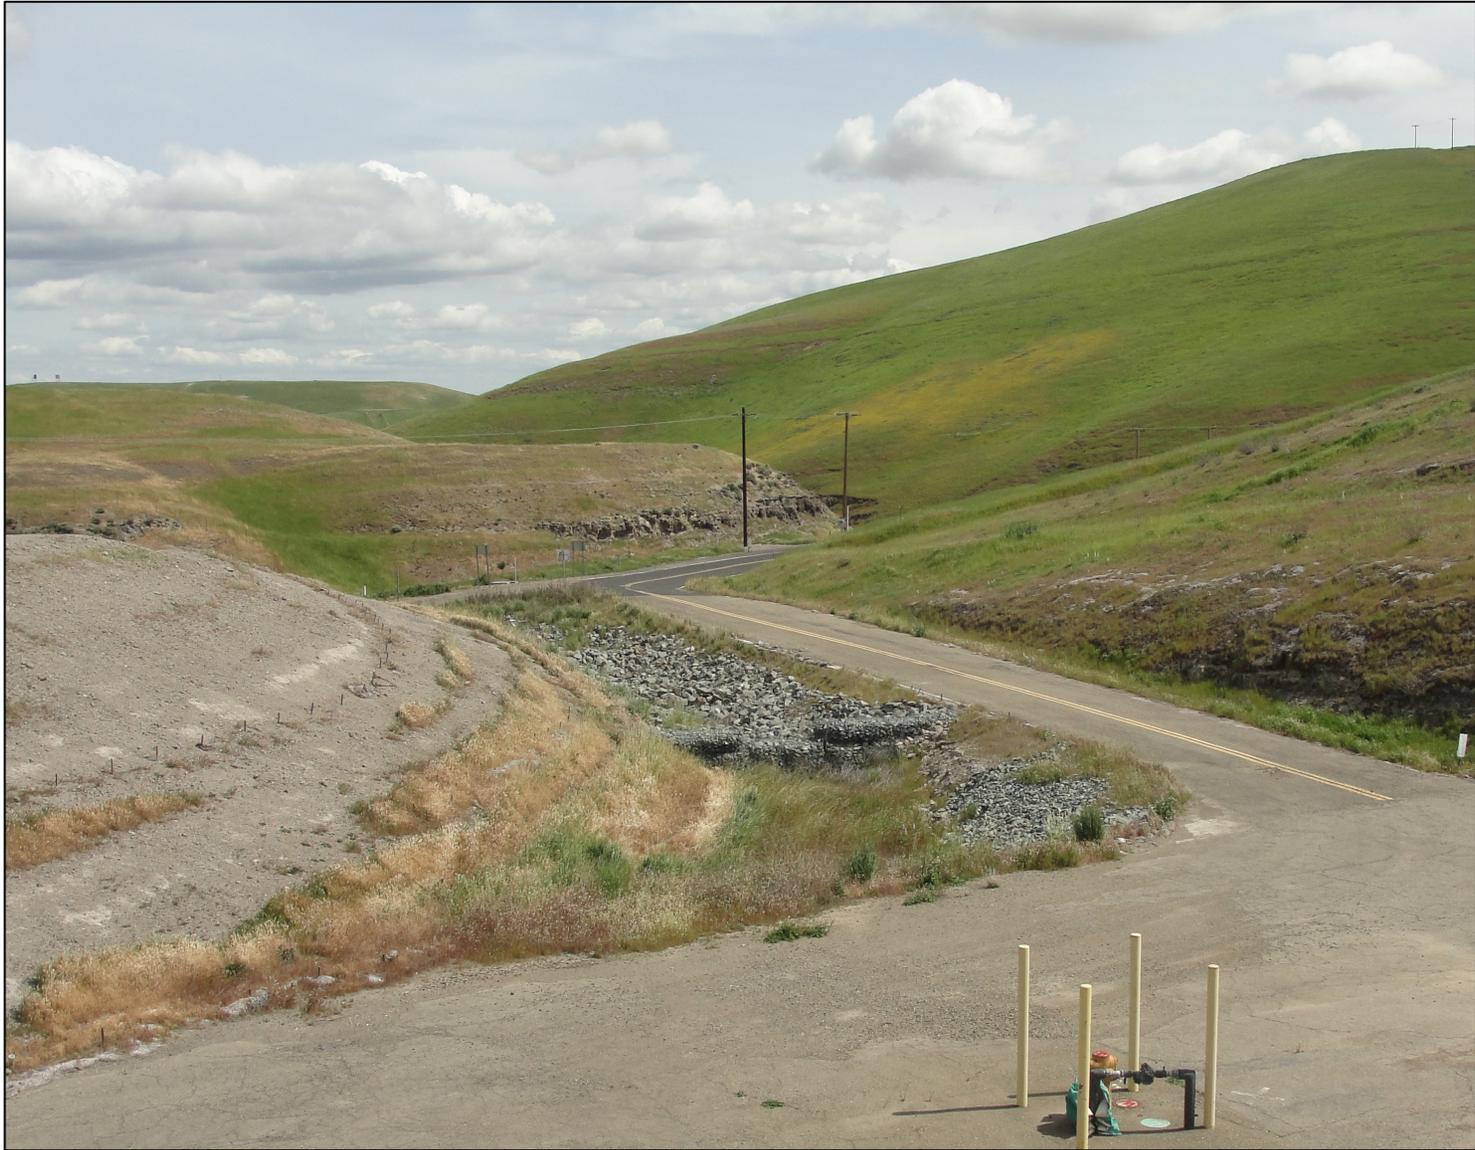
Photograph of drainage channel on south side of CAMU (looking east).

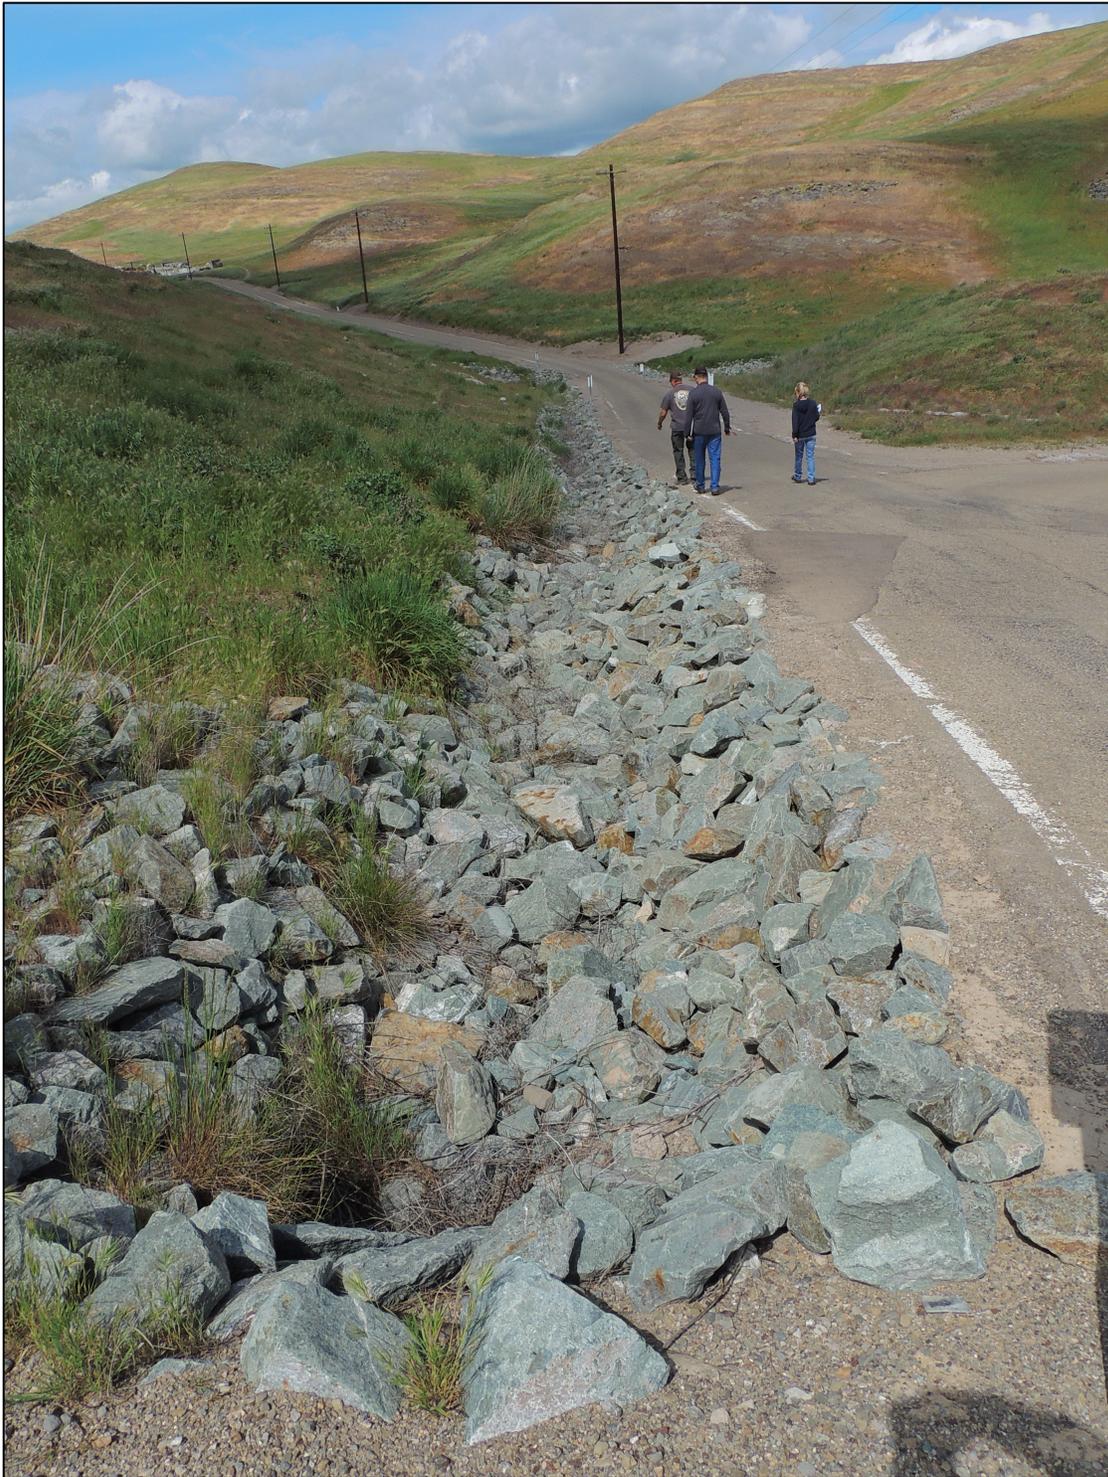
Drainage system channel on the east side of the CAMU.

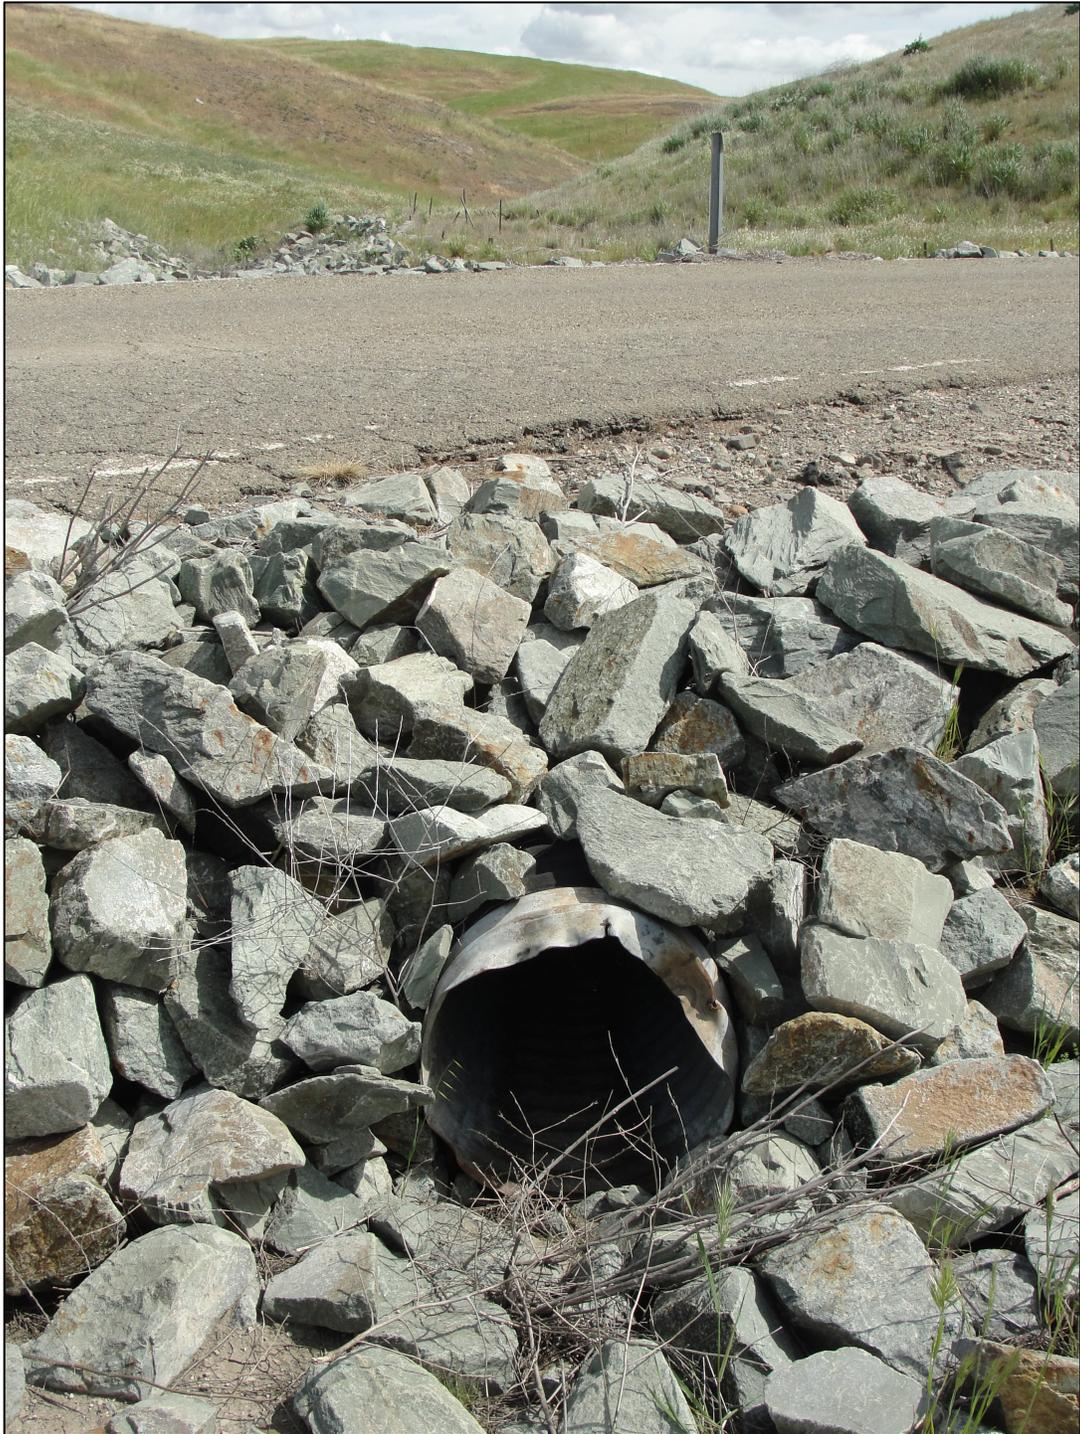
Drainage culvert under road.

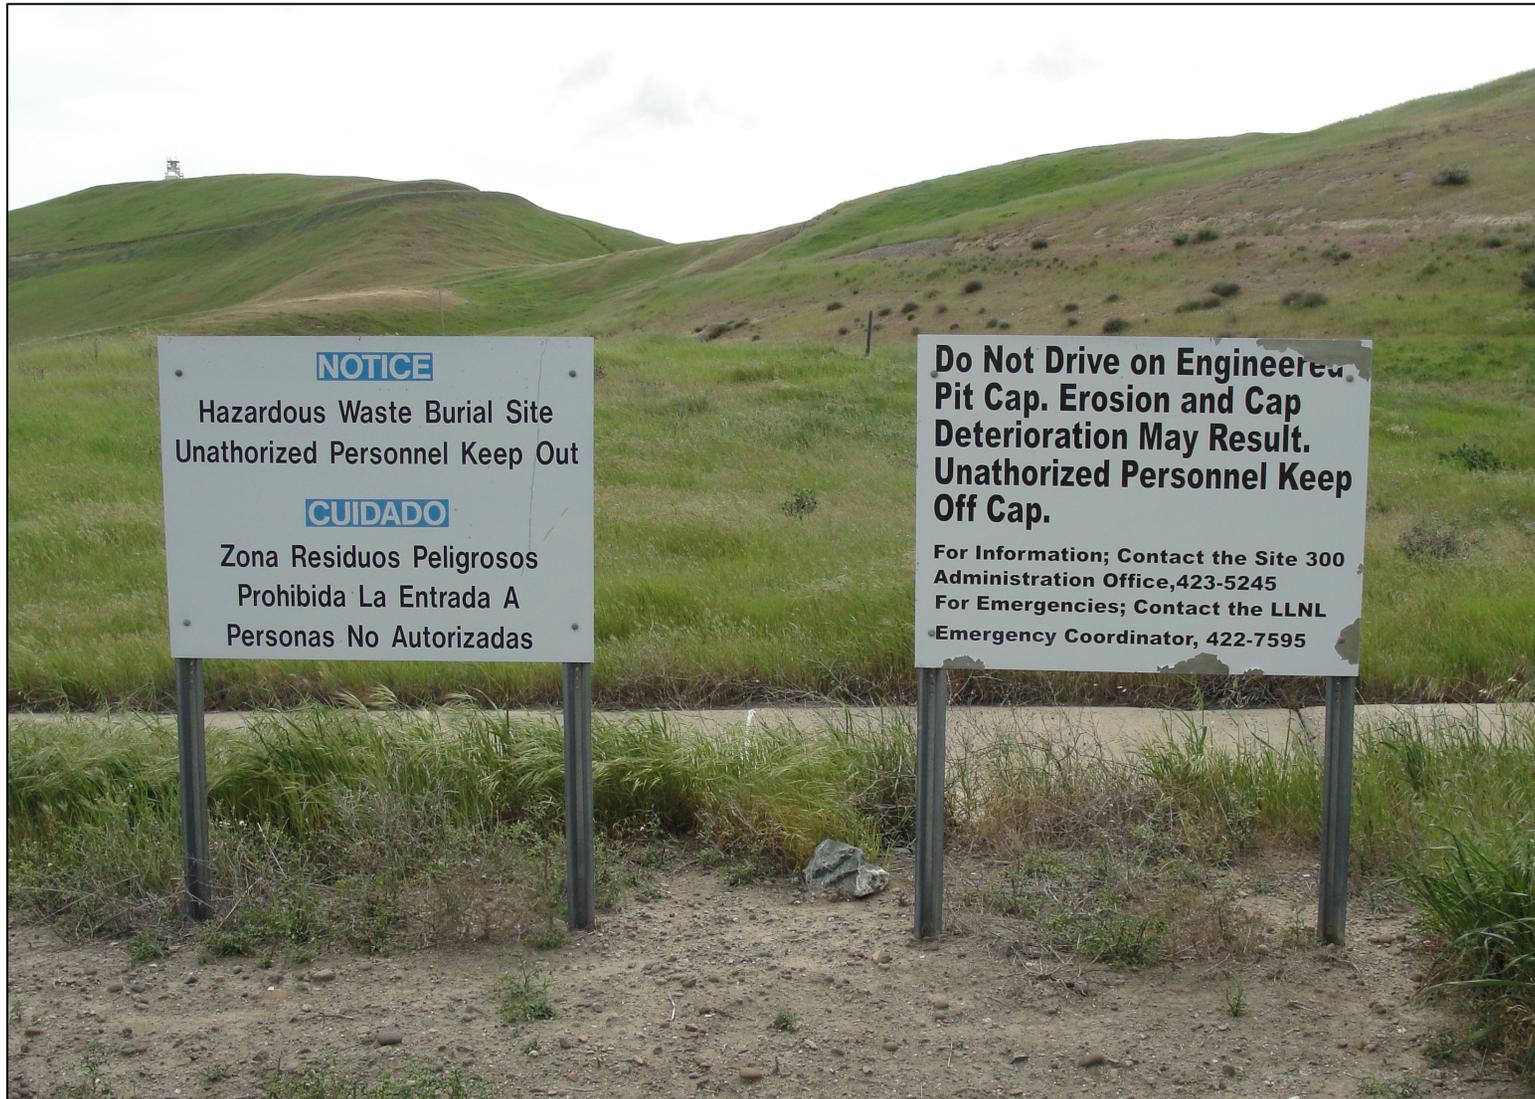
Signage at the Pit 7 Complex landfills (institutional controls).

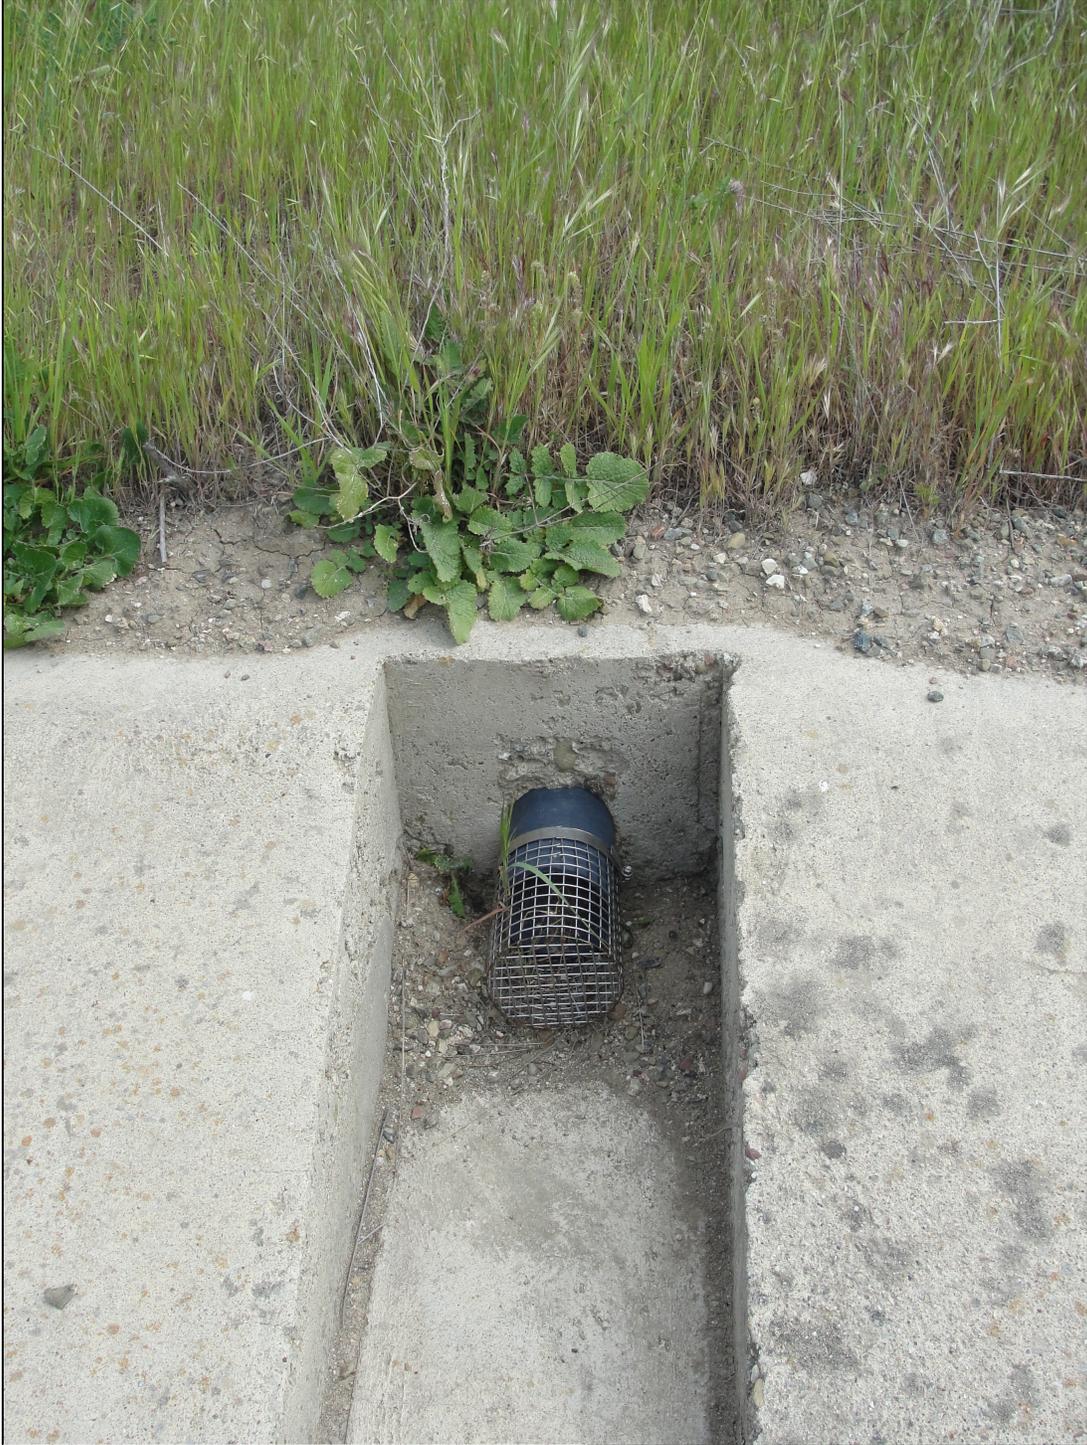
Pit 7 Landfill cap drainage outfall.

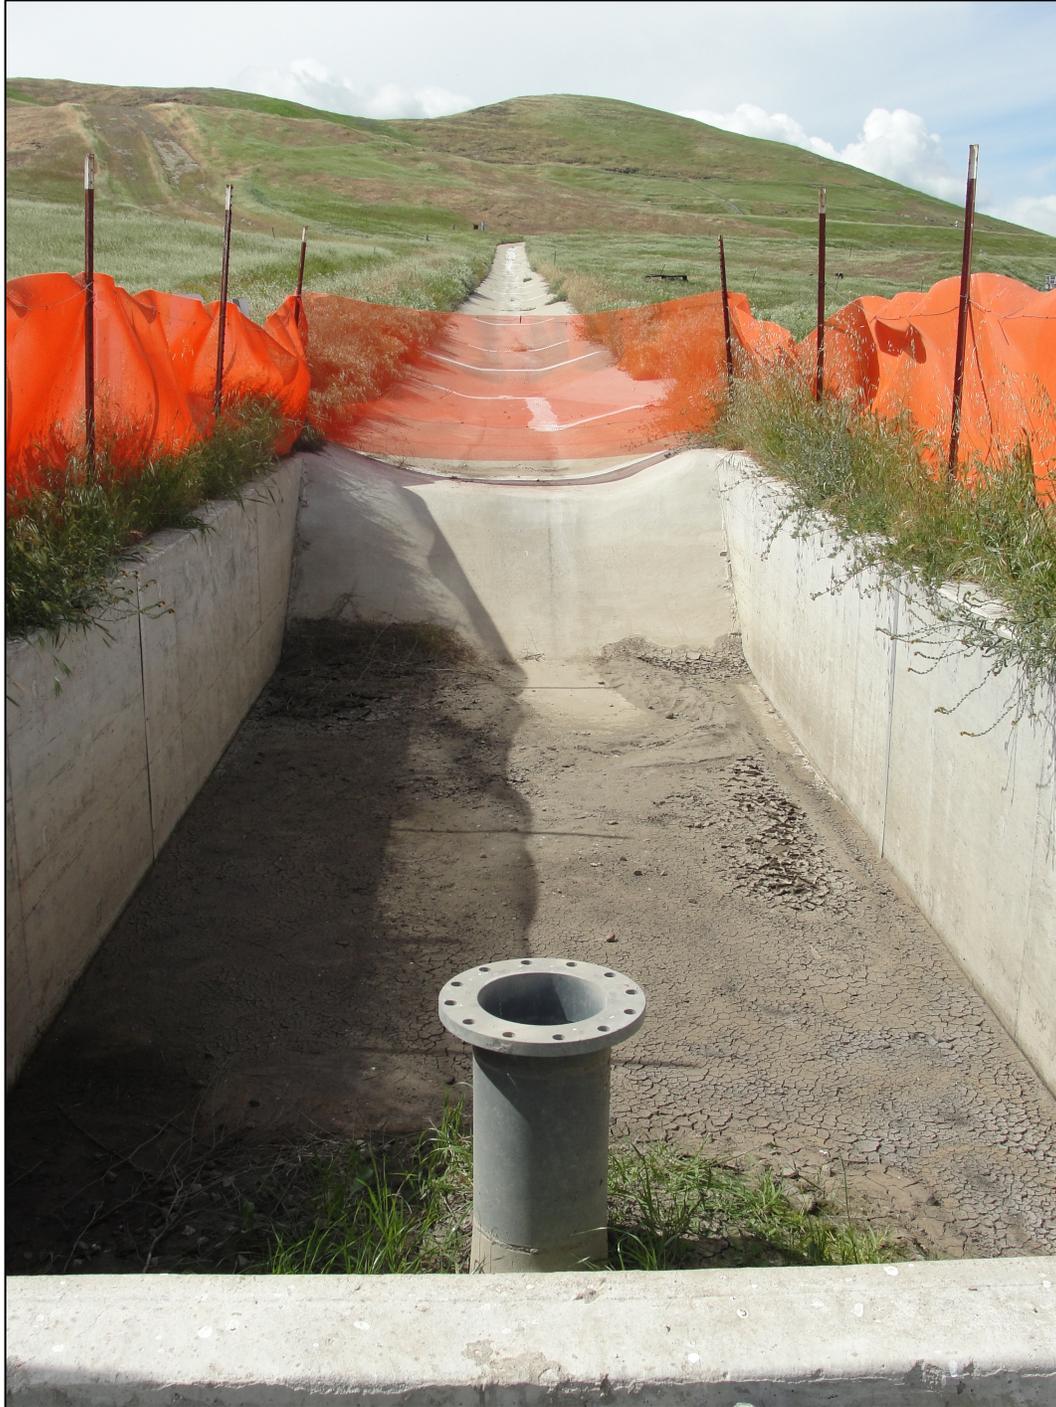
Drainage Diversion System: Southern Settling Basin

Current photographs of the Southern Settling Basin component of the drainage diversion system at the Pit 7 Complex.

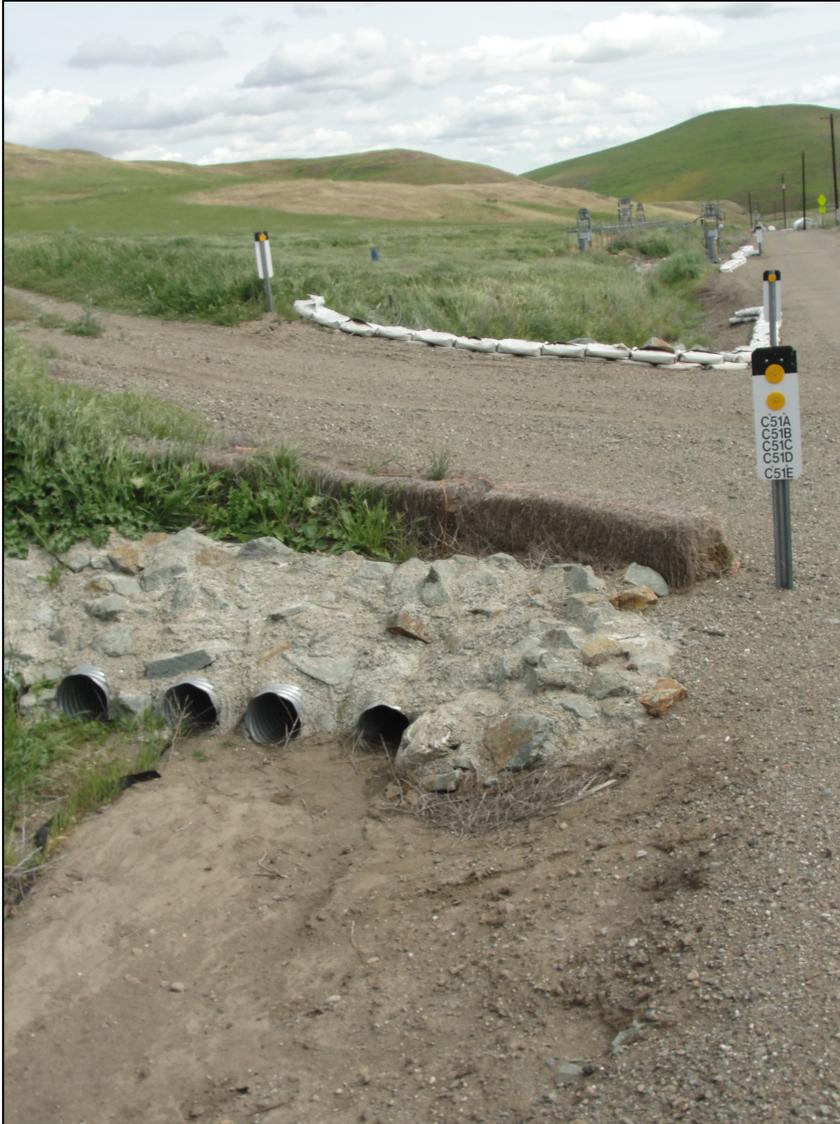
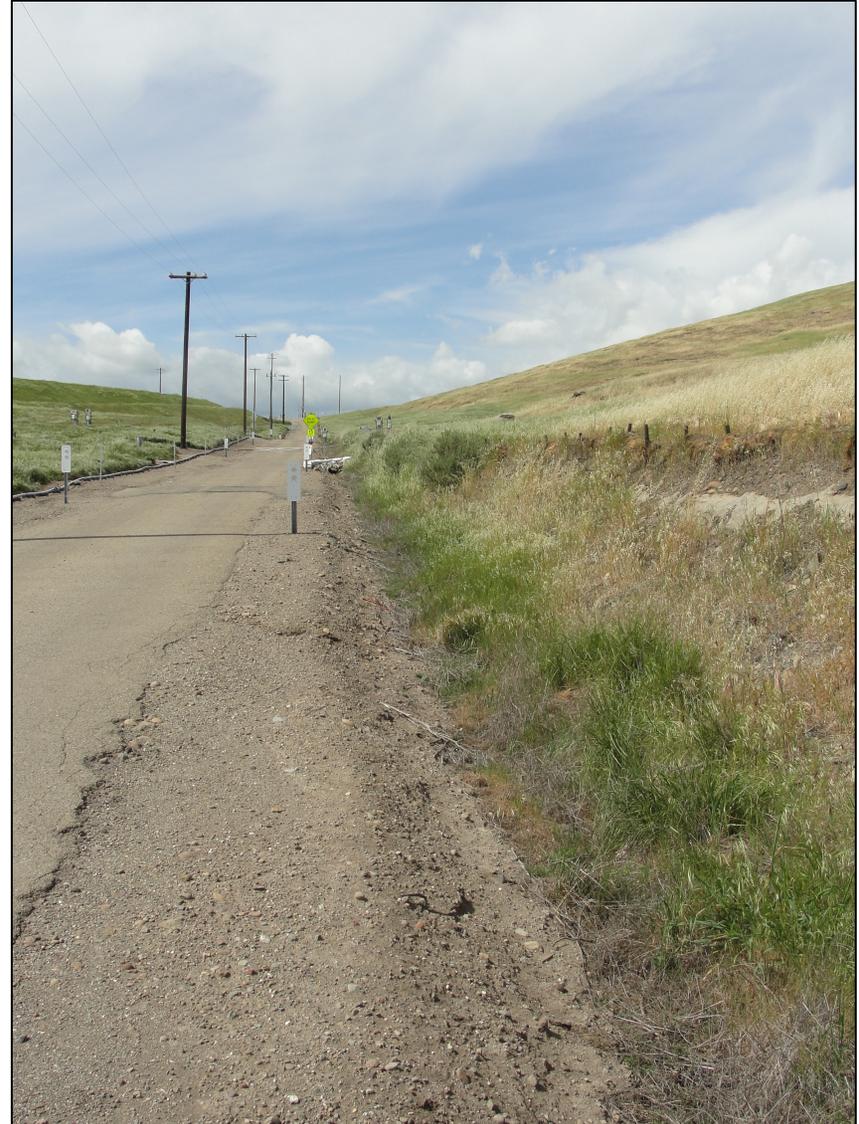
Drainage Diversion System: Eastern Vegetated Channel

Current photographs of the Eastern Vegetated Channel component of the drainage diversion system at the Pit 7 Complex.
