**First Five-Year Review Report for the
Building 850/Pit 7 Complex Operable Unit at
Lawrence Livermore National Laboratory
Site 300**

April 2016

Environmental Restoration Department

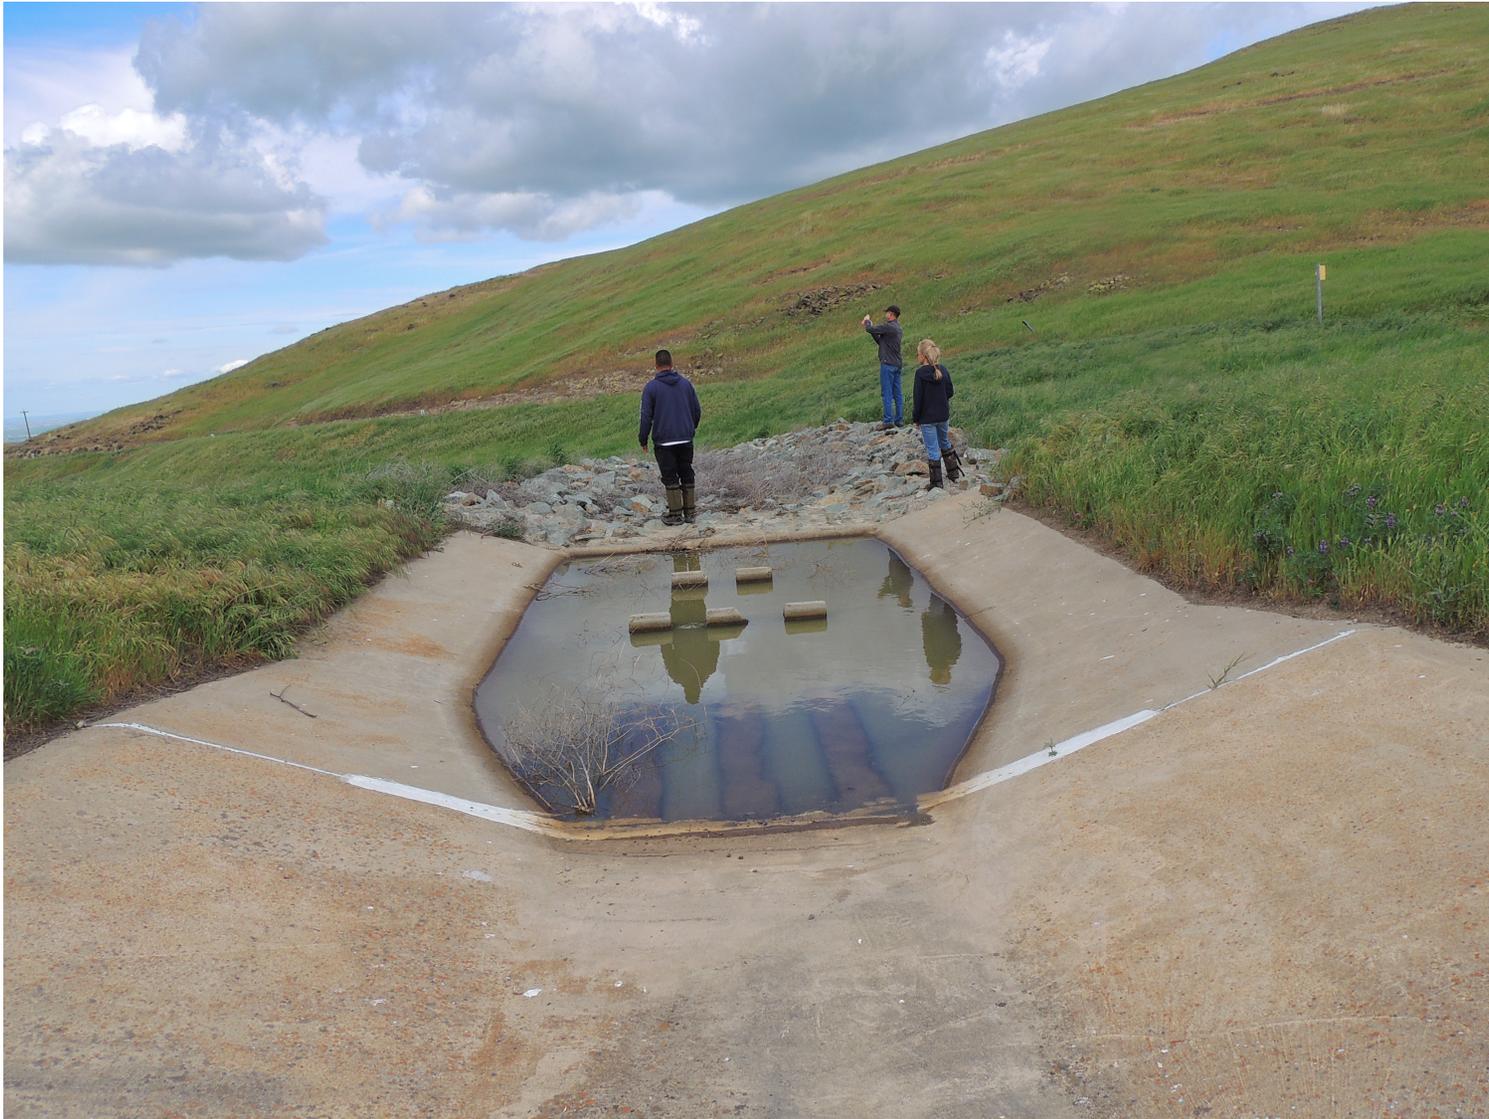
Drainage Diversion System: Northern Rip-Rap

Current photographs of the Northern Rip-Rap component of the drainage diversion system at the Pit 7 Complex.

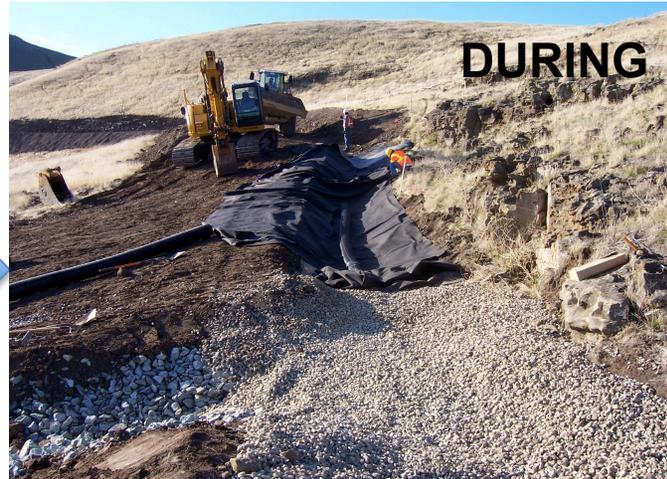
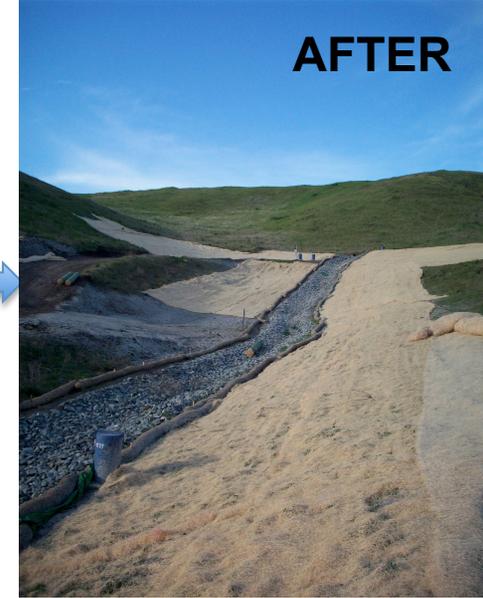
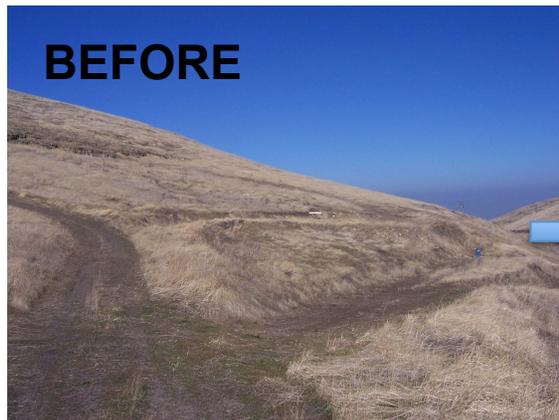
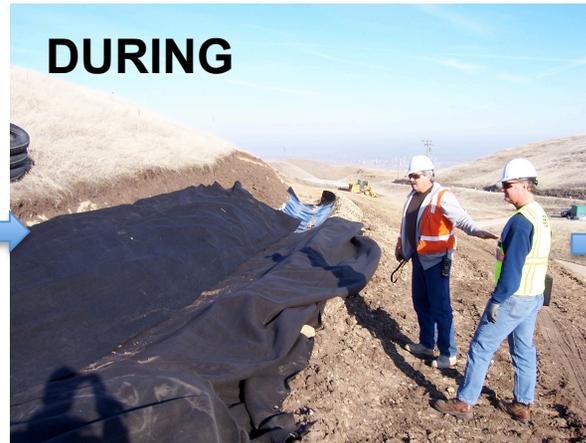
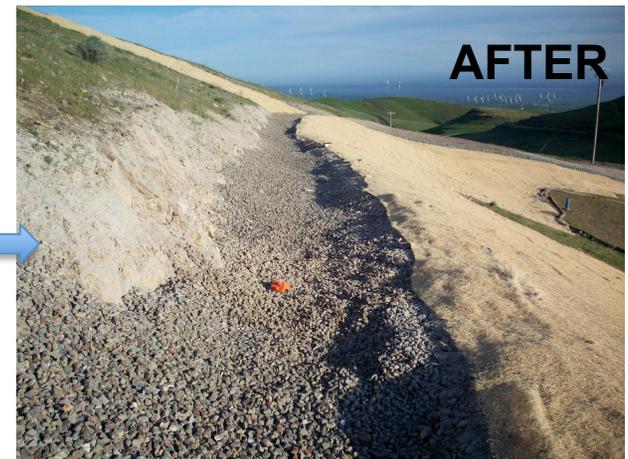
Drainage Diversion System: Western Drainage Channels

Photographs of the Western Drainage Channel component of the drainage diversion system at the Pit 7 Complex before, during, and immediately after construction.

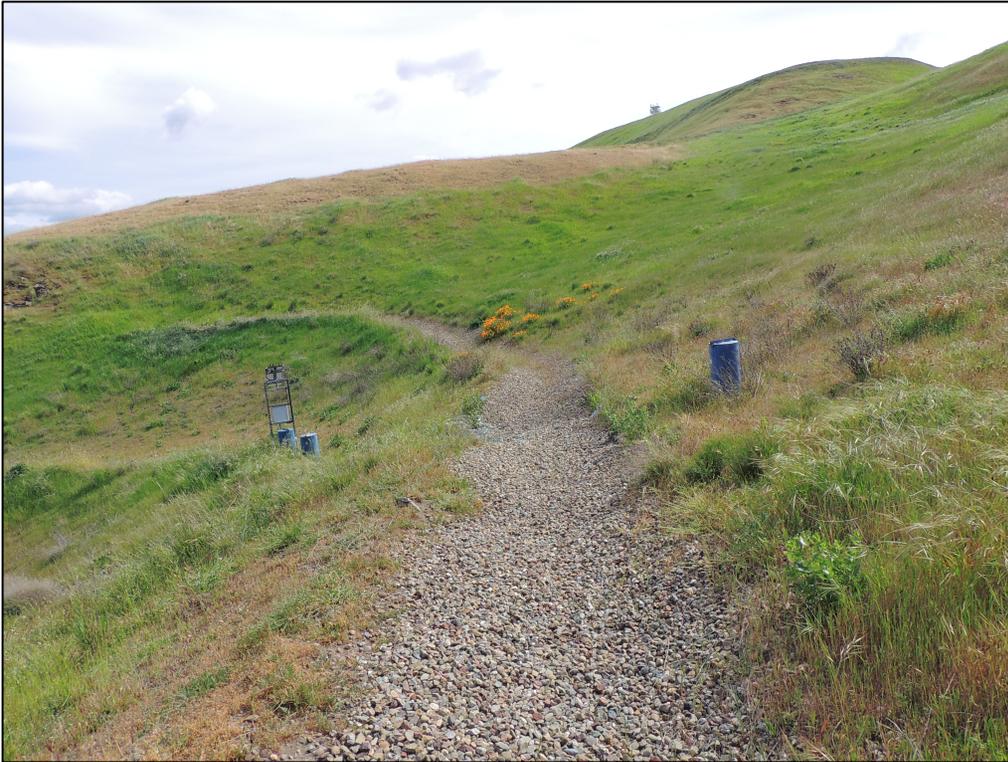
Western hillslope drainage and monitor wells

Current photographs of the drainage channels on the western hillslope that capture surface runoff and shallow subsurface flow during rainfall events.

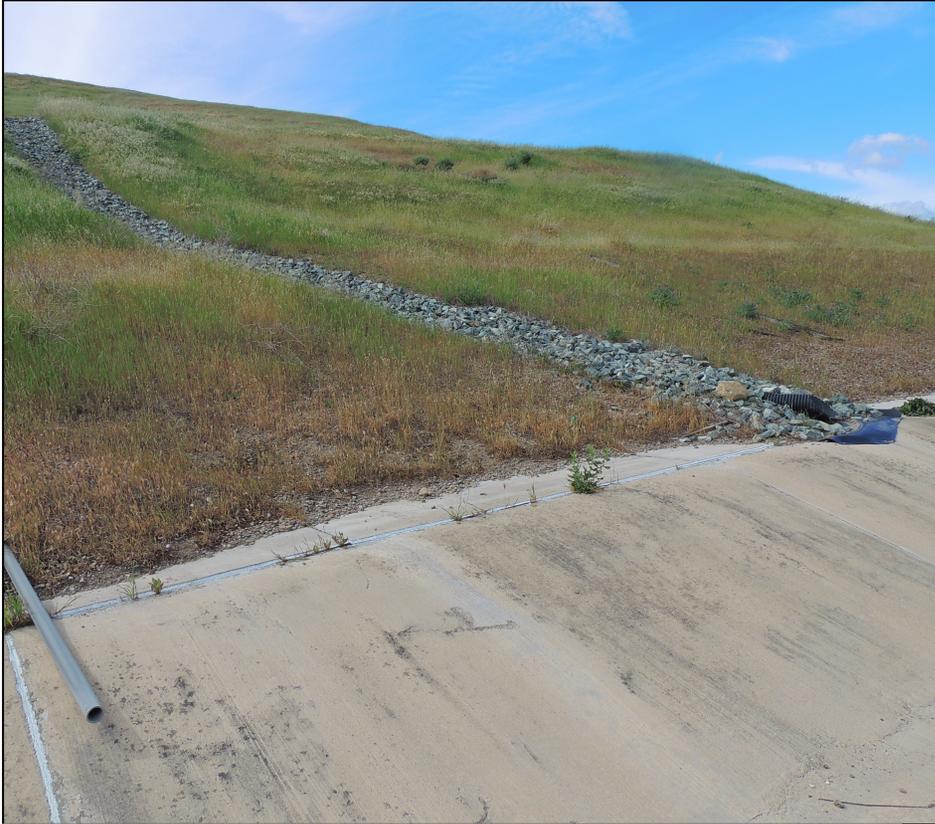
Western hillslope drainage to landfill drainage system

Drainages constructed perpendicular to the hillslope convey water from the western hillslope drainage channels to the landfill perimeter drainage system.

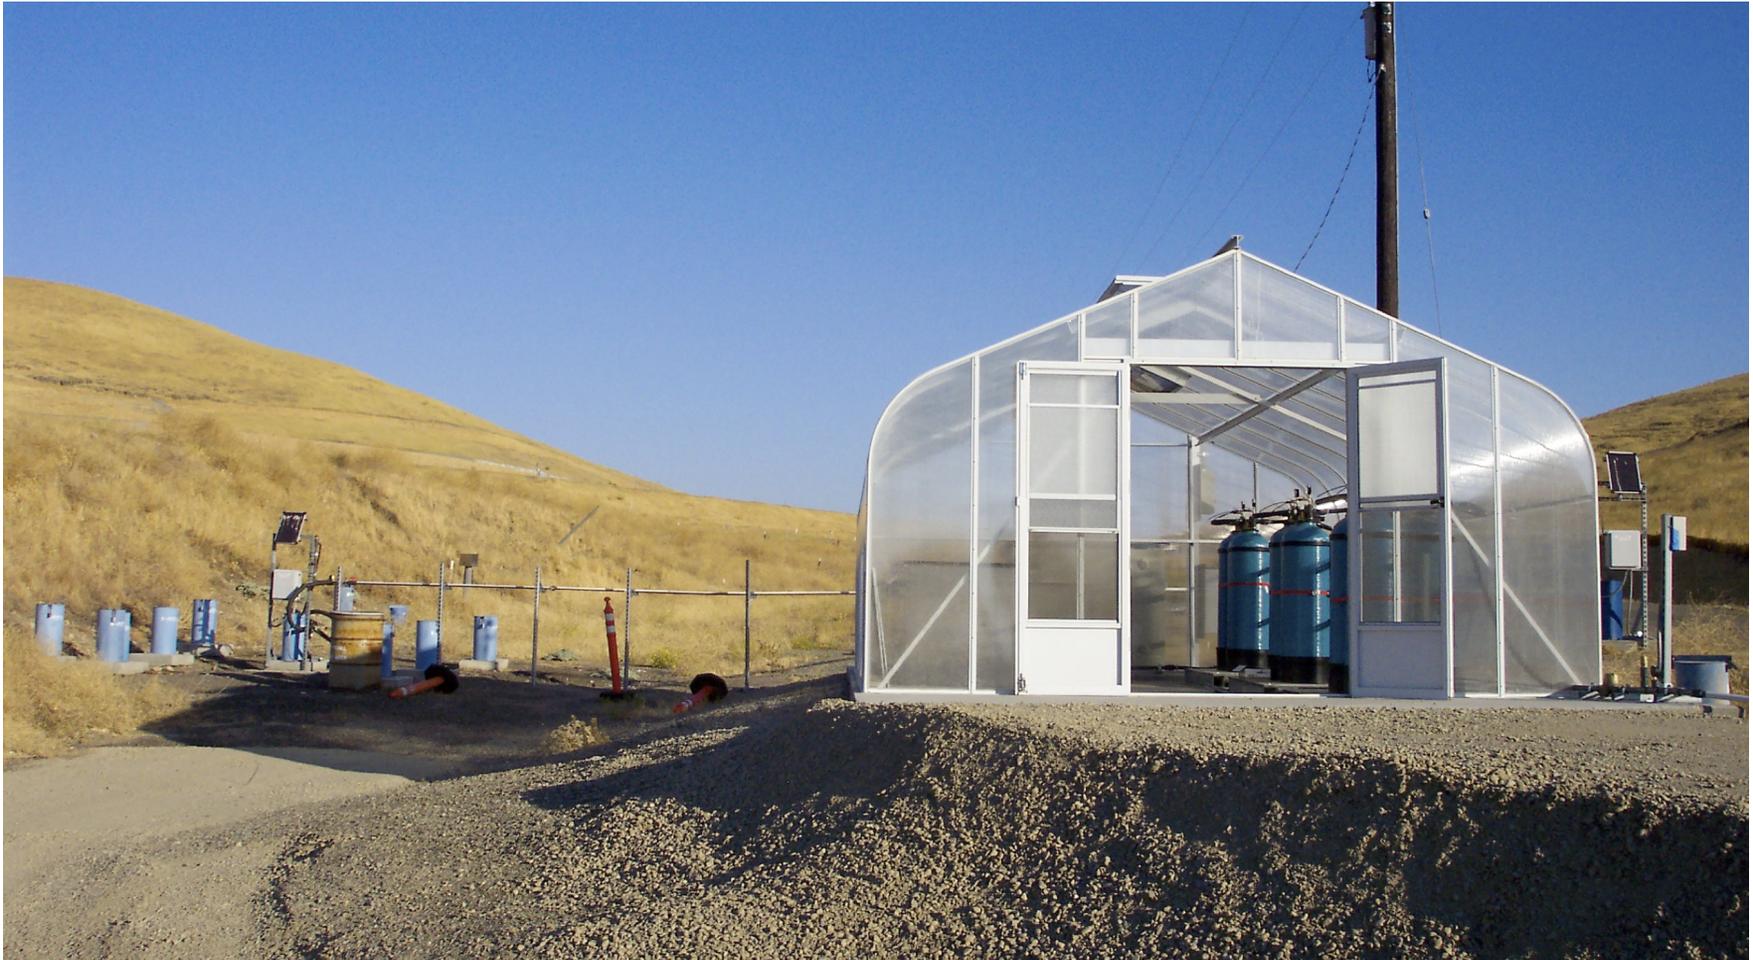
Pit 7 – Source extraction wells and treatment facility enclosure

The Pit 7 – Source extraction and treatment system removes contaminants already released to ground water.

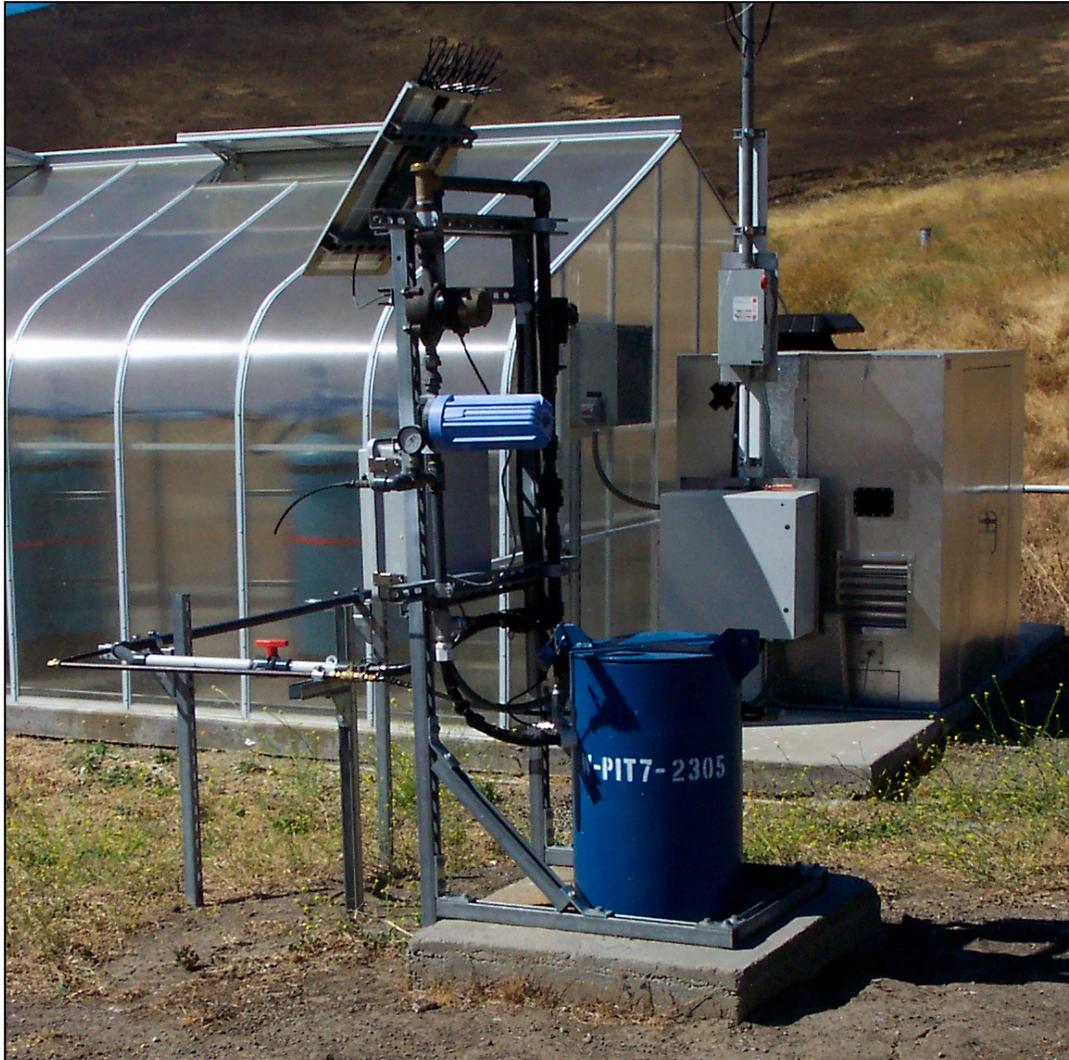
Pit 7 – Source extraction well and treatment facility enclosure

Ground water containing VOCs, uranium, perchlorate, nitrate, and tritium is extracted and piped to the Pit 7 – Source ground water treatment system.

Remarks: The ground water extraction wells are inspected weekly and are in good condition and operating properly.

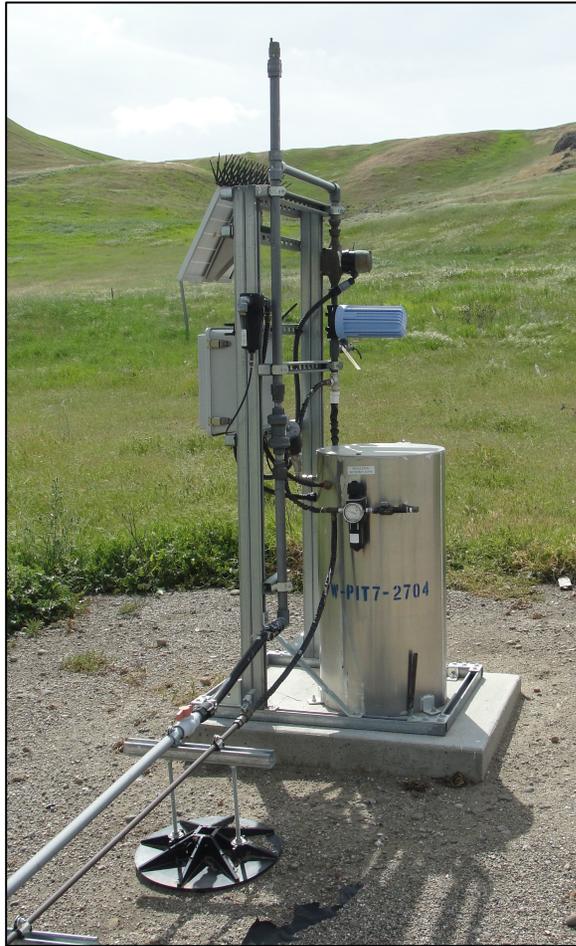
Wells are monitored to evaluate the effectiveness of both ground water cleanup and the drainage diversion system.

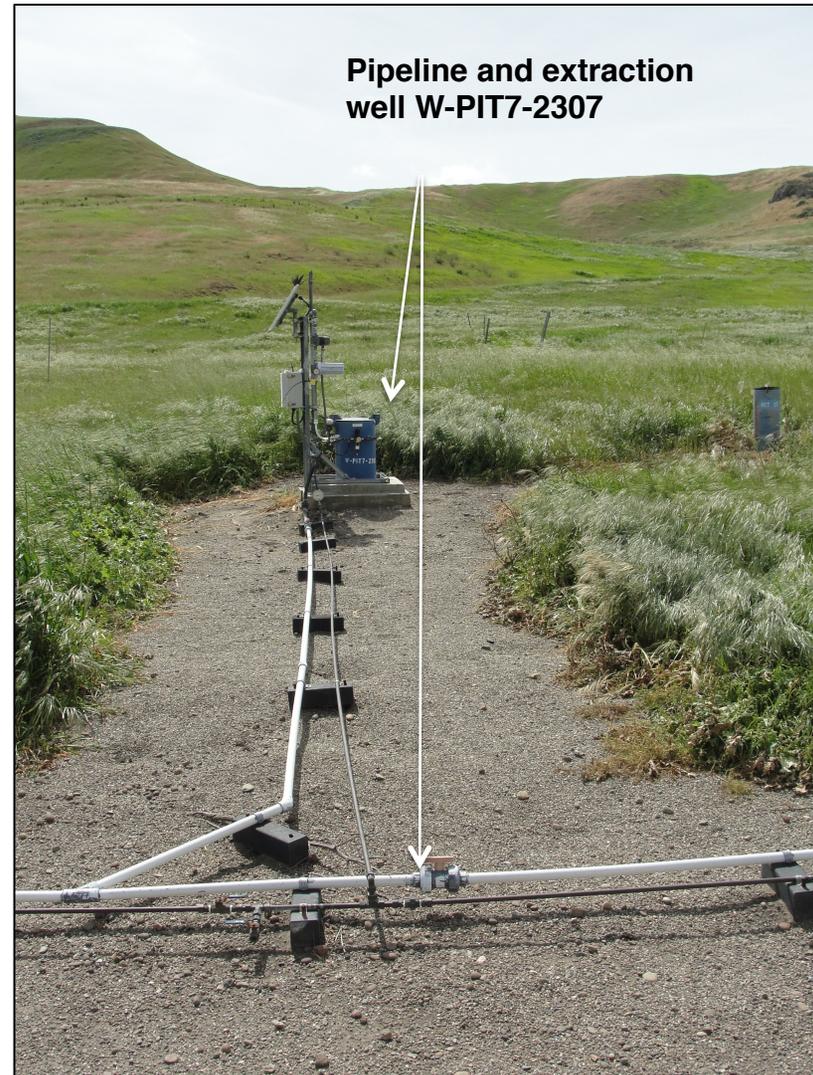
Pit 7 – Source extraction system pipelines

Above-ground pipelines convey extracted ground water to the Pit 7 – Source ground water treatment system.

Remarks: All extraction system pipelines and valves are inspected weekly and are in good condition.
